Investigation of the Cause of Failure of Building Structures in Damaturu, Northeastern Nigeria, Using Electrical Resistivity Method

¹Agada Livinus Emeka, ²Busari Kehinde Abdulsemiu

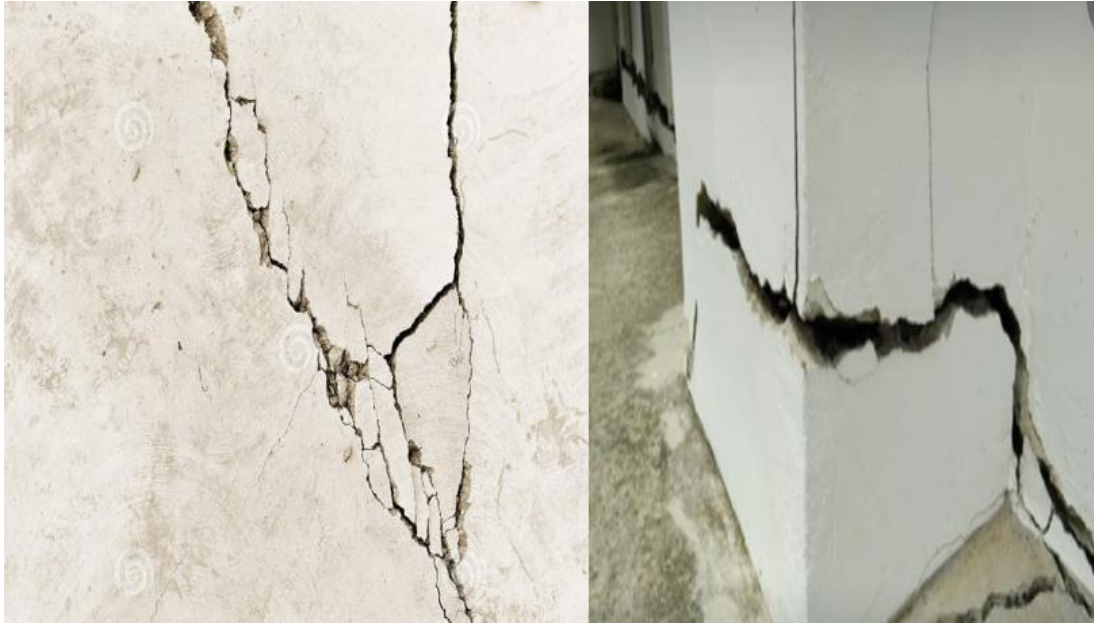
Failed buildings are common in Pompomari area of Damaturu, northeastern Nigeria. They are also easily seen in the other parts of Damaturu metropolis. Most of the affected buildings had cracks and deformations on their walls even down to their foundations (Figure 1). Considering the importance of geophysical investigation to building construction, this study investigated the cause of building failures in Pompomari area of Damaturu and its environs. It is also focused on delineating the subsurface stratigraphic sequence and the evaluation of the geoelectric parameters of the subsurface layers and their implications on the integrity of the foundations of the buildings in the study area and its environs.

Figure 1: A typical failed building with cracks down to the foundation in the study area.

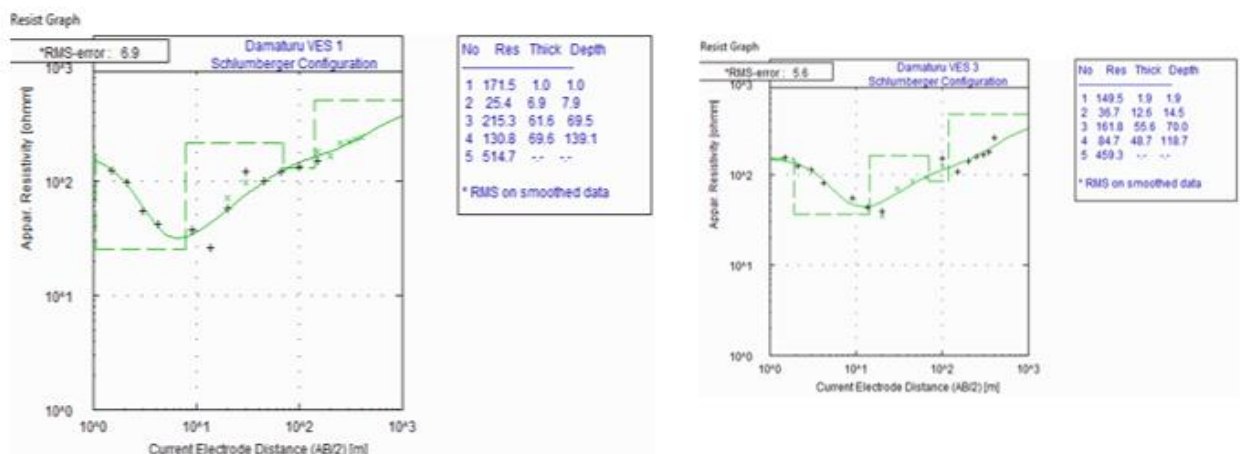
Five geoelectric layers were delineated as shown by the resistivity curves in the study area (Figure 3). The subsurface is composed of topsoil, clay, sand, sandy clay and sand (Figures 4 and 5).

Figure 3: Typical curves obtained from the study area.

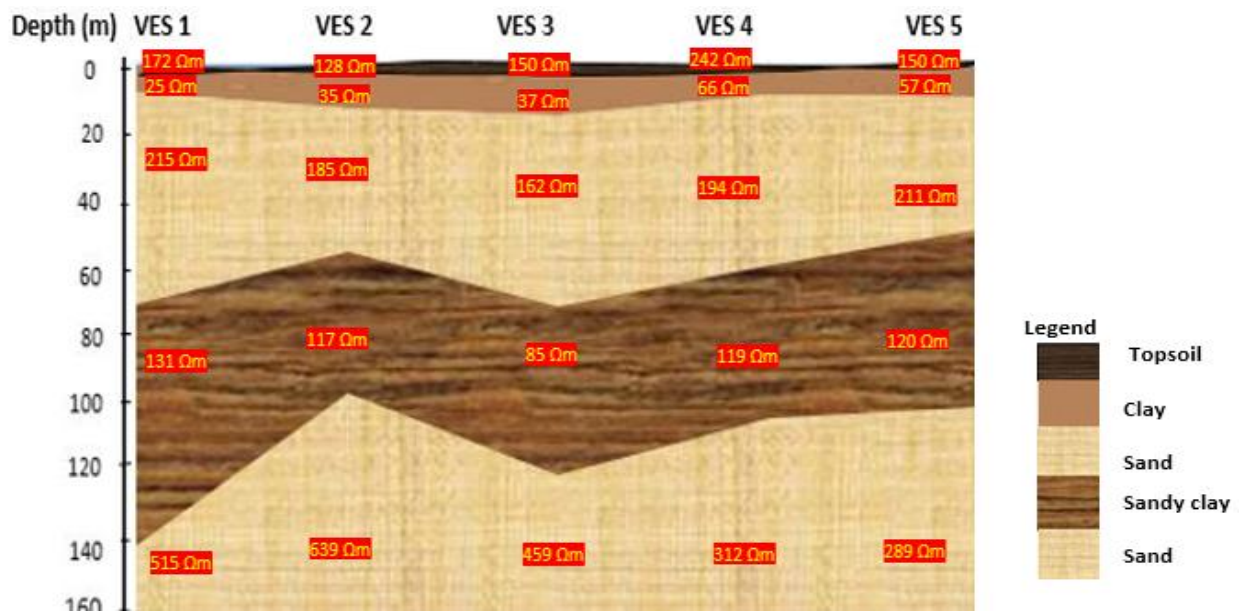
The thickness of the topsoil ranged from 0.7 to 1.9 m and has resistivity which ranged from 127.6 to 171.5 Ω m (Figures 4 and 5). It is composed of a mixture of sand and clay materials. The topsoil is relatively thin. The varying thickness and resistivity of the first layer is an indication that the topsoil is heterogeneous in nature (Table 1). The second layer has resistivity

values which ranged from 25.4 to 82.6 Ωm (Table 1). The low resistivity values of the second layer clearly indicates that it is a clay formation. Its thickness ranged from 6.9 to 12.6 m (Figures 4 and 5). The third layer is a sand formation whose thickness ranged from 38 to 61.6 m, and it has resistivity values which ranged from 130 to 409 Ωm (Table 1).

Figure 4. Geoelectric section of VES 1-5.

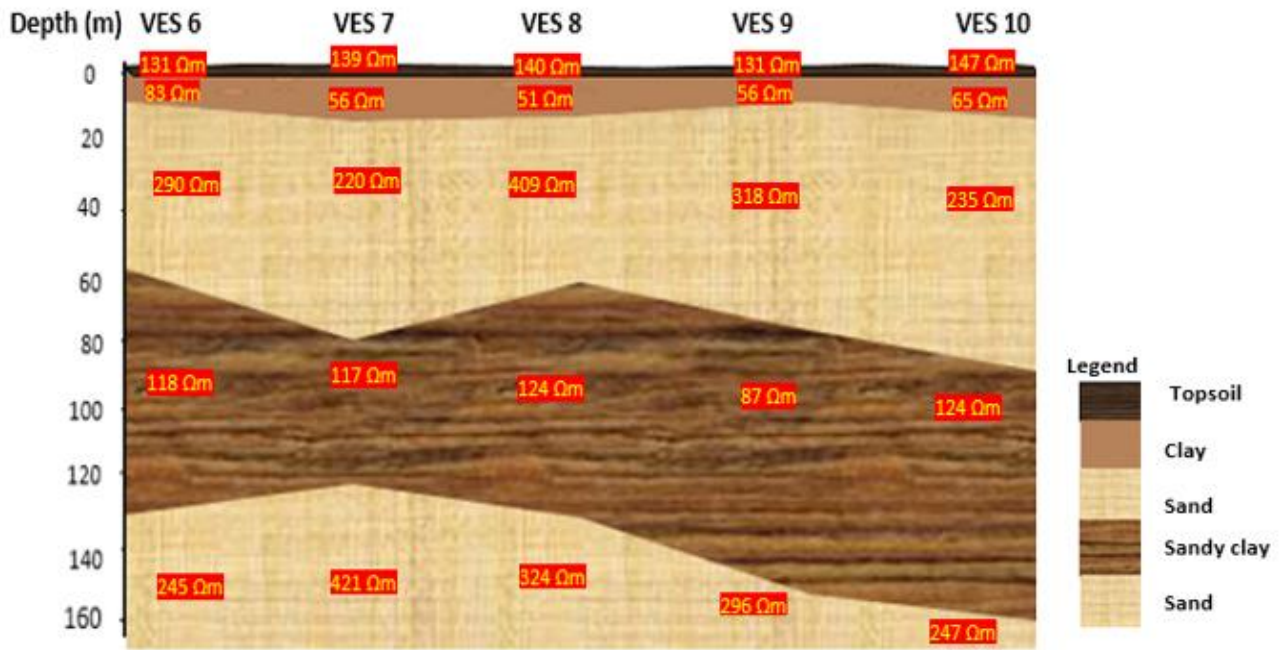
Figure 5. Geoelectric section of VES 6-10.

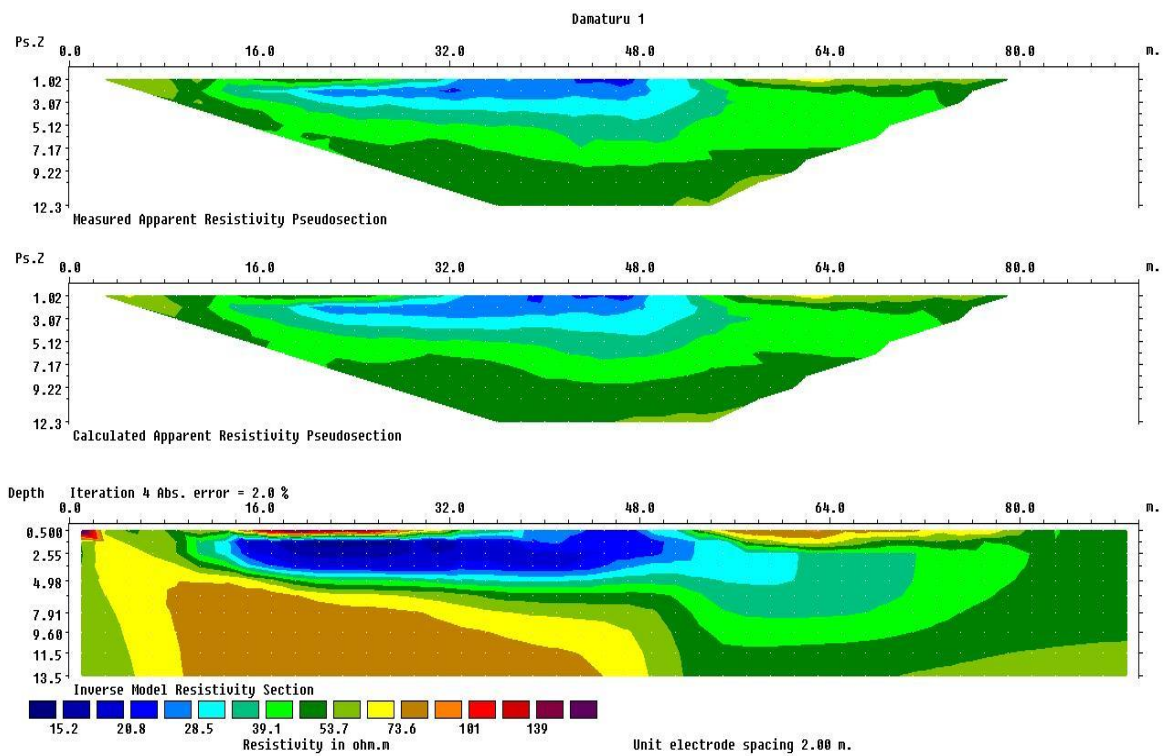
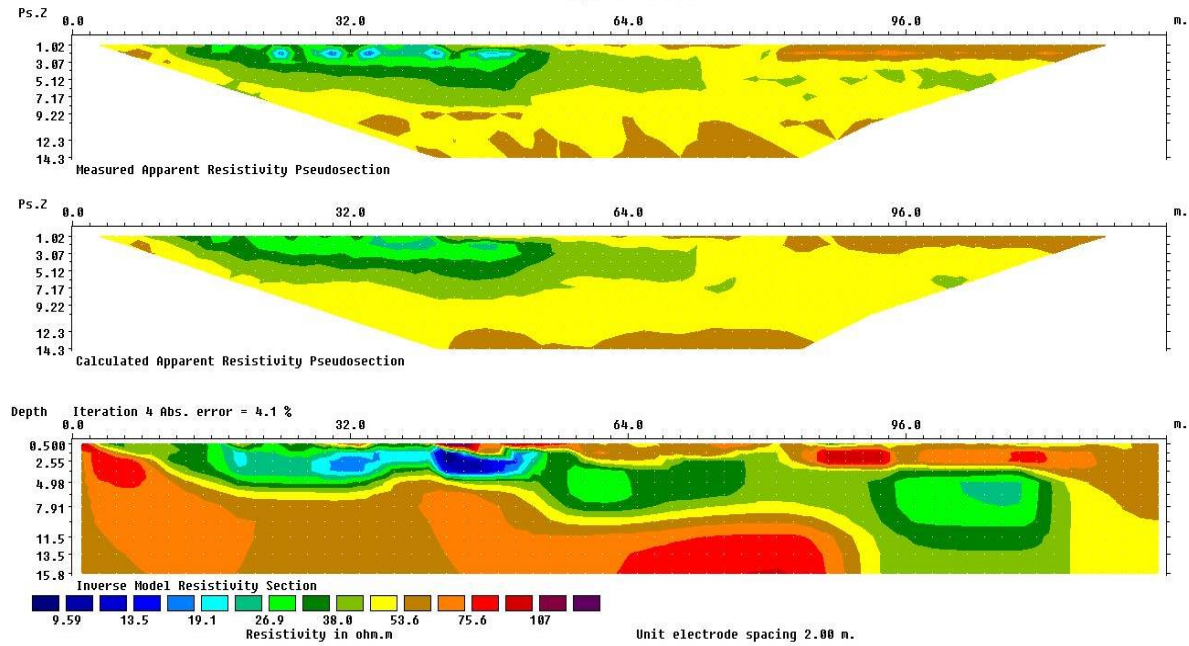
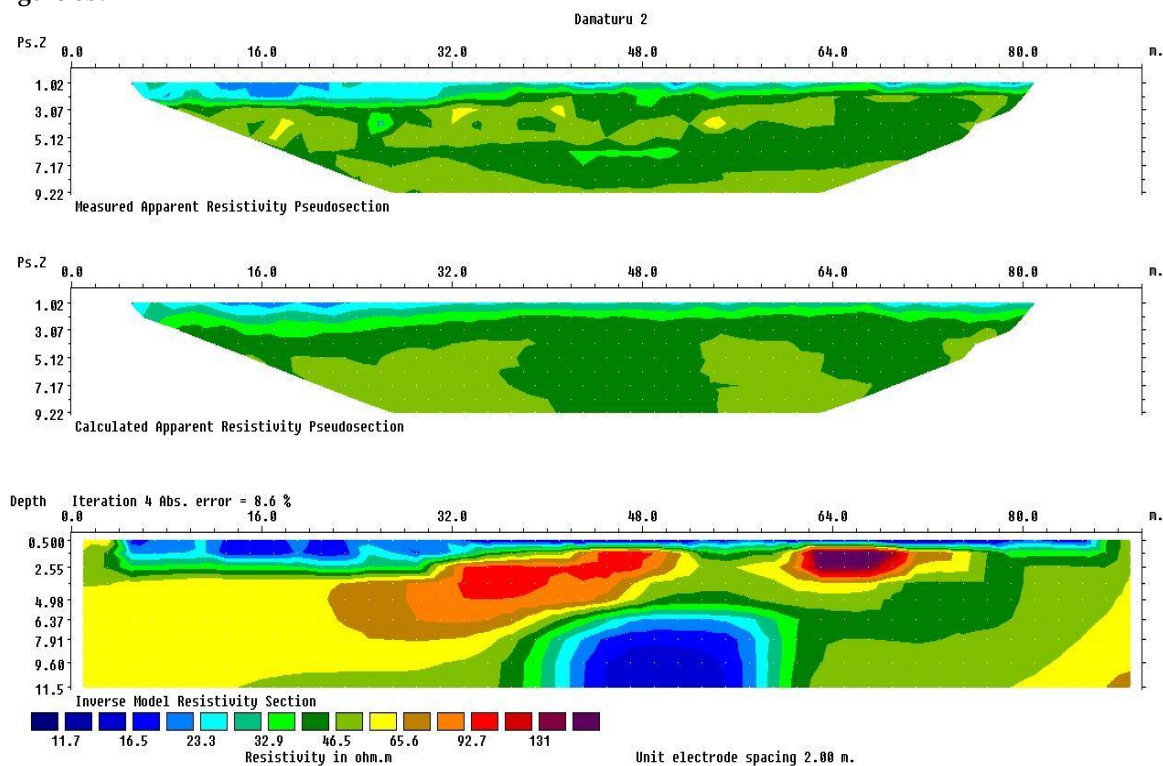
The 2- dimensional imaging results (Figure 6a, b, and c) showed that the study area is underlain by very low resistivity materials which is composed of dead organic matters (peat) and clay soil. These materials are known to possess poor geotechnical properties and exhibit low shear strength and high compressibility potential.

Figures 6a-c: Inverted resistivity models showing the distribution of clay and other incompetent materials in the subsurface of the study area. These materials are responsible for building failures.

The 2-D imaging sections showed that the underlying clay layer has low resistivities which varies from 9.59 to 92.7 Ωm (Figure 6a, b, and c). The VES results correlated well with the 2-D ERT results. Both results showed that the subsurface underlying the buildings in the study area is generally incompetent. The inhomogeneous nature of the topsoil by the virtue of its varying resistivities and thin sizes which varies from one location to another (Figures 4 and

5) made the topsoil incapable of providing the necessary footing for the foundation. During construction, the topsoil is mostly excavated, thereby making the building to rest much on the second layer which is incompetent. The clay soils are expansive and they contain smectite minerals. The smectites shrink upon drying and swell upon wetting.

These shrinking and swelling properties of clay leads to the cracking and failure problems associated with buildings built in the study area. Some parts of the study area have pockets of sand units (Figure 6a) which have competency for building foundation, but they are not continuous. The results of the study clearly showed that the cracking and failure of buildings in the study area were caused by the expansion and contraction of the materials underlying the building foundations. The soil layer underlying the foundation is incompetent to bear the buildings. The results are in agreement with the reports of Aderoju and Adebayo (2017). Aderoju and Adebayo (2017) in their study in Lagos State, observed that buildings in Ogun river valley estate were sited on incompetent soil formation which led to their failure and eventual collapse.

The role of geophysical investigation of a proposed site for civil engineering construction cannot be over-emphasized since it helps to provide vital information on the suitability of the soil for building purpose and the type of foundation to be adopted. It also reveals some hidden geological features which might constitute a serious problem to the buildings in the future. The results of this study showed that the area needs significant improvement of the foundation soil through both mechanical and engineering reinforcements, in the form of pile foundation and soil replacement with highly compacted materials such as gravel and crushed concrete.
