APPRAISAL OF THE CAUSES OF PAVEMENT FAILURE ALONG THE ILESA - AKURE HIGHWAY, SOUTHWESTERN NIGERIA USING REMOTELY SENSED AND GEOTECHNICAL DATA

Remotely sensed and geotechnical data have been used to establish some of the causes of perpetual pavement failure along the Ilesa Akure highway in the southwestern part of Nigeria. Four failed segments and two control stable segments were selected for the geotechnical study. The remote sensing investigation involved the processing and interpretation of Landsat-7 ETM+ images covering the study area and its environment for lineaments. The geotechnical investigation involved grain size analyses, Atterberg Limits, Compaction Test and California Bearing Ratio (CBR) determination. Lineaments were identified across virtually all the failed localities with a predominantly N-S structural trend. The geotechnical properties of the soils beneath the stable and failed segments of the highway show significant overlap which suggests that the cause of road pavement failure along the highway may be due to factors other than or complementary to the geotechnical factors. The pavement failure may have resulted from suspected near-surface linear (geological) fe

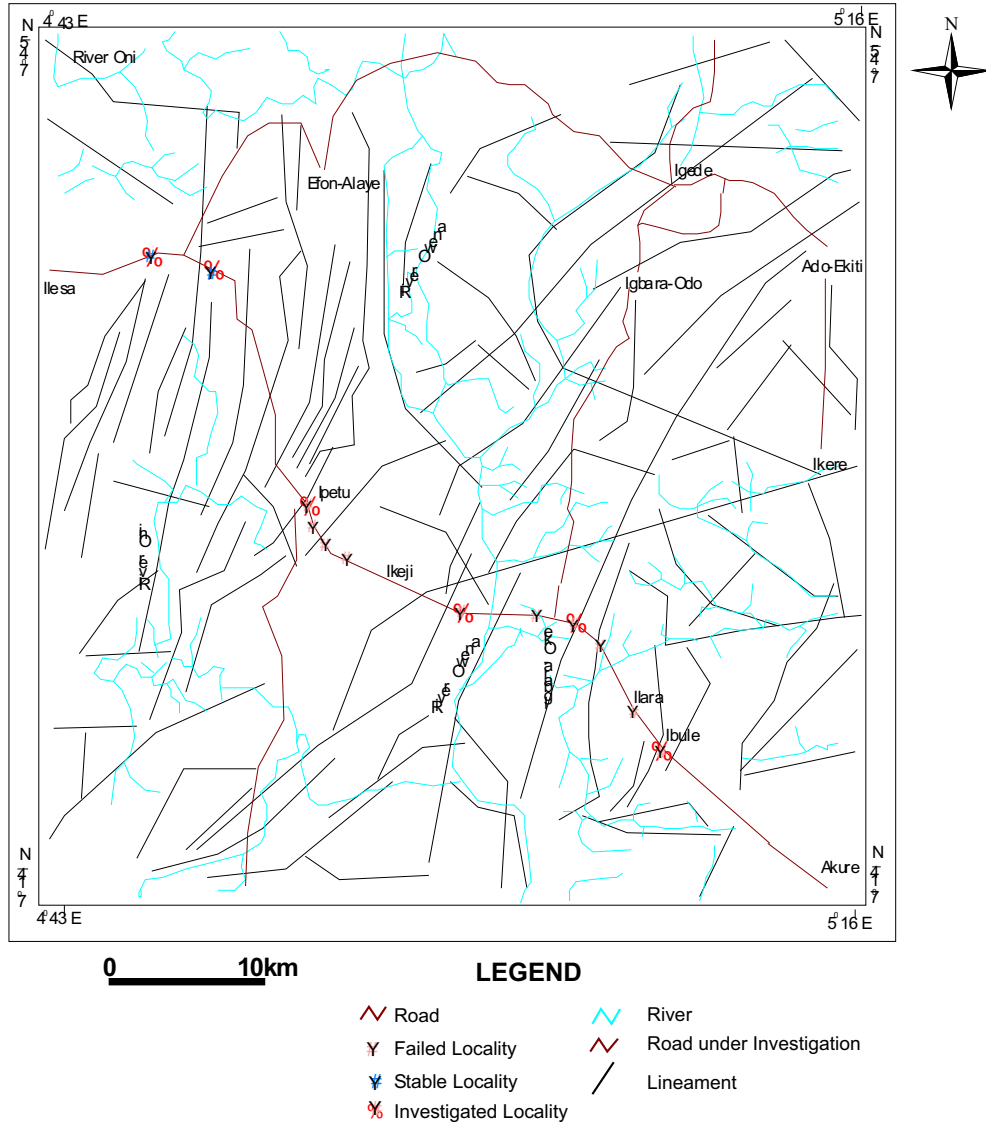
Fig. 6: Lineament Map of Ilesa Akure Area

equated with structural elements such as folds, fractures, faults and joints (Viljoen et al., 1983). Some of the lineaments in which the road cut across may be fault particularly those that show relative displacement. Other linear features are suspected to be fracture and fissure zones. As shown in the rose diagram (Fig. 7), the four major

structural trends (N-S, NNE-SSW, NW-SE, and E-W) that are typical of the Nigerian Basement Complex (Rahaman, 1989) are represented in this area. The N-S lineament trend constitutes the dominant structural trend. As shown in Figure 6, several of the linear features cut across the highway investigated and most especially within

and around failed segments of the highway. It is suspected that such linear features may be one of the factors responsible for the perpetual failure of the failed segments of the highway, since linear features are characteristic zones of weakness.

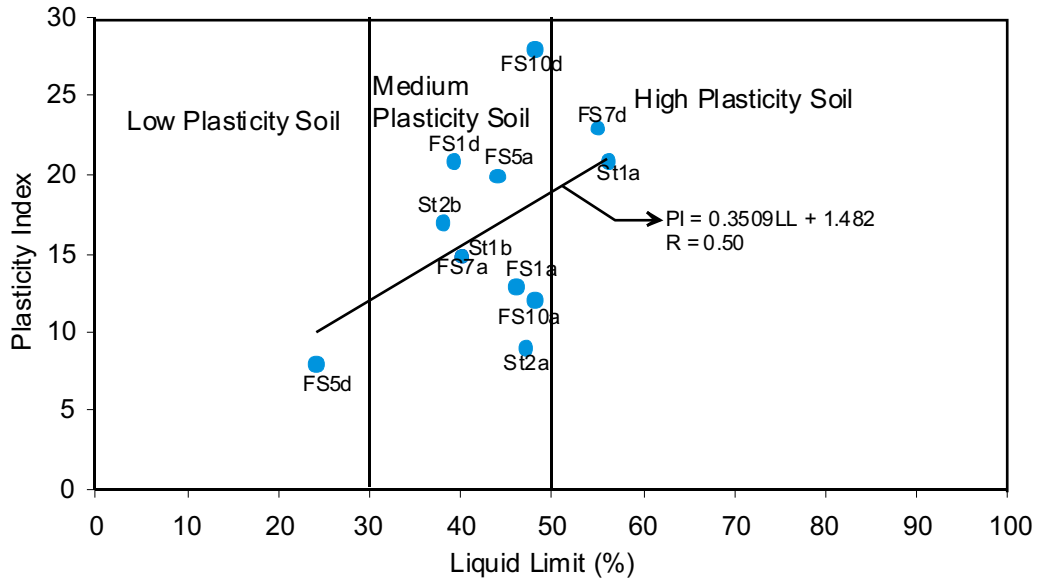
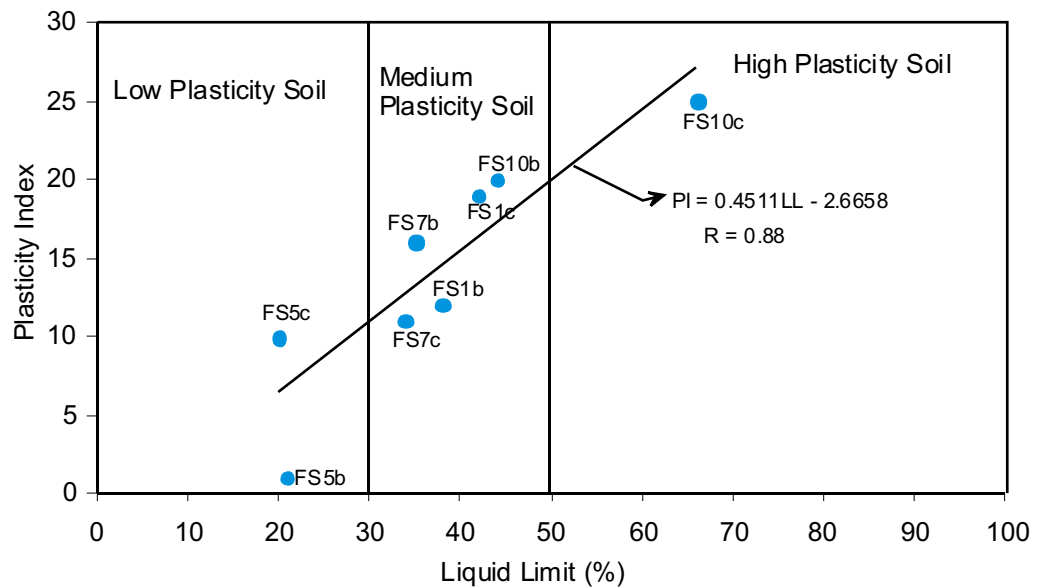
shown in Table 2, the soil samples from both the stable and failed segments belong to group A-4 to A-7, hence the soil can be rated to be of fair to poor sub-grade materials. The Casagrande (1948) Chart (Figs. 10a and 10b) generally indicate medium plasticity for both the soils beneath the stable and failed segments, hence, the soils are expected to exhibit low to medium swelling potential (Ola, 1982). The Linear Shrinkage of the soils beneath the stable and classified stable (?) segment ranges from 1-8% and 3-12% respectively, while that of the failed segments ranges from 3-16% (Table 1). The Linear Shrinkage of most of the soils are $\leq 8\%$ recommended by Brink *et. al.* (1982) and Madedor (1983) for highway sub-grade, hence the soils are good sub-grade materials. As discussed above, the consistency limits of the soil beneath the stable and failed segments of the studied highway did not exhibit significant difference and generally fall within the recommended specification by FMWH, 1972. Both soils are rated poor to fair for pavement materials, hence, the cause of failure along the failed segments of this highway may be difficult to explained from the point of view of consistency limits only.

Fig. 10a: Casagrande Chart Classification of the Soils beneath Stable Segments (Based on Casagrande, 1948)

Fig. 10b: Casagrande Chart Classification of the Soils beneath Failed Segments (Based on Casagrande, 1948)

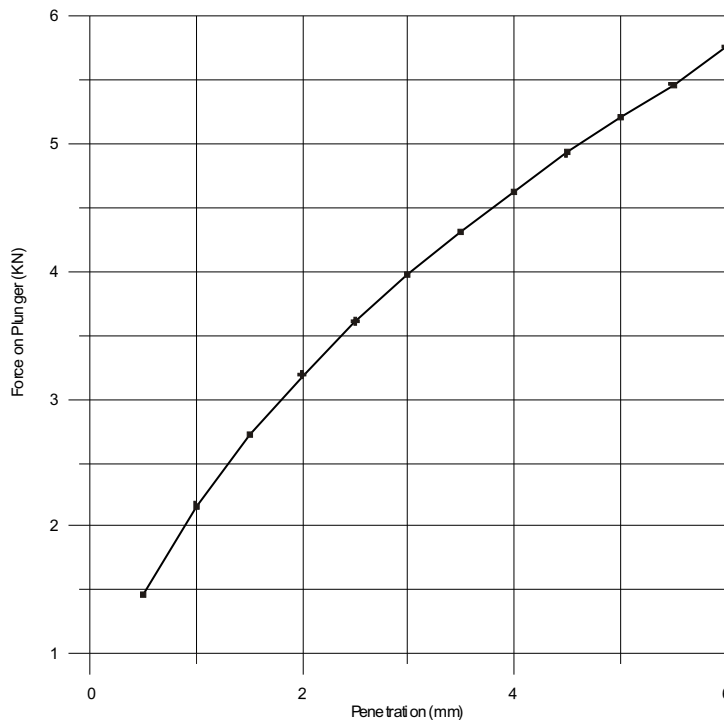
Fig. 12: Typical CBR Curve Soil Sample taken from Failed Segment 1 (FS1d)

The unsoaked California Bearing Ratio (CBR) values for soil beneath the control stable segments ranges from 38 - 55%, while those of the classified stable (?) and failed segments range from 20 to 72% and 25 to 84% respectively (Table 1). Figure 12 shows the CBR curve for sample FS1d. The unsoaked CBR value stipulated by the FMWH standards (1972) for sub-grade soils is 80% minimum (Table 3). The only soil sample with CBR value within this specification is the soil sample FS7b taken from the failed segment at locality 7. There is thus, no clear-cut correlation between the values of CBR of sub-grade soils and the degree of stability of highway pavement. The

cause of perpetual failure of the failed segments along this highway may therefore not be related to the CBR. From the above, there seems to be a poor correlation between the geotechnical properties of soils and the road stability.

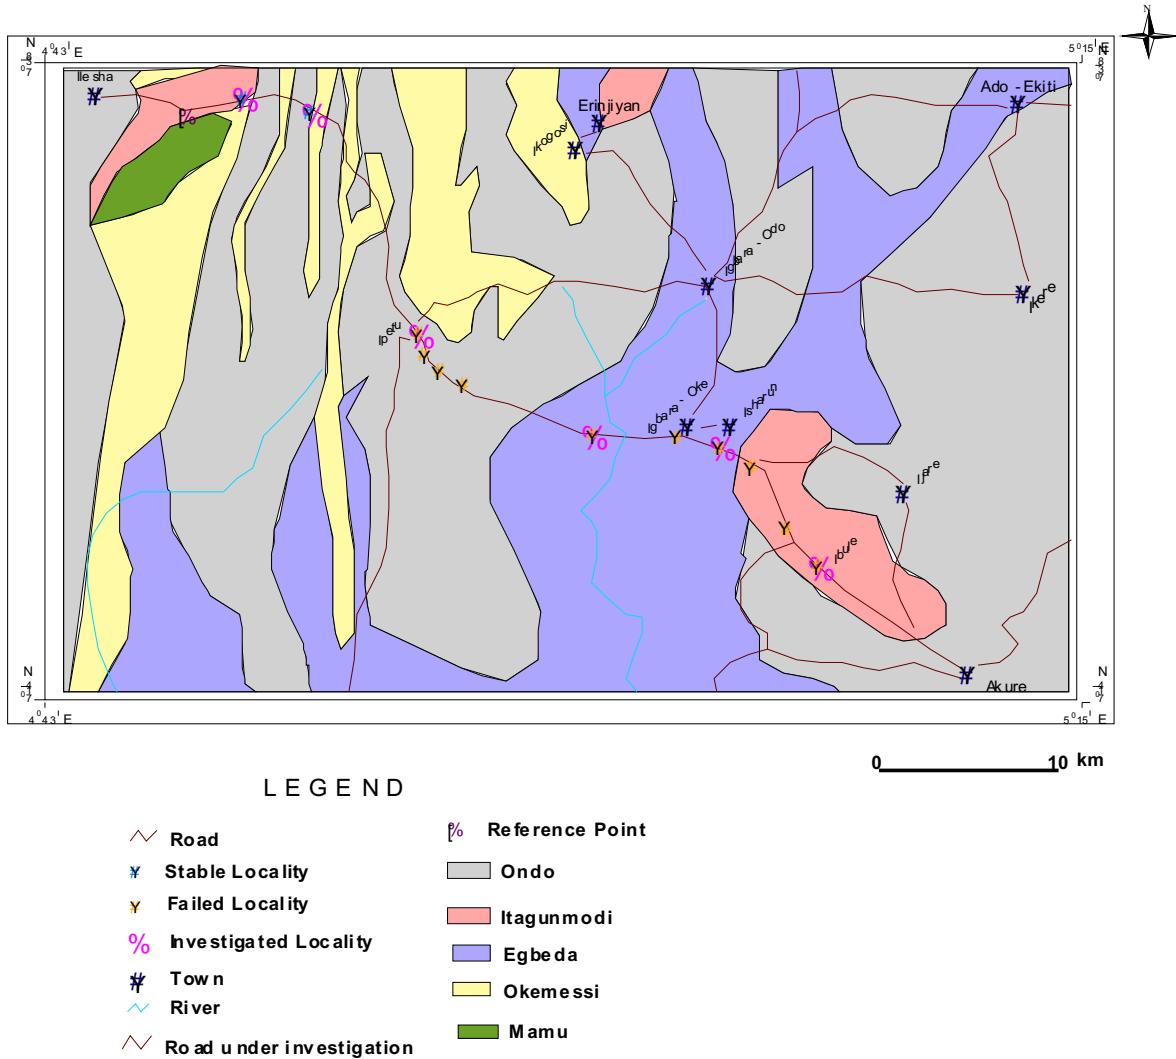
Fig. 13: Soil Map along the Ilesa-Akure Highway (Modified After Smyth and Montgomery, 1962)

The highway is underlain by the Okemesi, Ondo, Egbeda and Itagunmodi soil associations (Fig. 13). The Okemesi Association are composed of well-drained coarse texture, very gravelly soils derived from quartz schist and massive quartzite. The soils underlie stable segment 2. The Ondo Association underlie failed segment 1. The soils are well-

drained, medium to fine texture soils overlying orange, brown, yellow brown and brown mottled clay derived from medium-grained granitic rocks and gneiss. The Egbeda Association are also well-drained fine textured soils overlying red, brown yellow brown and white mottled clay mainly derived from fine-grained biotite gneiss and schist. The soils Association underlie failed segments 5 and 7. The Itagunmodi Association underlie failed segment 10. The soils are composed of brownish red very clayey soils derived from amphibolites and charnockite rocks. It follows from the above that the failed segments are underlain by clayey subsoils.
