HIGHWAY PAVEMENT FAILURE INDUCED BY POOR GEOTECHNICAL PROPERTIES AT A SECTION ALONG THE F209 OKITIPUPA – IGBOKODA HIGHWAY, SOUTHWESTERN NIGERIA

G. JEGEDE

Department of Applied Geology, The Federal University of Technology, P.M.B. 704, Akure, Nigeria.

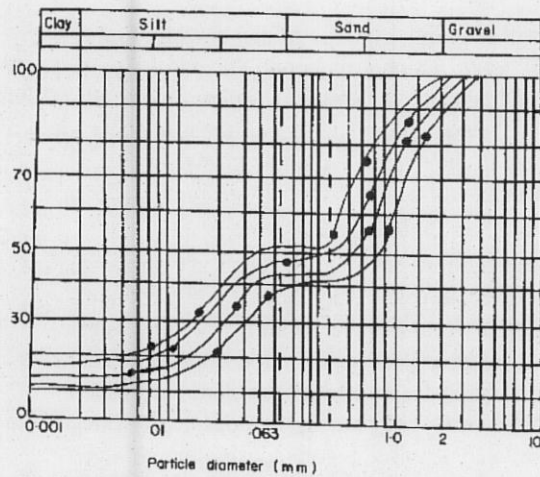
Fig.2: Gap graded curves for Okitipupa subsoils

The geotechnical properties of the subsoil materials that were used in constructing the road are presented in Table 1. The soil textural analysis indicated that it classified as gap graded silty clay. The percentage fine is well above 25% (Fig. 2). There is clear deficiency of coarse fraction especially gravelly fraction in the soil profile. The definite increase in the soil natural moisture content may be best explained by decreasing evaporation trend from surface to subsurface along a soil profile in the crust. High plasticity and high in situ moisture content imply that a soil will take longer periods to dry after the heavy rains associated with the wet season (Jegede, 1995, 1997, 1998, 2000).

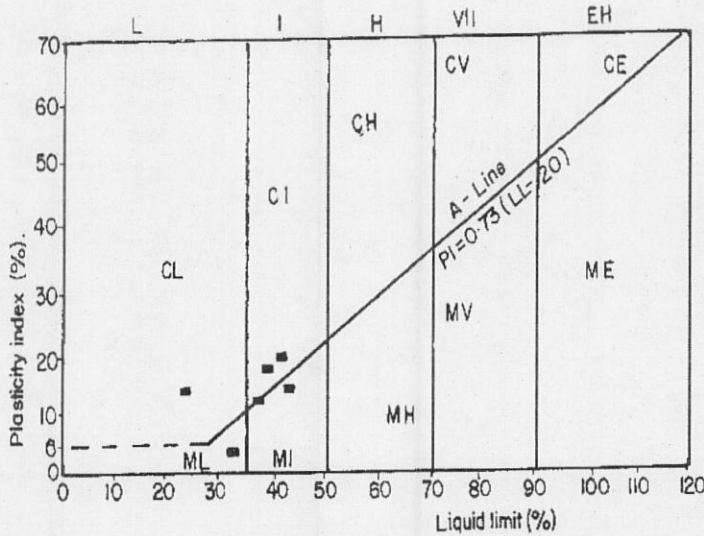
The consistency (Atterberg) limit values plot in the region of CL – CI and ML – MI groups (Fig. 3). This indicates that the soil contains both clay and silt fractions. It also implies that they may both be regarded to consist of clay of low to intermediate plasticity and silt of low to intermediate plasticity (Casagrande, 1974; Jegede, 1994, 2000). The liquid limit values of the soil may be considered high, ranging from 22% to 43.50%. This further supports the lack of high plasticity in the soil. Therefore, the soil with regard to the extremely high liquid limit values may be considered too weak in strength. The linear shrinkage values because of their relatively low values indicated a non-shrinking, non-heaving soil (Brink *et al.*, 1982).

Fig. 3: Casagrande's plasticity chart for studied soil samples (Okitipupa).

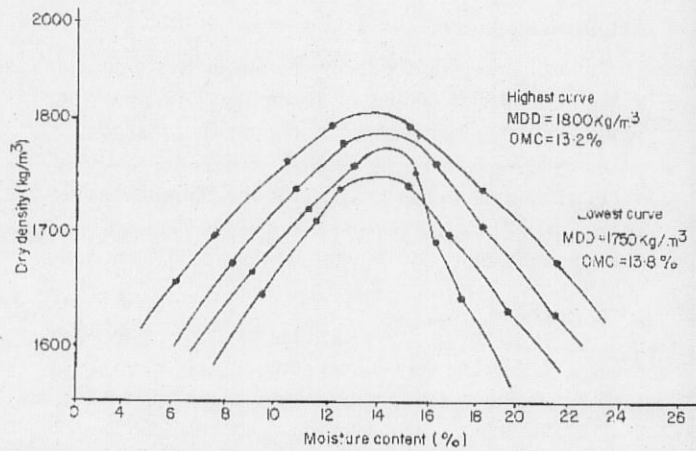
Fig. 5: Moisture/density relationship for Okitipupa subsoils

The moisture density relationship, i.e. the compaction curves (Fig. 5) showed a maximum dry density ranging from 1750 kg/m³ for the lowest curve and 1800 kg/m³ for the highest curve at an optimum moisture content of 13.8% and 13.2% respectively. The CBR value of 55% (Fig. 6) is indicative of a strong reduction in the strength of the soil (pavement) materials. The extremely low value of 55% may be best explained as being due to the possible incursion of surface water through tiny openings which are mainly cracks and joints of differing geometry. The downward percolation or infiltration of this moisture into the base layer of the road prism further aggravates weakening and destruction of the road pavement (Jegade, 2000). It should be noted that the

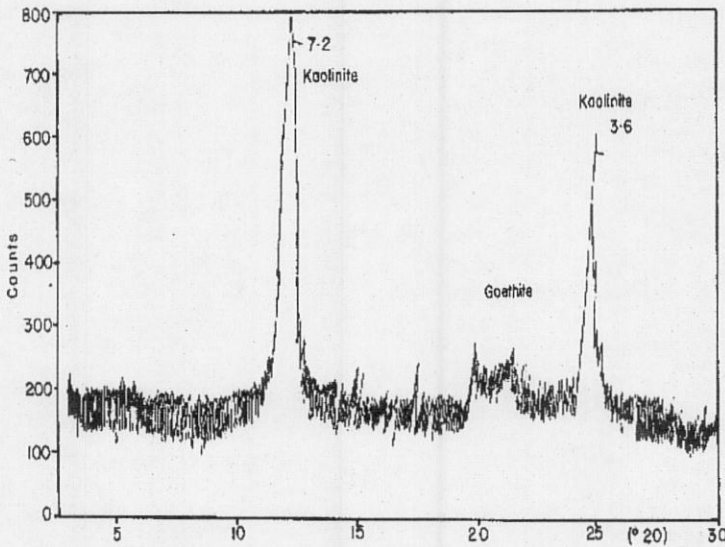
Fig. 4: XRD diffractogram for the clay (2 micron) fraction from Okitipupa locality.

X-ray diffractogram showed very sharp and prominent Kaolinite peaks (more than 80% and a subdued goethite peak (less than 10%) without any trace of montmorillonite (Fig. 4). The presence of abundant kaolinite in the soil confirmed the linear shrinkage test results (Table 1). Both information confirm the presence of a non-heaving, non-shrinking clay soil material (Jegade, 1998). The specific gravity values range from 2.60 to 2.66.

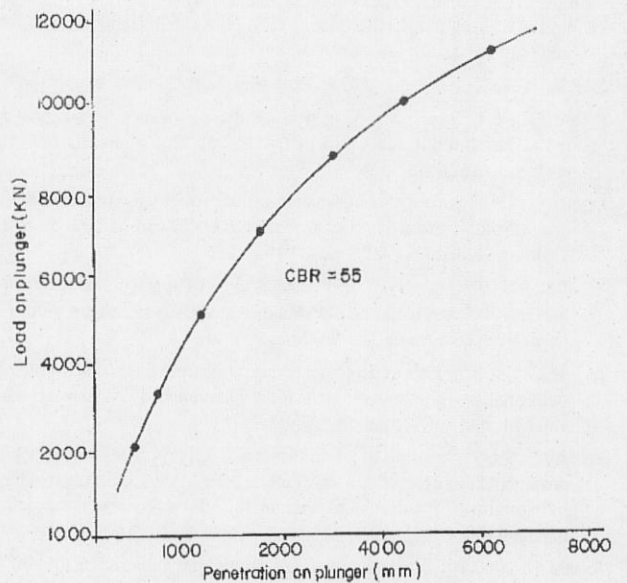
Fig. 6: CBR Curve for Okitipupa studied soil sample

Highway pavement failure at a section along the F209 along Okitipupa – Igbokoda highway had been mainly induced by very poor soil properties as revealed by the excess fines (above 25%), high liquid limit values and very low California bearing ratio value of just 55%. The very low CBR value was mainly induced by surface water ingress into lower layers of the road prism including the base elevation, which resulted into failure of the highway pavement at this locality. The strength of the soil may be improved by soil stabilization techniques while cracks and joints may be sealed during road maintenance programme. The collapsible coastal plain sands at this location also contributed to pavement failure.
