Electrical Resistivity Tomography Survey of Some Failed Segments along Selected Major Highways in Cross River State, Southeastern Nigeria

ABSTRACT: This study investigated some failed segments along Okuku – Okpoma and Abuochichie – Obanliku highways. Six (6) measurements employing electrical resistivity tomography (ERT) were conducted at the side of selected failed portions of the road and at the stable portions which served as controls. It was found that along Okuku – Okpoma road, the resistivity values of weak zones ranged from 25Ωm – 71Ωm at Okpoma and competent zones ranged from 840Ωm – 1376Ωm at Ugaga and 600Ωm – 800Ωm at Ogbudu. Along Abuochichie – Obanliku road, the resistivity values of weak zones ranged from 25Ωm – 35 Ωm at Ukwutia and 78 Ωm – 90Ωm at Bukumanya and competent zones from 828Ωm – 1021Ωm at Amunga. The results further indicated that the remote causes of road failure are as result of geologic factors such as clay/shale materials/highly weathered materials at Okpoma, Ukwutia and Bukumanya where they occurred. It was recommended that geophysical surveys should be conducted prior to the construction of roads. Also clay materials as well as highly weathered geolog

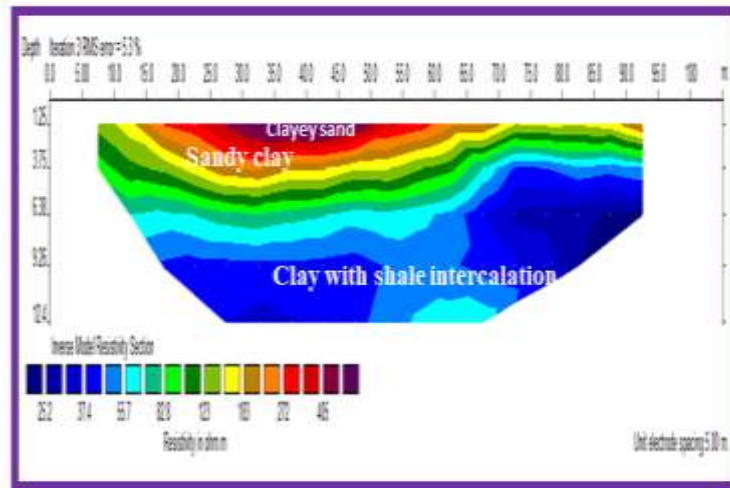
Fig. 3 Inverted 2D least square inversion apparent resistivity pseudo-section for ERT 1 at RF1A Okuku – Okpoma road

The processed results are as shown in Fig. 3 - Fig. 7. The pseudo sections reveal features that may be responsible for the causes of road failure. In ERT 1 and Fig.3, resistivity values $>405\Omega m$ between lateral distances 27.0m – 50m with a thickness of 2.50m constitutes the top soil considered to be clayey sand. Beneath this is a resistivity that ranged from $123.0\Omega m$ - $272\Omega m$ considered to be sandy clay. Below it is a low resistivity layer that ranged from $25\Omega m$ – $83.0\Omega m$ across the profile with thicknesses between 6.38 – 12.4m and 3.75m – 11.0m. This low resistivity is considered as clay/shale intercalation. The low resistivity characterized by clay/shale intercalation accounts for the failure of this segment. In ERT 2 and Fig.4, a high resistivity at the top layer $840\Omega m$ – $1376\Omega m$ but with thicknesses 3.75m – 6.0m and 6.50m indicates sandstone with mudstone intercalation. Underlain this layer is a low resistivity material with resistivity ranging from $44\Omega m$ – $71\Omega m$ found between lateral distances 20m – 33m and 45m –

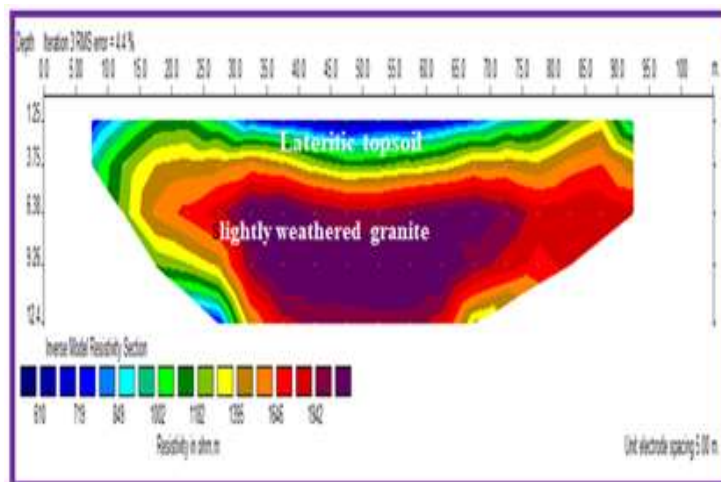
Fig. 5 Inverted 2D least square inversion apparent resistivity pseudo-section for ERT 3 at RF3B Okuku – Okpoma road

75m with thickness between 10m – 12m. The low resistivity range is considered to be clay and is responsible for the road failure in the segment. In ERT 5 and Fig.5 which served as a control, show a relatively moderate resistivity material $600\Omega m$ – $800\Omega m$ between lateral distances 30m– 70m with thickness 1.25m forms the topsoil interpreted as lateritic topsoil. Below this is a very high resistivity material $1646\Omega m$ – $1942\Omega m$ across the entire profile. The high resistivity underlying the road pavement which indicates typical of sandstones, granite and laterite are responsible for the stability of this segment. In ERT 6 and Fig.6, a resistivity value in the range $200\Omega m$ – $284\Omega m$ was observed between lateral distances 60m – 80m interpreted as lateritic topsoil. Underlying this topsoil layer is a low resistivity material with resistivity range from $25\Omega m$ – $35\Omega m$ with thicknesses 9.0m, 11.0m and 6.38m – 11m respectively across the profile between lateral distances 7m – 83m. The low resistivity range is considered to be clay materials and is responsible for the road failure in the segment.

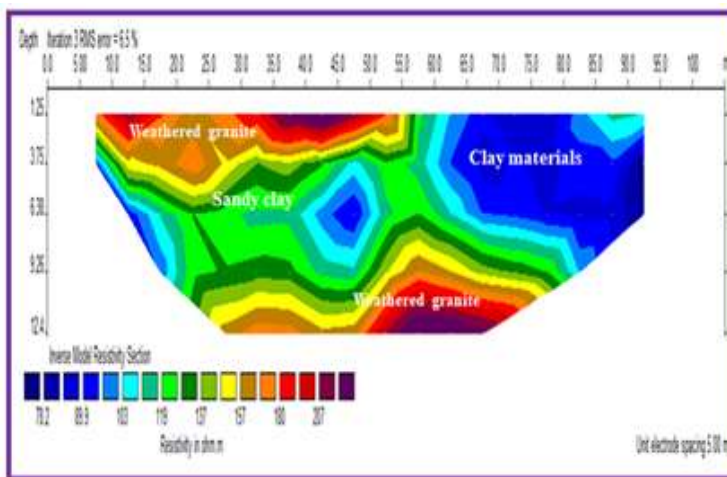
Fig.7. Inverted 2D least square inversion apparent resistivity pseudo-section for ERT 5 at RF 5A Abuochiche – Obudu – Obanliku road

In ERT 7 and Fig.7, the top layer has resistivity ranging from 180Ωm – 207Ωm between lateral distances 7m – 20m, 30m – 53m with thickness of about 2m which indicates weathered granite. A low resistivity of value ranging from 78Ωm – 90Ωm was found at lateral distances 40m – 50m, 60m – 93m respectively interpreted as clay materials and are responsible for the failure of this segment. In ERT 8 and Fig.8, a very high resistivity material 828Ωm – 1021Ωm and moderate resistivity 440Ωm – 671Ωm at lateral distances 7m – 60m and 60m – 85m with thicknesses 9.0m and 11.0m spread across the entire profile. This can be interpreted as granitic rocks/weathered granitic rocks and the absence of clay material in the profile shows that the area is highly resistive and competent.
