# Decade of Electrical Submersible Pumps Failures: Case Study on Performance and Optimization

## MAHMUD, WM; JALUTA, AM

Department of Petroleum Engineering, University of Tripoli, Tripoli, Libya

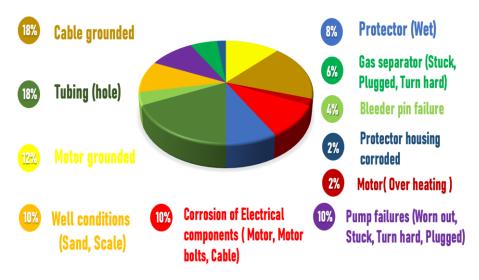
The overall performance of the ESP systems indicates that the two most common failures were grounded cables and holes in production tubing as shown in Figure 1. Other significant failures included grounded motors, well condition-related issues, corrosion, sand production and scale. Table 4 presents the pump types and their run times (in days) for the six wells during the study period. In well #1, three pumps were installed with run lives of 1,804, 472 and 171 days, respectively, showing a significant decline in run times over time. Production tests in well #2 revealed that the pump operated under both up- and down-thrust conditions which likely contributed to reduced run life. Similarly, in well #3, pumps were replaced three times, indicating recurring failures. In well #4, pump type D725N initially operated within the production range, however, as fluid production exceeded the pump's capacity, upthrust conditions developed leading to failure due to wear. To address this, pump type D800N was installed between 2021 and 2023 with different stage configurations. However, the pump was still unable to accommodate production surges and up-thrust reoccurred causing further failures. In well #5, pump DN460 ran for 355 days before failing due to a washed-out bleeder. Although both pumps (D475N

Fig 1: Overall performance of the ESP systems of the six wells.
