A SURVEY OF DIAGNOSTIC X-RAY ROOM DESIGN AND SHIELDING INTEGRITY OF LEAD APRONS IN A STATE IN NORTH EASTERN NIGERIA.

ABSTRACT

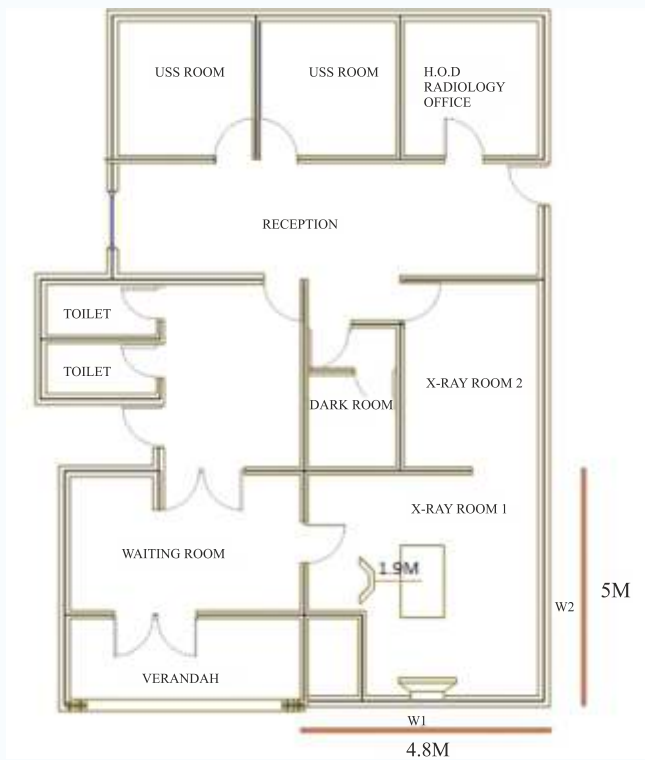
Figure 1: Radiology department layout for facility A

Facility A (figure 1) had two x-ray room, with functional and non-functional x-ray machine. The room with functional x-ray machine had a dimension of 24m² with distance of 1.9m from the x-ray tube to the control panel (Tables 1a). A 2.0 mm lead sheet bonded to plywood was used as the shielding material.

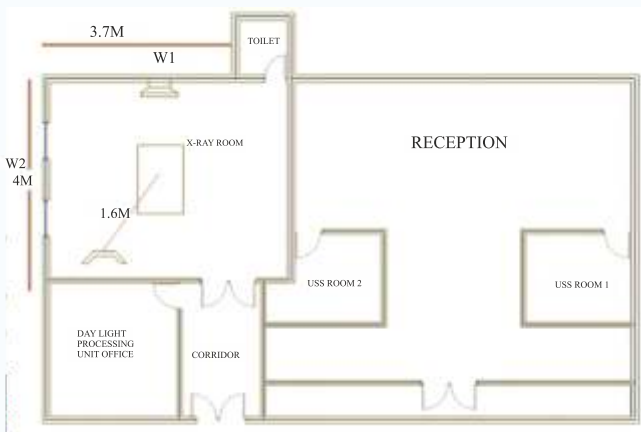
Figure 2: Radiology department layout for facility B

Facility B (figure 2) had an x-ray room dimension of 14.8m² with distance of 1.6m from the x-ray tube to the control panel (Tables 1a). A 2.0mm lead sheet bonded to plywood was used as the shielding material.

Facility B however, did not meet any of the standards. According to the inverse square law, the larger the room dimension; the more distance would be between the x-ray tube and the control panel, the lesser the radiation that will reach the operator and the wall of the radiographic room. Some corrective measures such as enlarging the size of x-ray room etc. are recommended for facility B, to prevent increased radiation exposure to personnel. Time, distance and shielding are well-established dose reduction strategies in radiography. Measurement of distances in diagnostic radiography is of great significance, as the intensity of radiation decreases as the square of its distance from the source, according to the inverse square law [6]. Apart from decreasing the intensity of radiation, maximized distance also helps to minimize the cost of shielding, and also has clinical significance as it aids in proper patient positioning and geometric display of anatomy of interest and pathology on radiographs [6]. All the

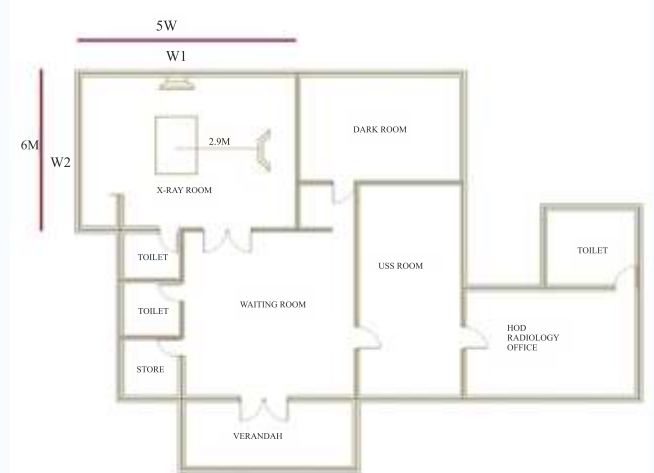
Figure 3: Radiology department layout for facility C

Facility C (figure 3) had an x-ray room dimension of 30m² with distance of 2.6m from the x-ray tube to the control panel (Tables 1a). A 2.0mm lead sheet bonded to plywood was used as the shielding material.

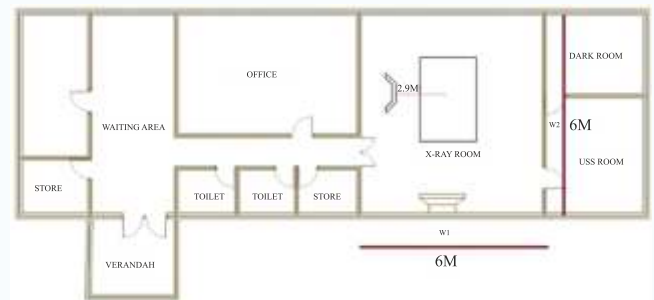
Figure 4: Radiology department layout for facility D

Facility D (figure 4) had an x-ray room dimension of 36m² with distance of 2.9m from the x-ray tube to the control panel (Tables 1b). A 2.0mm lead sheet bonded to plywood was used as the shielding material.

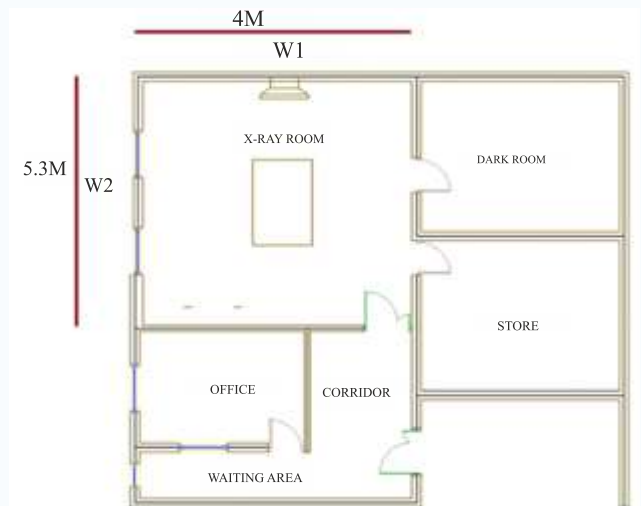
Figure 5: Radiology department layout for facility E

Facility E (figure 5) had an x-ray room dimension of 21.2m² with no control panel (Tables 1b). The wall was not lead lined, but however a block/cement with a thickness of 0.45m is used instead.

walls of radio-diagnostic room of facility A, B, C and D involved in this study as shown in table 1a and 1b were lined with 2 mm lead equivalent which satisfied the recommendations of NNRA. Facility E and F are not lead lined; this is contrary to recommendations for operating such facilities. Immediate closure, for necessary remedial action is advised. The findings of this study are similar to Nilantha *et al.*, (2015) who showed that 89% of X-Rooms studied in Sri Lanka, were larger than the recommended size of 20 m² (AERB standard) and 64 % had sufficient wall thickness [7]. There were lead aprons in the x-ray rooms of all the facilities. Radiation monitoring devices (thermo-luminescent dosimeter) was not provided to the staff in facility A, B, D, E and F, only facility C staff were provided with such device. Radiation survey meter was absent in all the facilities as shown in table 2.
