RESEARCH PAPER

**A HOLISTIC SURVEY OF DAMPNESS IN A SIX BEDROOM  
RESIDENTIAL APARTMENT**

**K. Agyekum<sup>1</sup>, J. Ayarkwa<sup>2</sup> and C. Koranteng<sup>3</sup>**

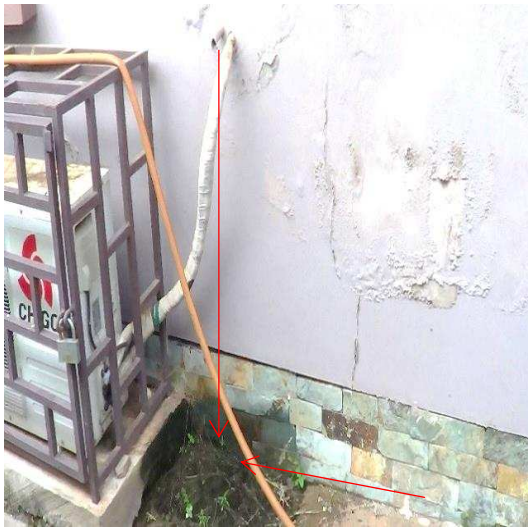
The site inspection carried out revealed that all the bedrooms were installed with air conditioners. On the eastern orientation, where the master bedroom was located, water from the air condition dripped directly against the base of the wall and that area appeared to be very wet (Fig. 6). Furthermore the upstand upon which the air-condition stands (Fig. 6), may act as a barrier to surface rain water, thus retaining storm water and preventing it from flowing away, thereby enabling the wall to soak it.

**Fig. 6: Water from air condition dripped against the base of wall**

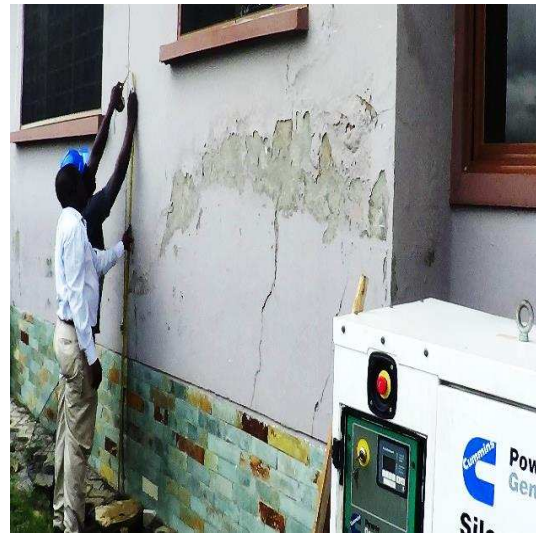
Symptoms of dampness were identified on the external walls of all the four orientations and were very severe in the walls of the bathrooms and the adjoining bedrooms. Blistering of paint, flaking of plaster and surface efflorescence were evident on most of the external and internal wall surfaces. Dampness was evident in all the walls but was very pronounced, rising to a maximum height of 1200 mm in the walls in the western orientation (left elevation, Fig. 7).

**Fig. 7: Western orientation-Dampness measured up to 1.2 m on external walls of bathroom**

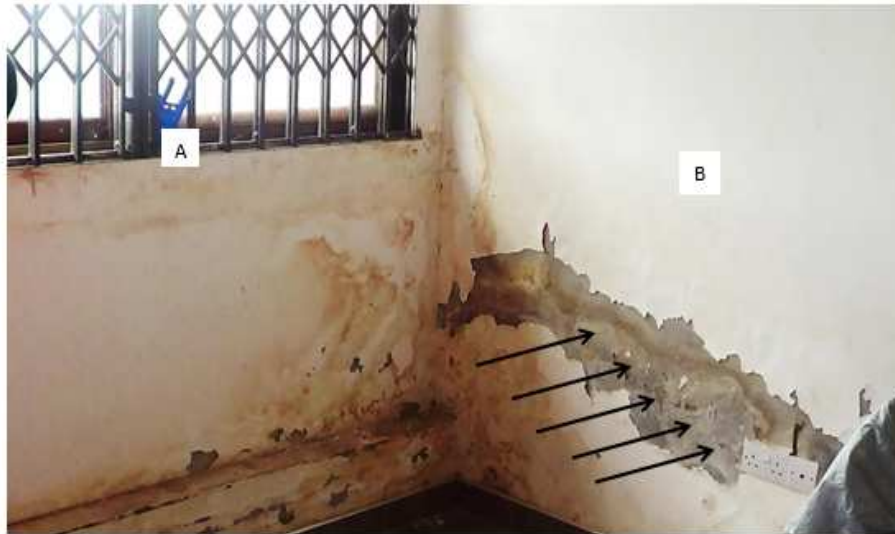
Salt deposits (arrowed part) (Fig. 8) were seen on the partition wall (B) between the bathroom and bedroom 1. The stains on the wall (A) was only in the room and no signs or symptoms were identified behind the walls externally. This could be a clear case of condensation because the room was being used as a store room instead of a bedroom, with the windows closed always. This made it difficult for the room to be ventilated. According to Noy and Douglas (2005), plinths when applied to solid walls will bridge damp proof courses if any and this will cause rising damp to penetrate through the wall plaster and skirting. If this is the case then there could be combinations of different sources of dampness in this room. Similar situations occurred internally in the other bedrooms.

Fig. 8: Stains on internal walls of bedroom 1 (A) and partition of bathroom and bedroom (B)

in Fig. 17 and this resulted in the leaked water penetrating the porous block masonries of adjoining walls (Fig. 8). The support for trays need to be level and as stable and rigid as possible (Burkinshaw, 2009). If there are no upstands for trays, failure of the edge seals will mean that shower water can penetrate through the edge of the tray down and stay underneath to cause damp damage. Poor seals can result in wetting and deterioration of the wall plasters as seen in Fig. 8.

Improving the ventilation in bedroom 1 should improve the situation of dampness in this room. Fixing the flexible tubes that link the shower trays to the waste pipes and re-fixing the shower cubicles should reduce the problem of leakages in the washrooms and adjoining walls of bedrooms.

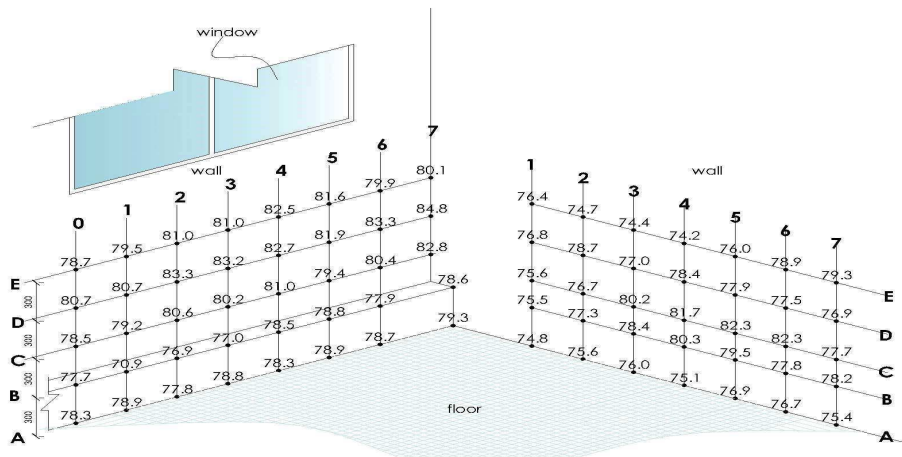
Fig. 9 shows relative humidity readings recorded by the moisture meter in the walls of bedroom 1 (Fig. 8). All the readings fell within the ranges of 70% and above which indicated high levels of dampness (Halim and Halim, 2010).

Fig. 9: Relative humidity readings from two internal walls of bedroom 1

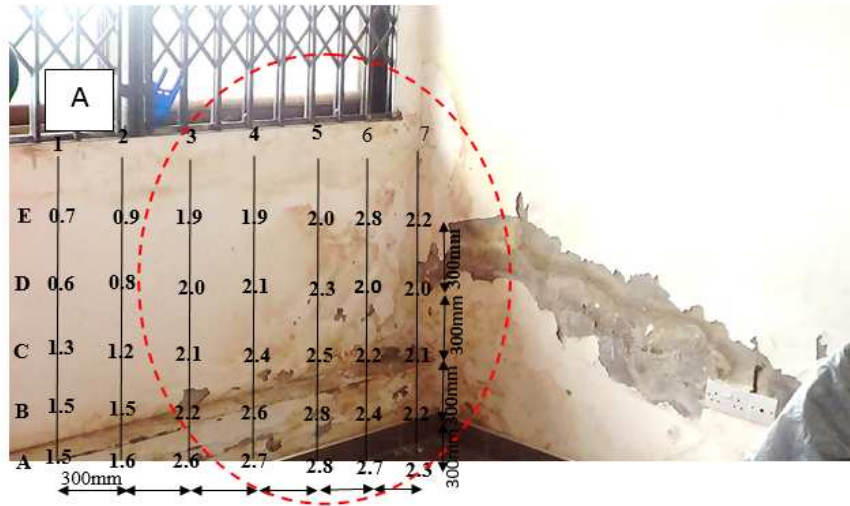
Results from the moisture content measurements on the internal wall (A) of bedroom 1 (Fig. 10) showed that dampness was dominant in the part of the wall towards the partition wall (B) between bedroom 1 and Bathroom 1. The damp zones were identified between gridlines A3-A7 through to E3-E7 (circled in red). On the other internal wall of bedroom 1 (B) (Fig. 11), the damp zones were identified between gridlines A1-A5 through to E1-E5.

Fig.10: Moisture content readings from internal wall (A) of bedroom 1

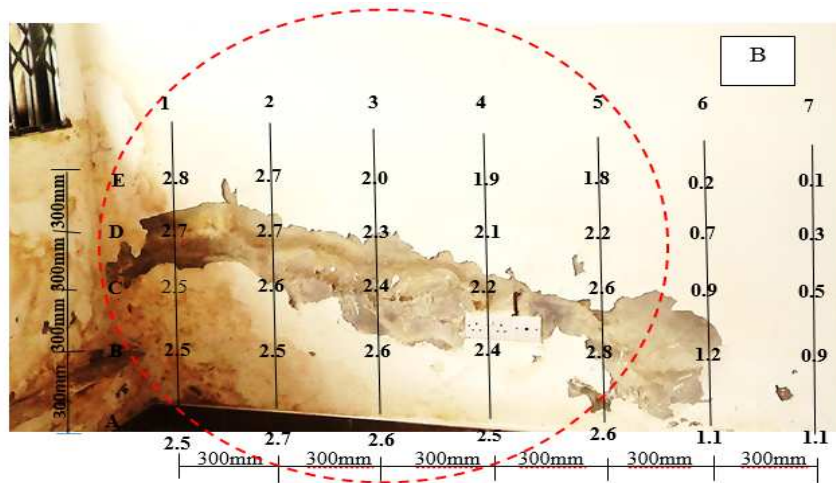
Fig. 11: Moisture content readings of internal wall (B) of bedroom 1

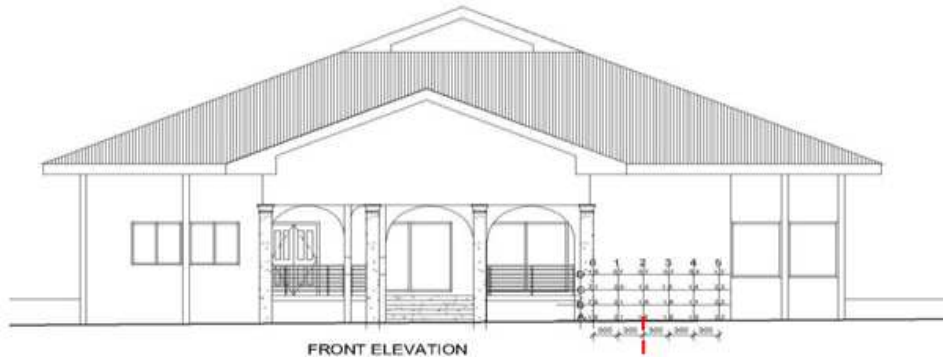
Fig. 12 and 13 show the distribution of moisture externally on the walls oriented in the southern direction. From the moisture contents recorded, the damp zones were identified to fall

within gridlines A0-A1 through to C0-C1. Furthermore, gridline A5 - C5 were identified as part of the damp zones.

Fig. 12 Moisture meter readings on walls of Southern orientation (front elevation)

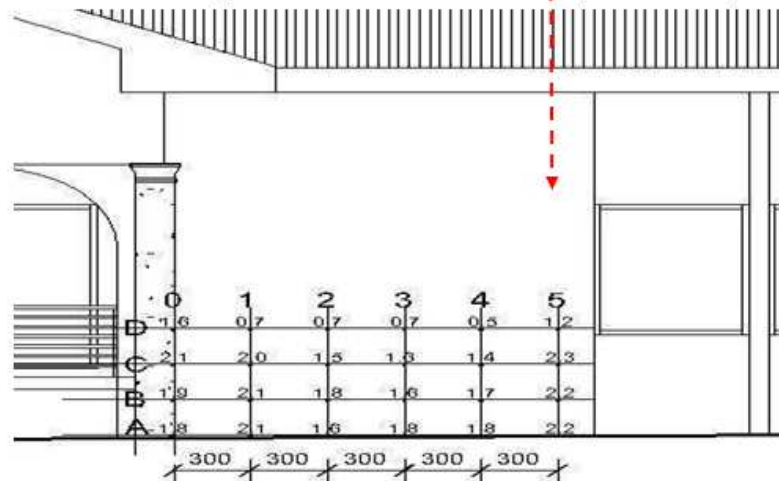
Fig. 13: Moisture contents measured on walls of southern orientation (enlarged)

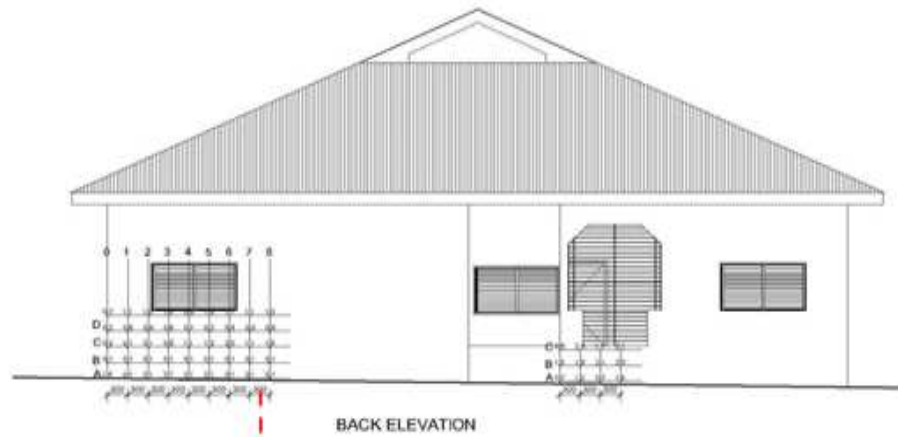
Though there appeared to be minor symptoms of dampness such as peeling off of paints and

cracks on the walls in the northern direction, readings taken from the moisture meter indicated that dampness was not severe. These symptoms could possibly be due to problems associated with poor workmanship.

Fig. 14 Moisture meter readings on walls of northern orientation

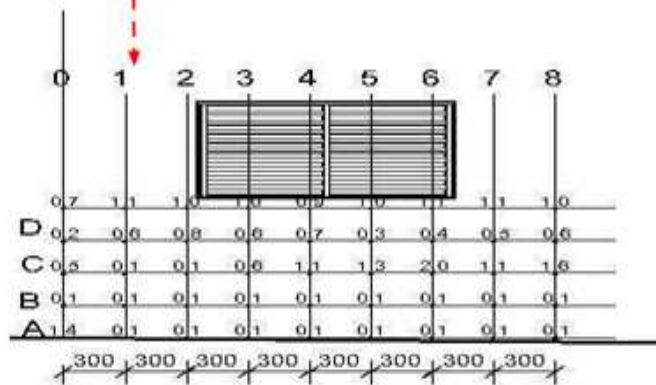
Fig. 15 Moisture contents measured on walls of northern orientation (enlarged)

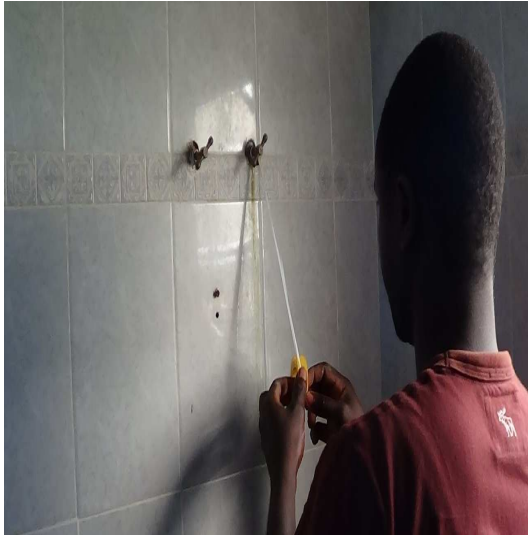
Bathrooms 1 and 2 (Fig. 5 marked in red) had similar problems. Steady drips in concealed voids from around the spindles of the traditional stop valves amounted to substantial water escapes over prolonged periods and these penetrated the walls. In Fig. 16, drips of water is seen as a plumber tries to solve the problem.

**Fig. 16: Inspection of stop valves by a plumber**

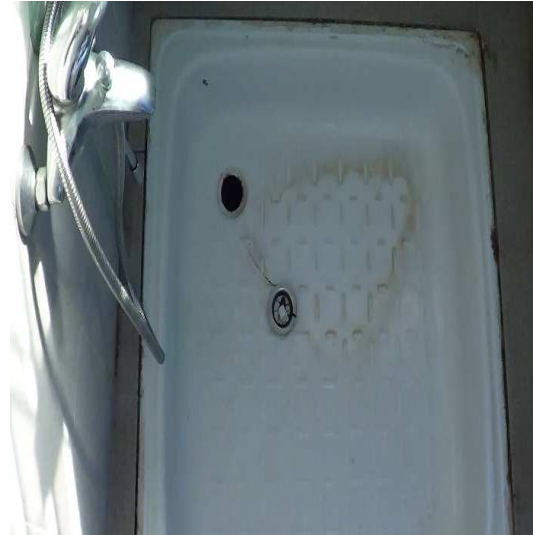
available always have upstands (Burkinshaw, 2009). Fig. 17 shows that the trays were very shallow. The glass panels were not enclosed on all three sides to create a shower cubicle. This caused water to splash out of the tray onto the floor and this was confirmed by the owner who said the floors became flooded any time someone took a bath. This situation is very dangerous because anytime this happened, the water that fell outside the tray could find its way through any gaps or flaws in the tile grouting (Burkinshaw, 2009). This is the situation seen

**Fig. 17: Shower tray fixed in bathroom 1**

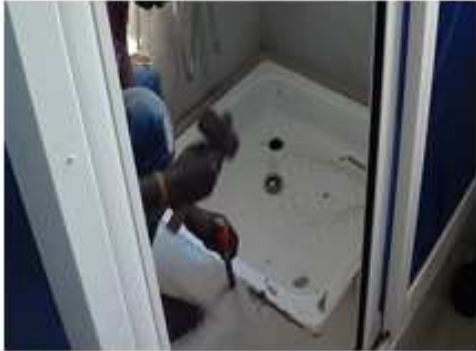
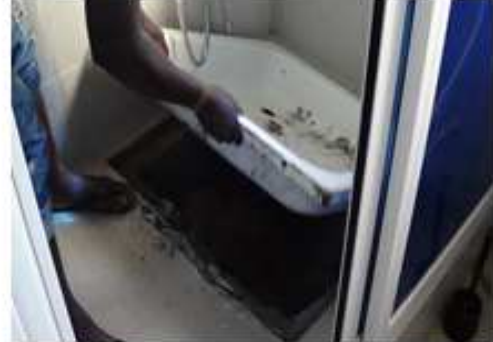
The trays offered no opportunities to access the traps and waste connections underneath. Therefore, it became very difficult to see early warning signs of developing damp problems, especially from very small but persistent drips, and these can contribute to the wetting of the porous block walls. Such situations can also create conditions of high air humidity under the tray (Burkinshaw, 2009). A destructive test conducted on the trays revealed poor fitting of the flexible connector that linked the tray to the

**Fig. 18: Shower tray being removed to check the situation underneath**

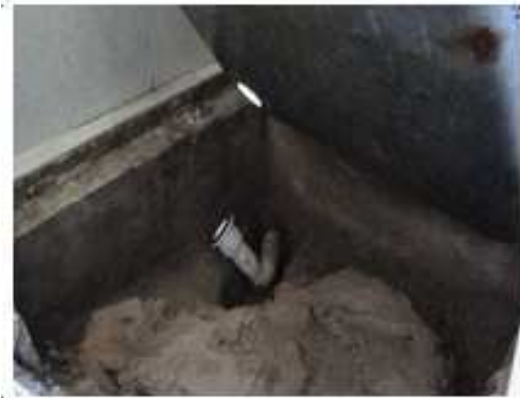
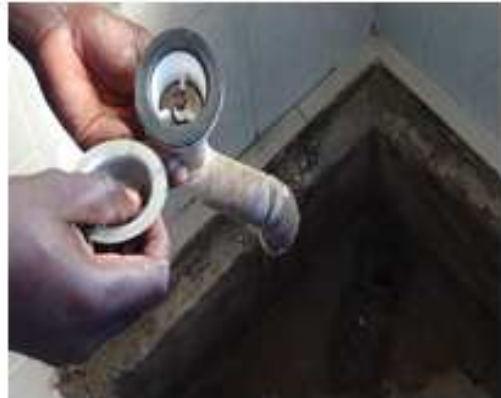
waste pipes. Because this connector was faulty, water that tracked under the tray from bathing stayed on the solid floor and soaked the porous block walls.

**Fig. 19: Faulty flexible connector being examined**

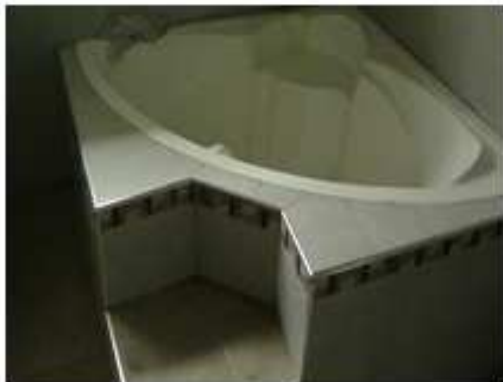
Bath ledges are possible leak zones (Burkinshaw, 2009). The bath tub in Fig. 20 had a peculiar problem. Instead of the water travelling downwards from the tiles on the vertical walls to the bath tub's edge and then into the bath, water settled on the horizontal surface and seeped through any tiling flaws in the edge seals. This is what happened in bathroom 3 and resulted in the condition on the external wall located in the eastern orientation (Fig. 21). Fig. 24 is a blown up detail drawing of the bathtub showing the tub abutting the wall tiles.

**Fig. 20: Bath tub in master bedroom**

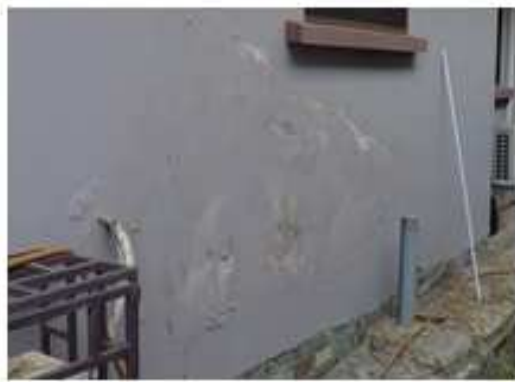
**Fig. 21: Dampness on external wall of master bathroom**

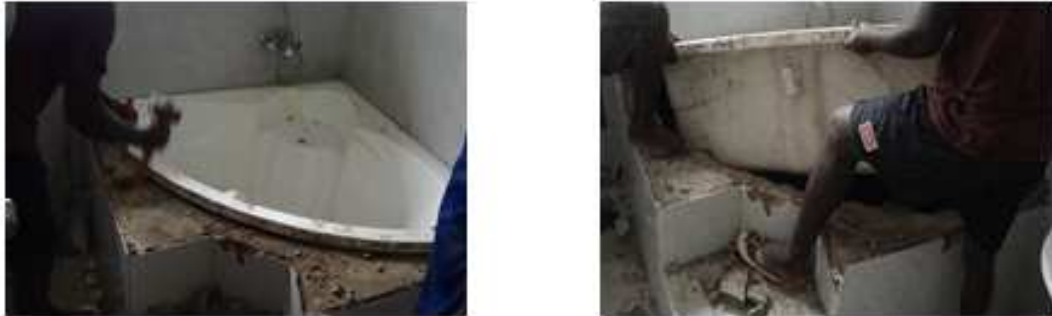
**Fig. 22: Tiled walls of the bath tub had to be hammered to pieces to enable the defective bath to be removed**

- There was no access for inspection under the shower trays and bath tub. The tiled walls of the trays and bath tub had to be hammered to pieces to enable the defective trays and bath tubs to be removed;

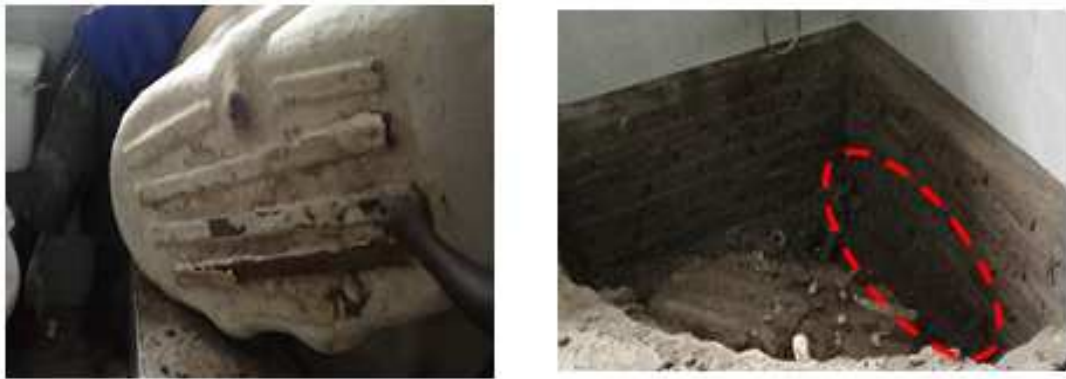
**Fig. 23: Conditions at the base of the bath tub after it was removed**

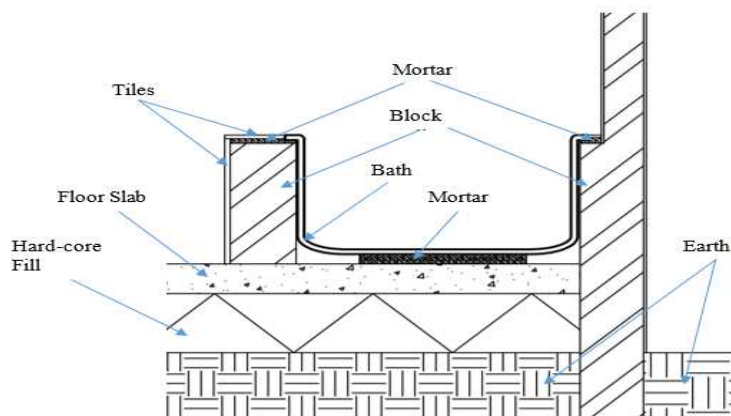
**Fig. 24: Detailed drawing of bathtub showing tub abutting wall tiles**
