## Condition Assessment of Heritage Structures: The Case of Fort Ikoma Historical Building in Serengeti National Park, Tanzania

The Fort Ikoma Historical Building, initially constructed by the Germans in 1905 and repurposed several times, holds significant cultural and military importance. Over the years, the fort has served as a hotel, an army-training centre, and an administrative centre and has undergone various structural and architectural changes. The main objective of this study was to assess the physical condition of the Fort Ikoma historical building in Serengeti National Park. This study assessed the fort's architectural and structural conditions through historical surveys, visual inspections, and materials analyses. The findings revealed significant deterioration due to weather exposure, lack of maintenance, and inappropriate interventions, leading to extensive decay in walls, roofs, and other structural elements. Nevertheless, a comprehensive Building Condition Assessment Rating System (BCARS) has revealed that the fort severely deteriorated with significant structural, architectural, and service-related defects. The building is rated five at a critical condition level,

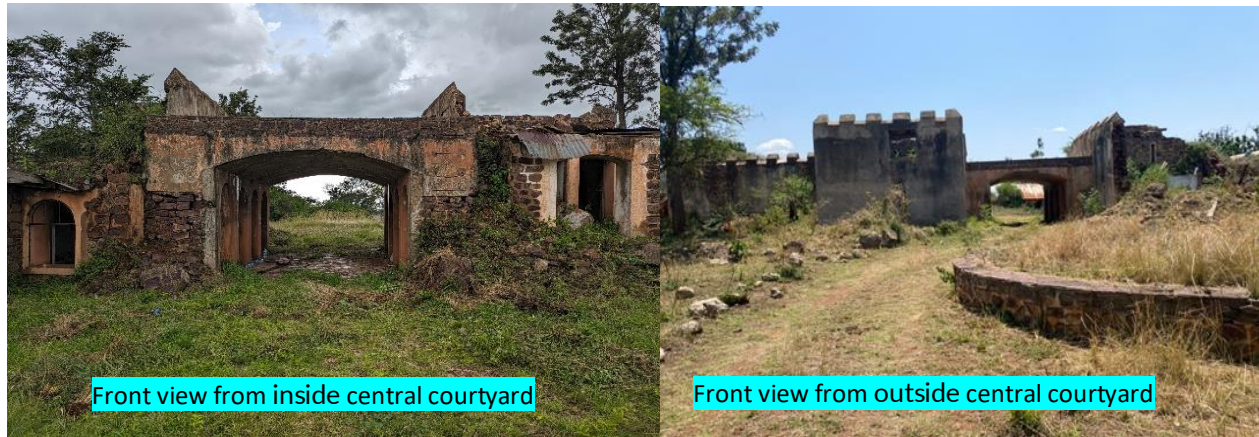
Figure 9

This area included the entrance porch/concrete curved dome, two entrance towers, and an adjacent office building on the northern side neighbouring the northeastern tower, as indicated in figure 9. The southern tower at the entrance porch had partially collapsed, and two side walls were severely damaged, and this is due to the

exposure of these walls to harsh weather. The same effect has caused the small observation windows made up of wood to rot and some of the members to be missing. The northern tower was intact, but various minor cracks were visually inspected during the site survey. Nevertheless, the remaining plasterwork has many indications of ageing because it has not been replaced and has been exposed to harsh weather for a long time. The neighbouring office area has been observed to have rotten corrugated sheet roofing materials that allow water to infiltrate the building area, causing the ceiling to get wet and rot. Also, because the building was abandoned, there were several areas where the roof timber structure had decayed due to the effects of insects (dry rot).

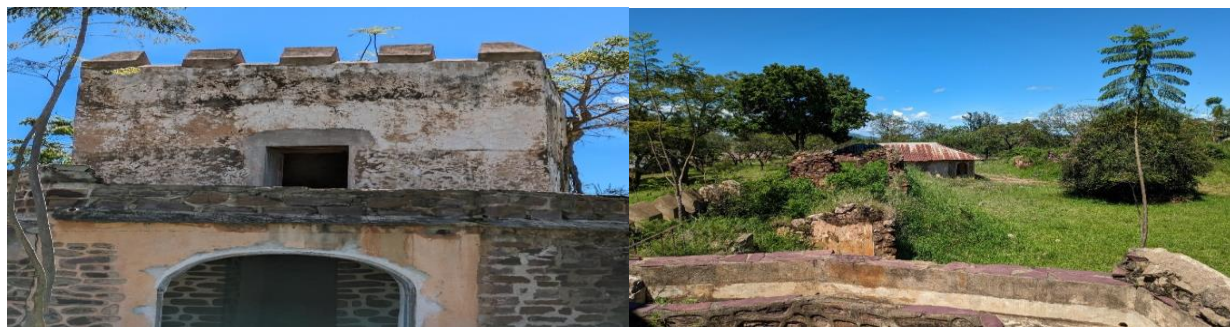
Figure 10

This part formulated the collapsed area of the fort at the northern side, an underground tunnel, a northern observation corner tower, and an in-use/habitable single detached house. The collapsed area was in a catastrophic condition with only traces of foundation walls and areas where the portion of the wall stood, as indicated in Figure 10. The reason for this collapse was possibly due to a

lack of protective roof cover that allowed rainwater to attack the massive walls put together by mud mortar. The northern observation tower was intact but exhibited numerous cracks in the plaster, and some vegetation grew on one side of the tower.

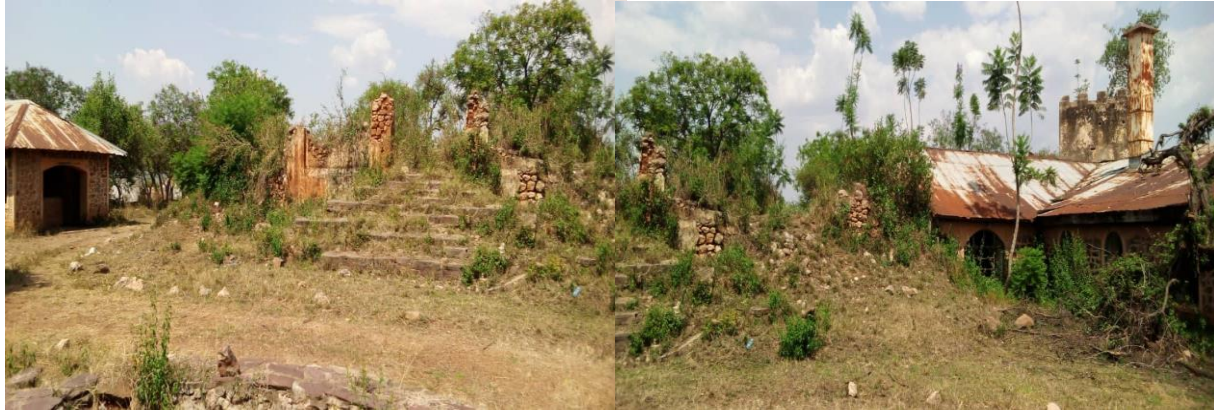
Figure 11

This part consisted of newly constructed short walls and a collapsed fort on the western side. The collapsed area was ruinous, with only traceable foundation walls and a few small portions of the fortified wall still standing. This was because the area was covered by a rotten roof that could no longer protect the building from rainwater, and ultimately, the condition caused the building to

collapse. The newly introduced walls on the western side were still standing, but they needed protection as they were not covered against weathering. The structure has endured harsh weather and formed a blackish burnt fungus, as depicted in Figure 11.

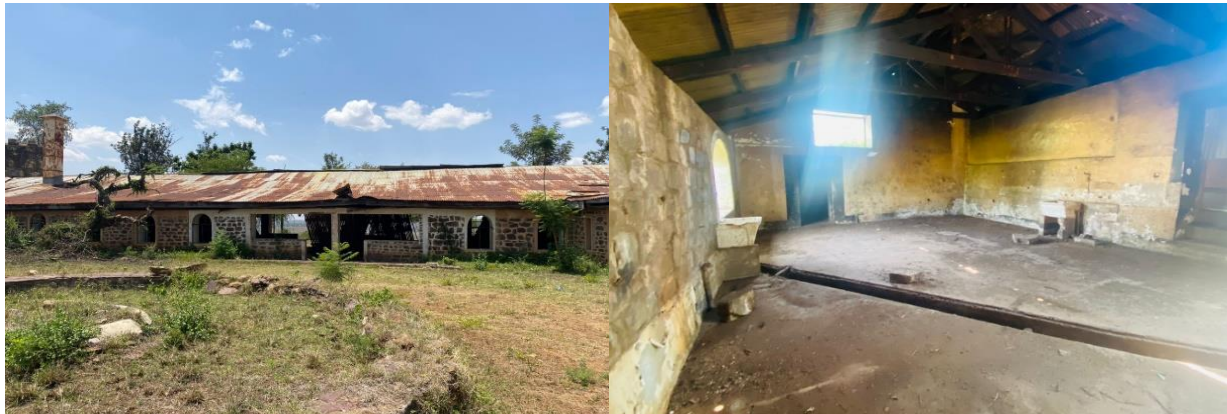
Figure 12

This area included the hall, kitchen, Southeast and Southwest towers, and the total area of the hall and its resting area. This part experienced maximum damage, and the southeast tower and its adjacent structure collapsed. During the collapse, some of the nearby elements of the building were downed by the tower's debris. The tower was in a state of disrepair. The hall and the kitchen were in

good condition, with the 28-gauge metal corrugated sheets of the roof causing only significant visible harm. The roof has been laid for a very long time. As it is exposed directly to weathering conditions, the roof has started to corrode, forming holes that allow rainwater infiltration to structural wooden members of the roof, as illustrated in Figure 12.

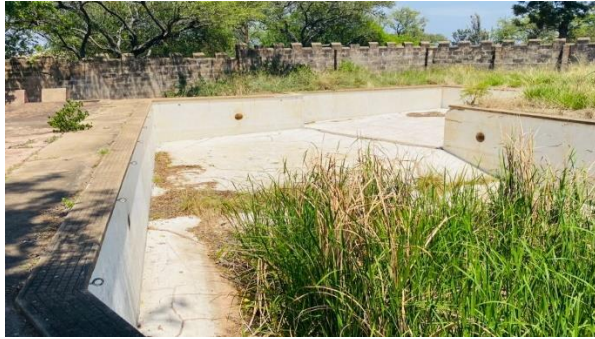
Figure 13

The pool area covers the pool's location and its surrounding open area, swimming pool facility building, and newly introduced fence wall. The swimming pool structure was intact, but some service systems, including drainage, clean water supply, and electrical systems, have not been used long. This may probably cause the system failure or disconnection. The poolhouse facilities were also intact, but various non-structural cracks were

visible on the surface of the plasterwork. Also, the fence was in fair condition, but the harsh tropical weather seemed to affect concrete blocks where burnt black fungus was visible. The pool's surrounding area was covered by square concrete pavements of approximately 400mm x 400mm x 10mm in size that were unclean due to prolonged use and exposure to weathering conditions, as shown in Figure 13.

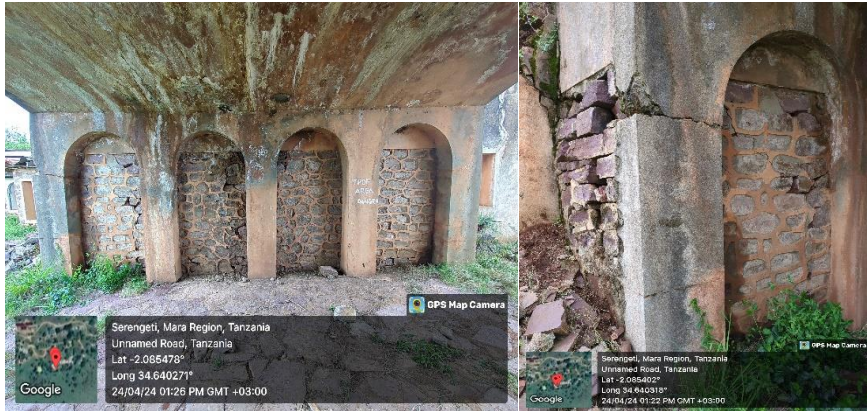
No	Types of Defects	Descriptions
1	 	Breakage/Collapse and Vegetation of Foundation

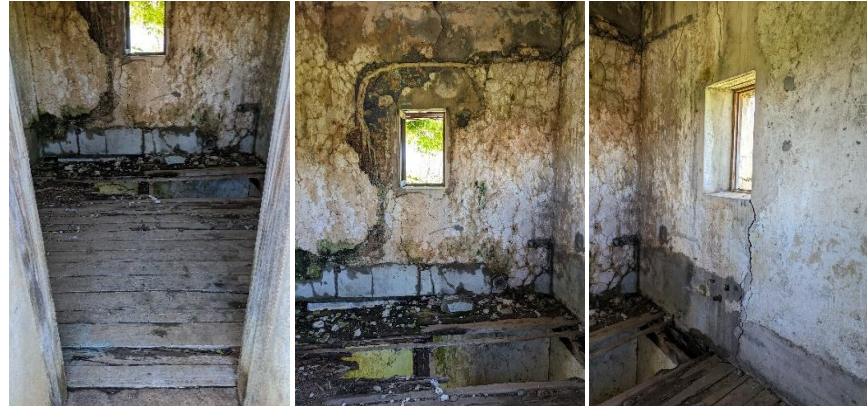
Crack or Fracture, Deflection, and Efflorescence and Delamination of Columns
3

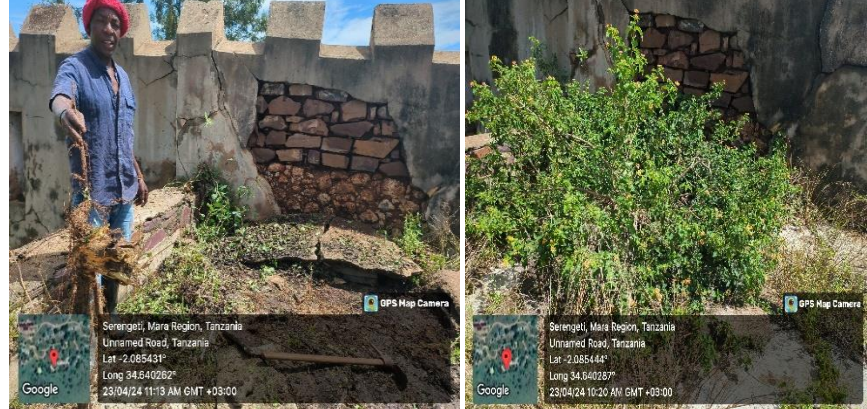
Breakage/Collapse and Textural Features of Wooden Slab
4

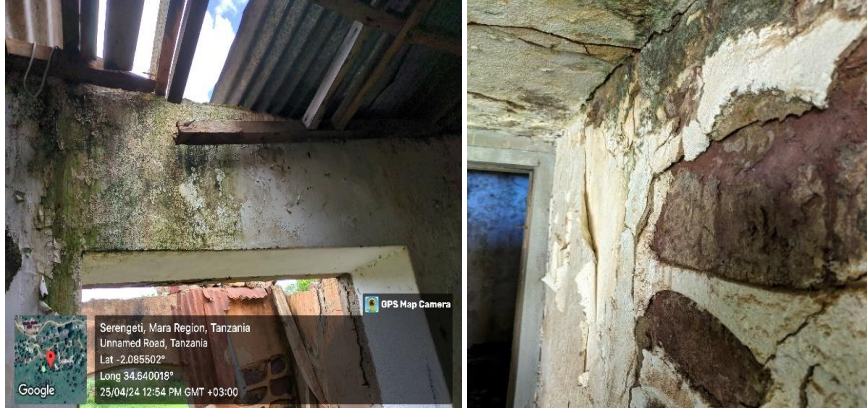
Breakage/Collapse and Vegetation of Concrete Slab
5

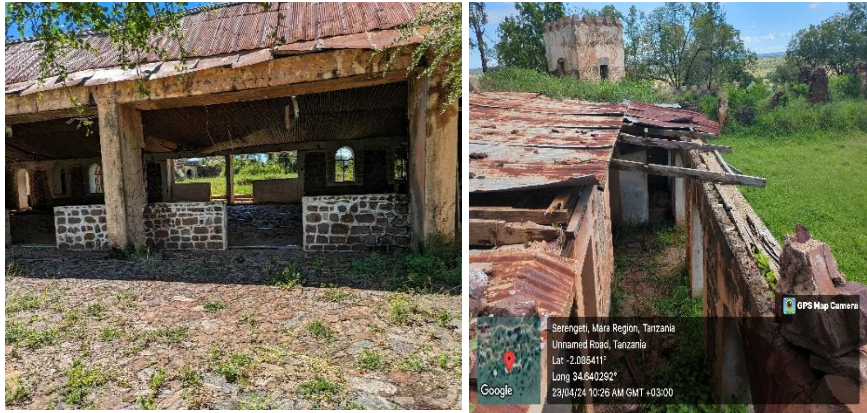
Flaking of Paints

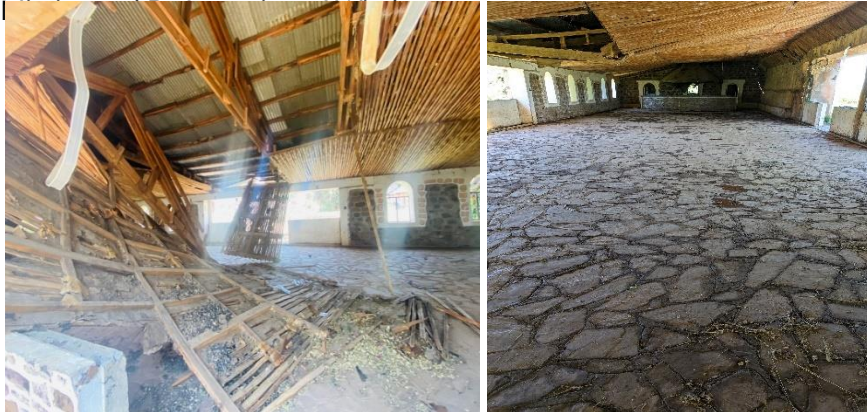
Breakage/Collapse, Corrosion, and Missing of Roof Covering
7

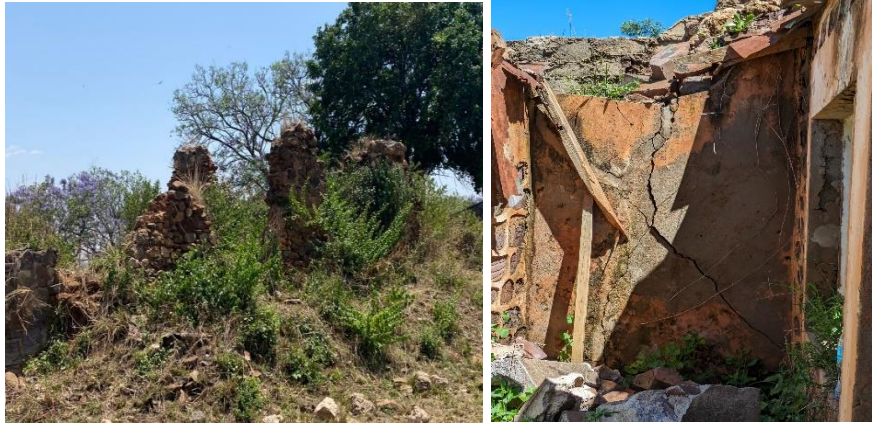
Spalling, Vegetation, Dampness, Fungus, and Efflorescence of Walls

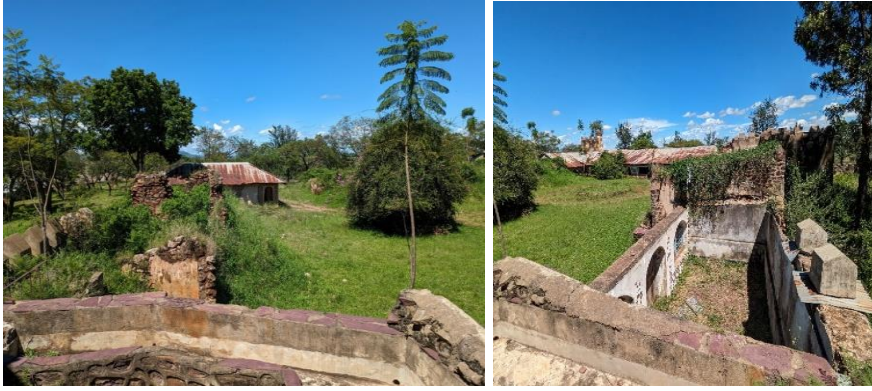
Cracks or Collapse of Walls
11
