# PERFORMANCE OF AN AUTOMOTIVE BUMPER FROM LALLOH (*Corchorus triden L.*) PLANT FIBRE REINFORCED EPOXY COMPOSITE UNDER MODIFIED DYNATUP MODEL 8150 TEST

## ABSTRACT

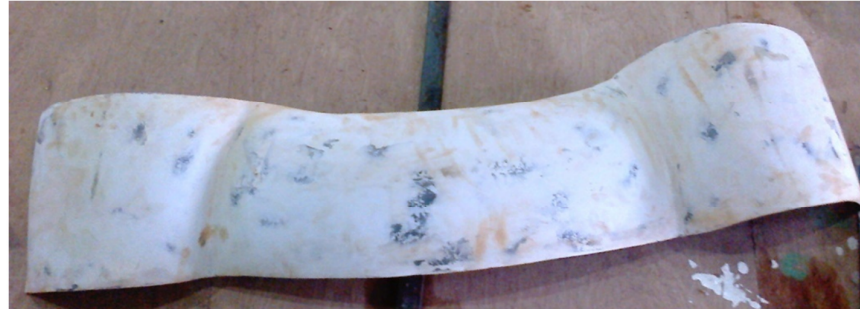
SN	Damage Assessment Criteria	Bumper with complete restraint	Bumper with two-point restraint
1	Damage is to the external bumper surfaces	There was no visible damage to the external surfaces of the bumper. The surface remained clean and free of any dent or scratches (see Figure 4(a)).	There was visible damage to the external surfaces of the bumper as shown in Figure 4(b). The damage includes scratches, dents and tears as indicated by arrows A, B and C
2	Localized dents or deformation are no more than 3/8 inch (0.95 cm) deep	Localized dents or deformation were absent on the bumper surface after the test (see Figure 4(a)).	Localized dents or deformation observed on the bumper surface after the test were not up to 0.95cm (see Figure 4(b)).
3	Overall bumper distortion or displacement is no more than 3/4 inch (1.9 cm) from the original contour, and there is no breakage of fasteners	The original contour and alignment of the bumper were maintained after the test with no distortion or displacement.	There was no overall distortion of the bumper; however, the left wing of the bumper was distorted from its initial contour as shown in Figure 4.40. In addition, the two fasteners meant to fasten the bumper to the chassis frame were completely removed from their original position during the test as indicated as X on Figure 5.

6	Gouging or cracking partially into the cover material if its length or diameter is no more than 2 cm and is not located in critical areas	There were no gouging or cracking into the cover material of the bumper (see Figure 4(a))	There were visible cracks into the bumper material of the bumper (see Figure 4(b)) which were more than 2cm in length although not located in critical areas
7	External paint or finish scuffing, delamination, wrinkling, and the like	The bumper was not painted as such paint or finish scuffing and wrinkling	There were tears and cracks into the material of the bumper although the material did not

Figure 4(a): Bumper surface after impact test with complete restraints

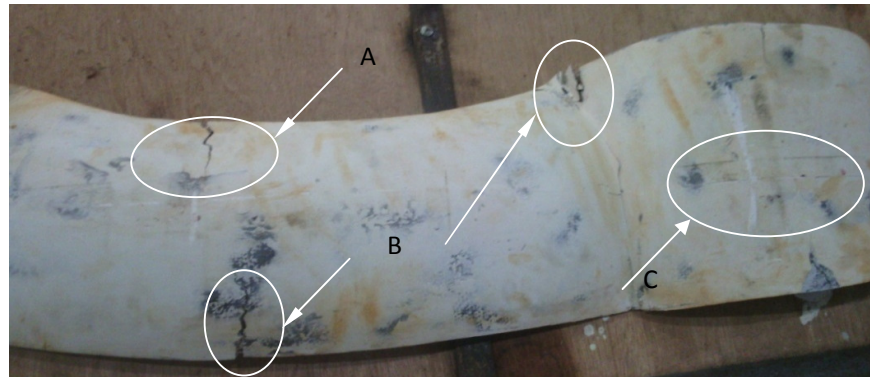
assessment from which inferences were drawn on the level of damage sustained on the bumper after impact. Result of the test with complete restraint showed that the bumper performed satisfactorily since there were no damage, cracks, dents or scratches on it. However, in the case of test with two-point restraint, tears, distortion and delamination of the bumper were observed. Although the extent of the tear, distortion and delamination were minimal which did not result in the shattering of the bumper. This therefore shows that, the bumper was able to absorb the impact energy by confining the damage to itself, thereby protecting adjacent components. Detailed assessment of the bumper using the damage assessment criteria set by IIHS [31] is presented in Table 1.

Figure 4(b): Bumper surface after Impact Test with Two-Point Restraints

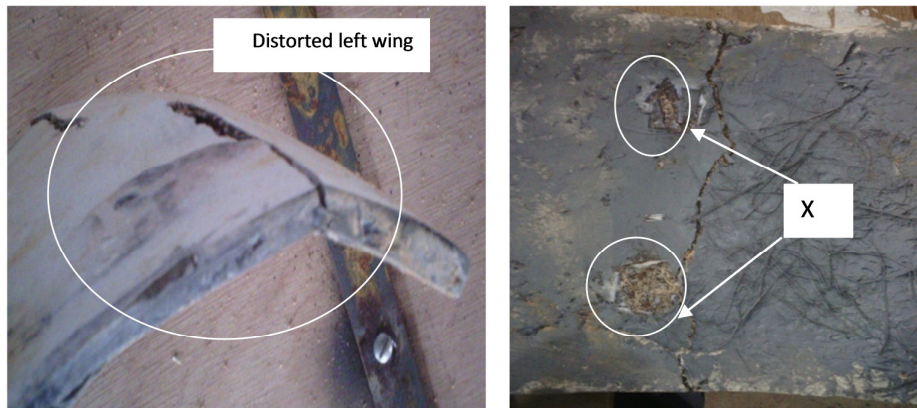
Figure 5: Bumper Displacement and positions of broken off fasteners

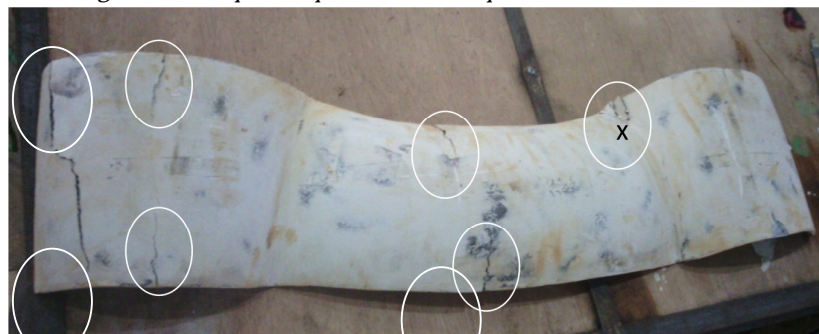
4	Larger localized dents, deformation, or distortion than indicated above if, in the opinion of the appraisers, the bumpers would meet the criteria after repairs to underlying damage such as replacement of reinforcement bars or foam absorbers	No localized dents, deformation or distortion.	There were no reinforcement bars in the initial design, however, the bumper brackets were completely displaced and will have to be replaced
5	ears or holes that penetrate completely through the cover material if they are no more than 1 cm in length or diameter and do not occur in critical areas such as openings for fasteners that secure the cover	There were no tears or holes on all the surfaces of the bumper after the test.	There were no penetrating holes on all the surfaces of the bumper after the test, however, tears of more than 1cm were observed on two locations as shown one of which occurred at a critical area marked X in Figure 6

Figure 6: Crashed bumper showing tears more than 1cm

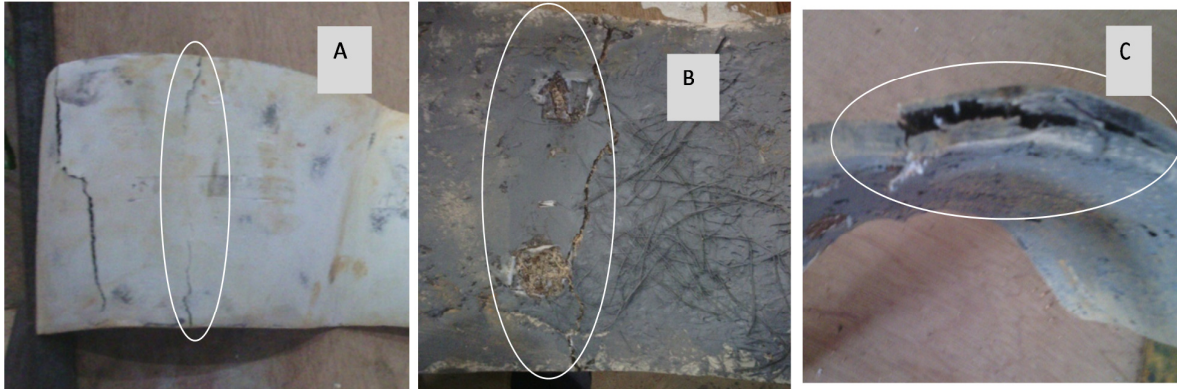
Figure 7: Bumper after impact test with two-point restraints showing Tears and Cracks on external surface (a) and internal surface Tears and Cracks (b) matrix delamination (c)

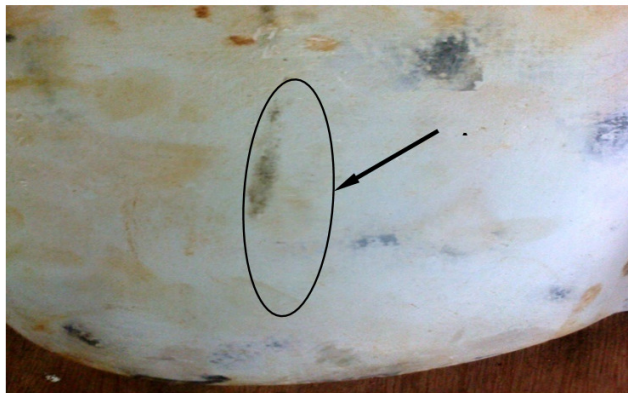
SN	Damage Assessment Criteria	Bumper with complete restraint	Bumper with two-point restraint
	if there are no tears or holes completely through or cracks or gouges part way into the material as described above	cannot be reported. However, there were no tears, holes, cracks nor gouges on the material of the bumper	part ways, but the cracks and tears went through the material of the bumper as shown in Figure 7.
8	Colour lightening of moulded-in-colour (unpainted) covers	Colour lightening was observed as indicated by arrow in Figure 8(a)	Colour lightening was observed as indicated by the circles in Figure 8(b)

Figure 8(a): Color lightening of bumper surface after impact test with complete restraints

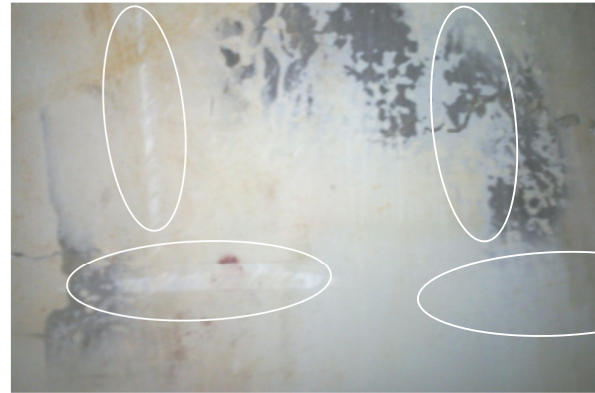
Figure 8(b): Color lightening of bumper surface after test with two-point restraints
