## TYPICAL PERFORMANCE REDUCTIONS IN PV MODULES SUBJECT TO SOILING IN A TROPICAL CLIMATE

**Keywords:** solar PV, PV soiling, infrared thermography, module failure, PV performance

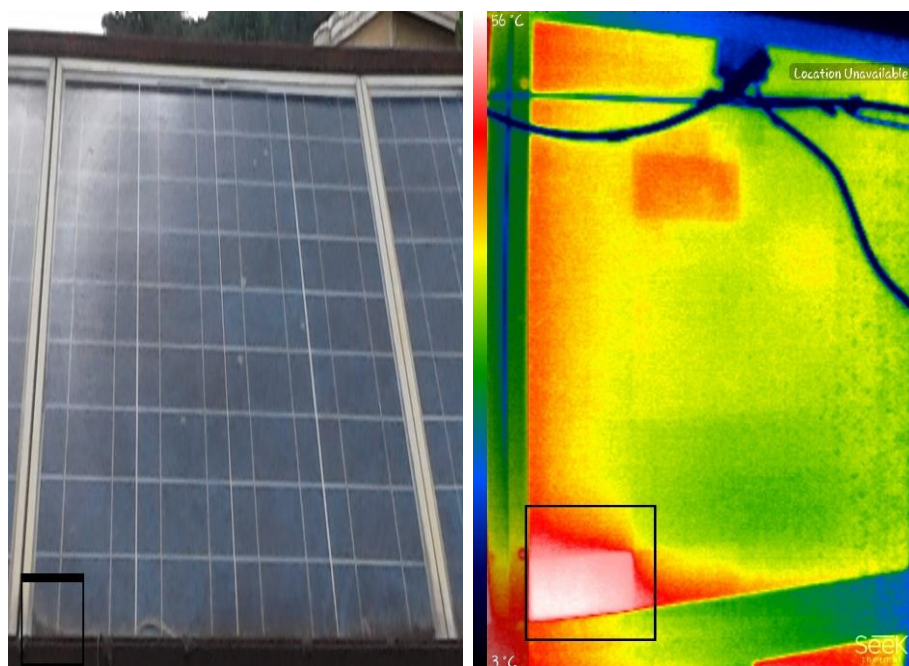
Prior to the cleaning of the PV installation at the NCERD, a visual inspection of the modules showed that the module surfaces were evenly soiled and major soiling had also accumulated at the lower end of the surfaces. Some of the soiling resulted from settled leaves evident at the module edges as shown by the left image in Fig. 1. The tilt of the modules and the design of the frames aided the soiling by preventing the run-off of dirt during the rains. The dirt hence accumulated at the lower ends of the modules. With the passage of time, this settled dust hardened and affected the PV module by the heat it generated under high irradiance.

Fig. 1: Normal (left) and IR (right) images obtained before cleaning the NCERD PV module surface.

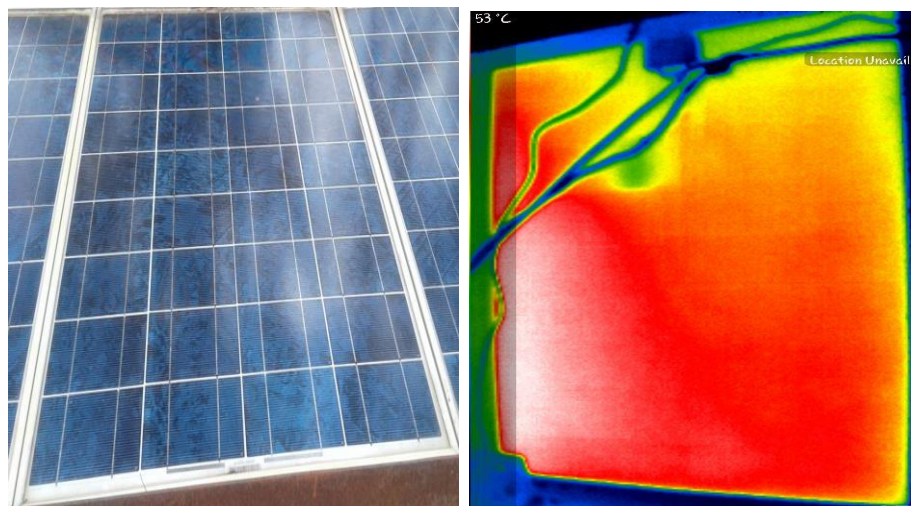
cleaning becomes obvious by comparing the left images in Fig. 1 and Fig. 2. The right images in Figs. 1 and 2 are representative IR thermograms of the PV modules before and after the system was cleaned, respectively. The IR thermogram of the soiled module (Fig. 1(left)) revealed an uneven thermal distribution over the module. Elevated temperatures at the bottom edge of the module are clearly evident. The IR thermogram of the cleaned module shows a more even temperature distribution, with the absence of the temperature elevations. The bright area to the left of the clean module's thermogram is an optical flare that occurred during the IR image capture.

Fig. 2: Normal (left) and IR (right) images obtained after cleaning an NCERD PV module surface.

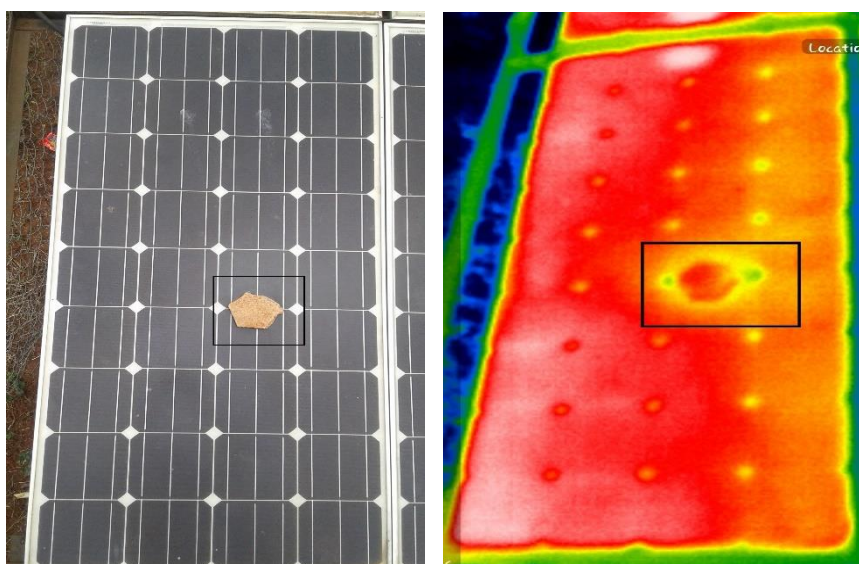
The IR image on the right of Fig. 3 shows the distortion in the module temperature distribution created by the stone resting on the soiled module surface. Generation of current by the PV cell beneath the stone was impaired by the shade cast on it by the stone, causing a cooling of the cell junctions adjacent to the stone (which appear greenish). This significantly impacted on current generation on the right side of the module. This is shown by the brighter coloration of the module's right side in the thermogram. Images of another module in the PV array at the USPS are depicted in Fig. 4. This module is also soiled with dust, and has stone and nail droppings on it. The thermal effects of these objects are clearly visible in the IR image on the right of the figure.

Fig. 3: Normal (left) and IR (right) images obtained before cleaning a USPS PV module surface.

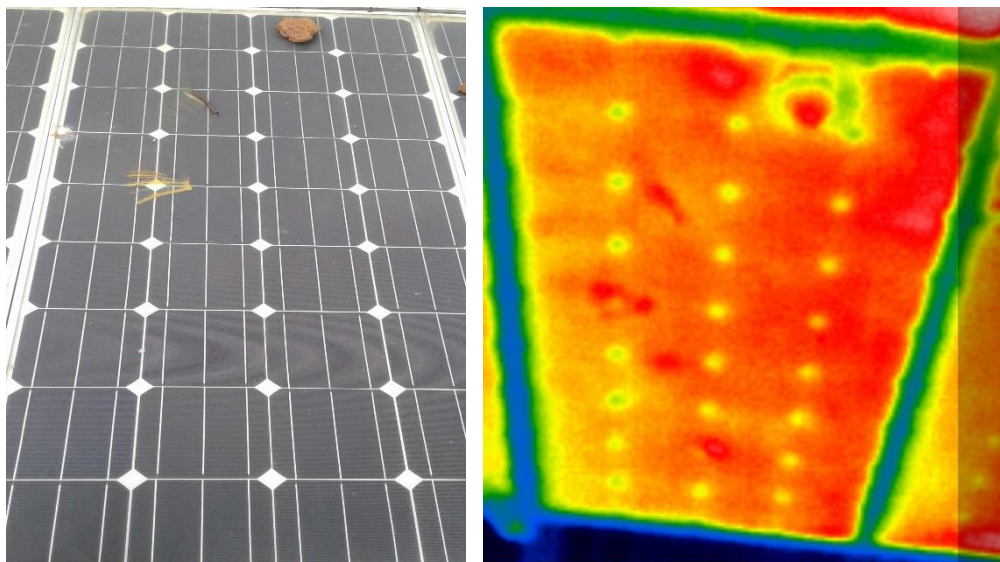
Fig. 4: Normal (left) and IR (right) images obtained before cleaning another USPS PV module surface.

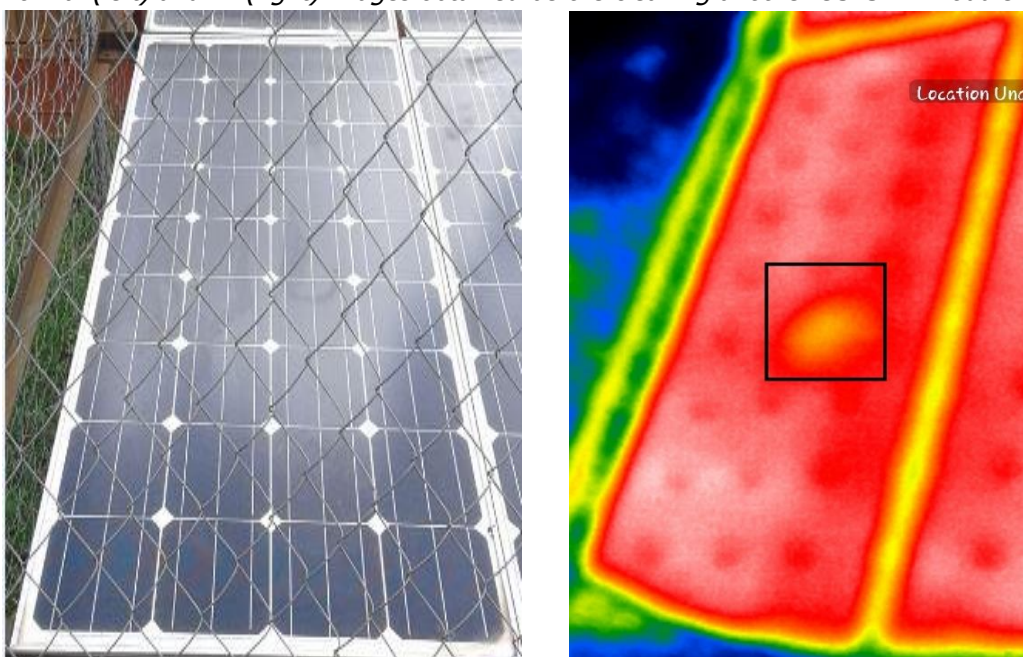
On the left of Fig. 5 is shown the normal image of the module of Fig. 3 after the system had been

cleaned to remove the droppings and dust deposits. Its corresponding IR thermogram is shown on the right of the figure. Inasmuch as the dirt and droppings were well removed, the IR thermogram shows that a permanent defect on the PV module may have resulted from the impact of the stone, which remained even after the cleaning.

Fig. 5: Normal (left) and IR (right) images of PV module surface obtained after the installation at the USPS.

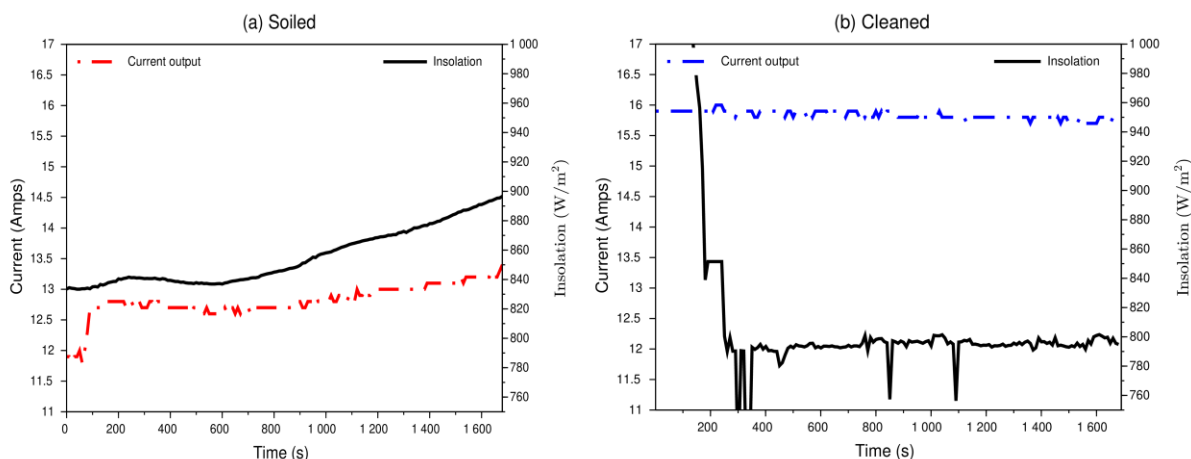
Figure 6(a) and (b) show the responses of the current outputs to changes in the insolation prevailing during the measurements on the soiled and clean modules, respectively. During the test on the soiled array (Fig. 6(a)), a gradual rise in insolation was recorded, and this caused a corresponding increase in the array's current output. The maximum short-circuit current generated by the soiled array within the test interval was 13.4 A when the radiation intensity was 896.6 W/m<sup>2</sup>.

There were major fluctuations in the insolation during the tests on the array after cleaning (Fig. 6(b)), with a maximum insolation of 1,090 W/m<sup>2</sup> recorded close to the start of the test. It steadied however in the course of the test to a value of 800

W/m<sup>2</sup>. The current output from the clean array was also relatively steady at a value close to 16 A. Comparing the outputs before and after cleaning, a remarkable rise in the generated current (~9 %) is observed despite the noticeable drop in insolation (~10 %). The current outputs from the PV array at the USPS are shown in Fig. 7(a) and (b), for array conditions before and after cleaning, respectively. A maximum *ISC* of 6.72 A was generated during the tests. The insolation was steadier during the test on the cleaned system, being mostly with the range of 960 to 1,100 W/m<sup>2</sup>.

Fig. 6: Transient response of the current output of the NCERD solar PV array to changes in solar irradiation when (a) soiled and (b) cleaned

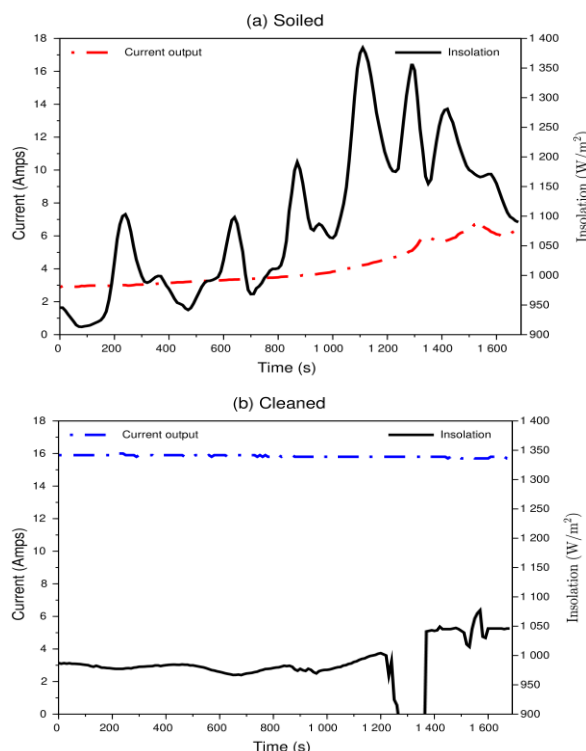
The maximum  $I_{SC}$  measured was 16 A coinciding with a radiation intensity of  $977.3 \text{ W/m}^2$ . Akin to the tests on the NCERD array, the cleaning of the modules resulted in a rise in current output (of  $\sim 300\%$ ).

Fig. 7: Evolution of current output of the USPS solar PV array when (a) soiled and (b) cleaned

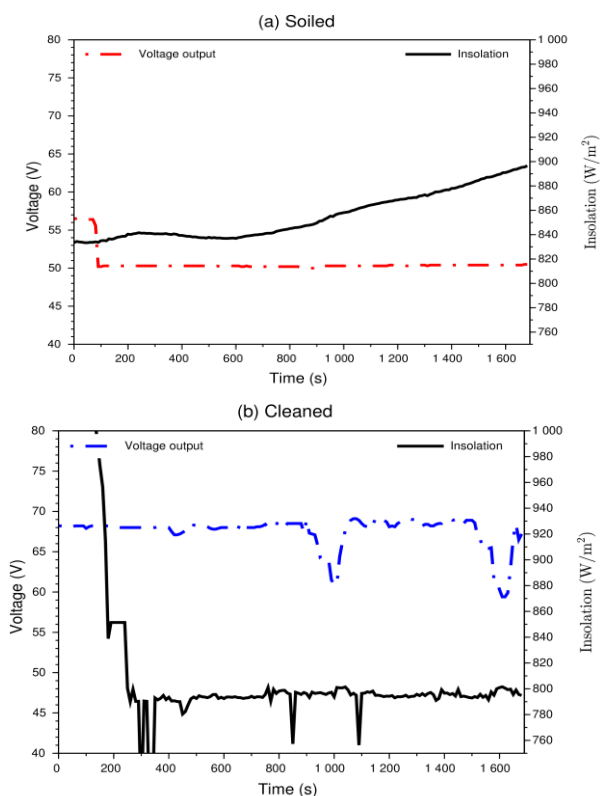
The impacts of soiling on the output voltages developed by the PV arrays were also assessed and found to be as significant as the impacts on the currents generated. For the NCERD PV array, the open circuit voltage ( $V_{OC}$ ) produced by the system when soiled were  $\sim 50 \text{ V}$ , as shown in Fig. 8(a). After the modules were cleaned (Fig. 8(b)), the recorded voltages increased to  $\sim 68 \text{ V}$ , indicating that the soiling had caused decrements in voltage as much as 26% (compared to the  $\sim 9\%$  decrease in the current generated).

Fig. 8: Transient response of voltages developed by the NCERD solar PV array to changes in solar irradiation when (a) soiled and (b) cleaned

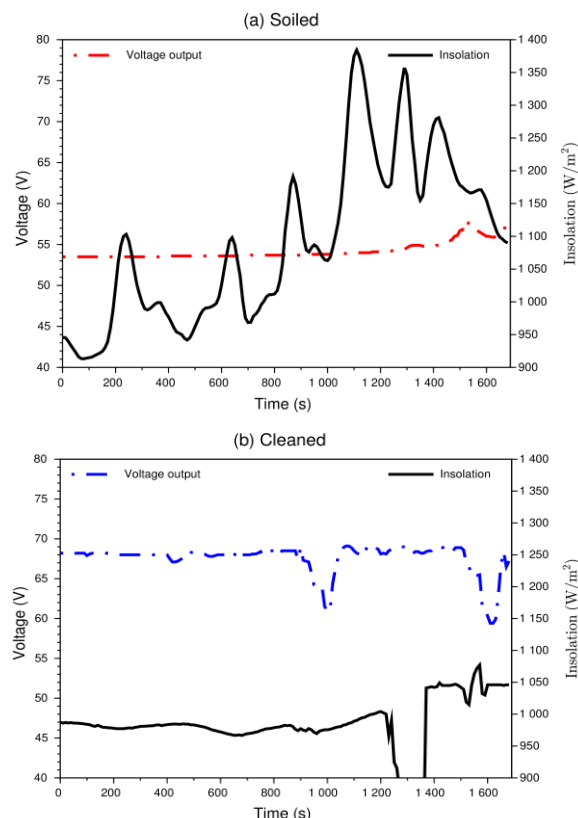
Figure 9(a) and (b) show the voltages produced by the PV array installed at the USPS. The voltages similarly increased from 53–58 V, when the modules were soiled, to  $\sim 68 \text{ V}$ , after they had been cleaned – an increase of  $\sim 24\%$ . These increases in current and voltage outputs recorded by the two PV systems as a result of cleaning corresponded to increases in power output. The soiling of the PV modules evidently caused greater deterioration in the power outputs of the USPS system than for the NCERD system.

Fig. 9: Evolution of voltages developed by the USPS solar PV array when (a) soiled and (b) cleaned

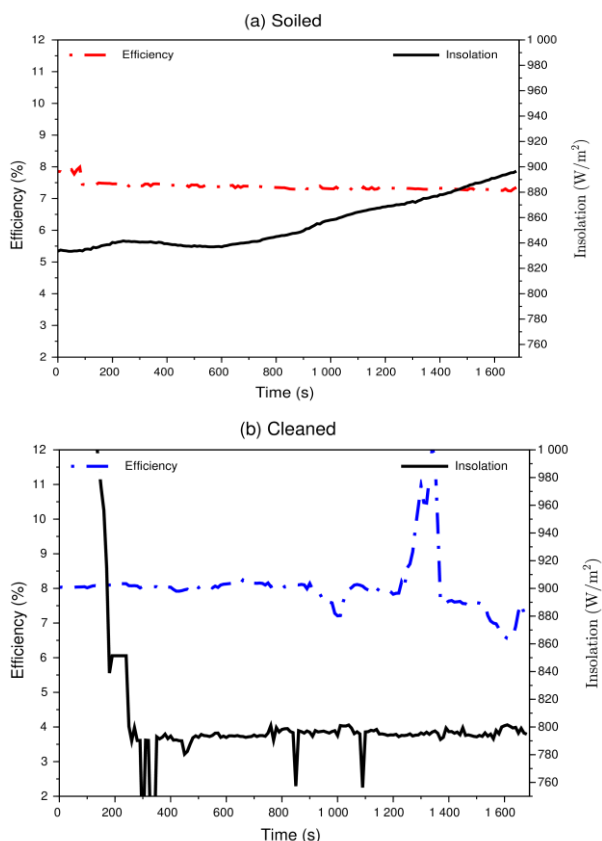
Fig. 10: Transient changes in the output efficiencies of the NCERD solar PV array when (a) soiled and (b) cleaned

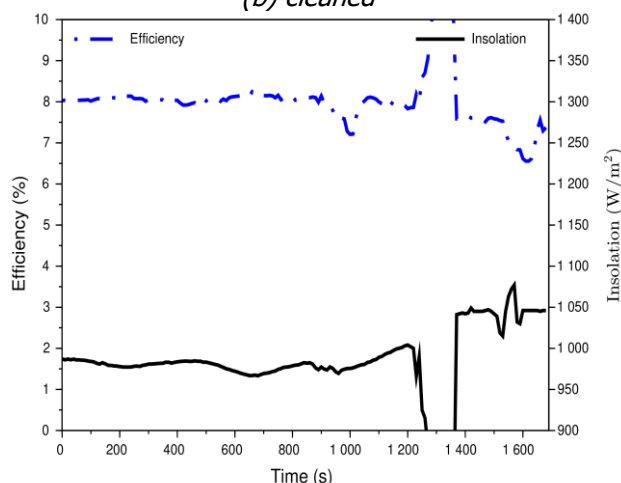
Fig. 11: Output efficiencies of the USPS solar PV array when cleaned
