APPLICATION OF 2-D IMAGING SURVEY FOR ASCERTAINING THE CAUSE(S) OF ROAD FAILURES ALONG SAPELE/AGBOR ROAD IN DELTA STATE, NIGERIA

Akpoiyibo, O.¹, Anomohanran, O.² and Ossai, C.¹

ABSTRACT

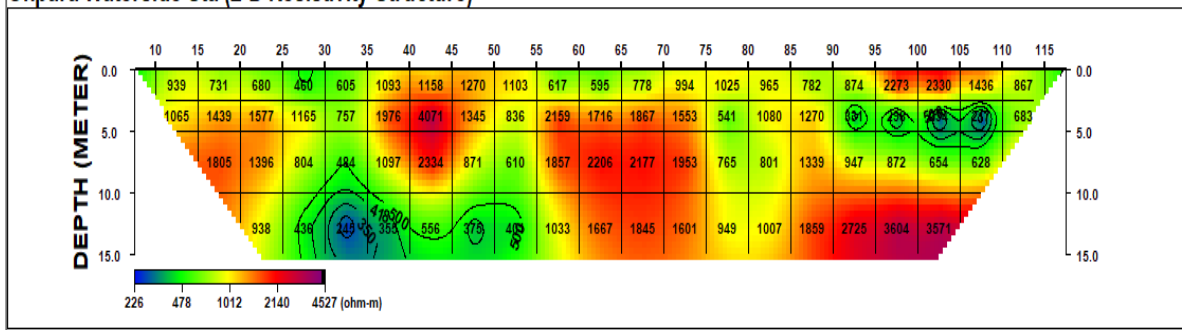
Fig. 3: 2-D resistivity structure along Okpara Waterside 1.

Figure 3 denotes the 2-D resistivity image from the known resistivity magnitude (measurement). It reveals topsoil resistivity ranged from 480 Ωm to 2230 Ωm and surface thickness of 2.5 m, the second layer contains clay and sand formation with resistivity from 226 Ωm to 4071 Ωm and thickness from depth 2.5-5.0 m, the third layer comprises sand settlement with resistivity ranged from 484 Ωm to 2304 Ωm with depth of 5 m, and the last (fourth) layer resistivity ranged within 245

Ωm to 3571 Ωm with thickness up to 15 m. Low resistivity can be depicted at both second and third layer as blue color zone with clayey sand settlement, and the area can fail in the process of time without rehabilitation due to the presence of clay. It shows a low resistivity set of values from 125 Ωm – 375 Ωm , between two major regions at lateral distances ranging from 10 m – 55 m and 85 m – 115 m from a depth of 2.84 m – 14.90 m and 2.54 m – 9.20 m respectively bounded with blue and green colors.

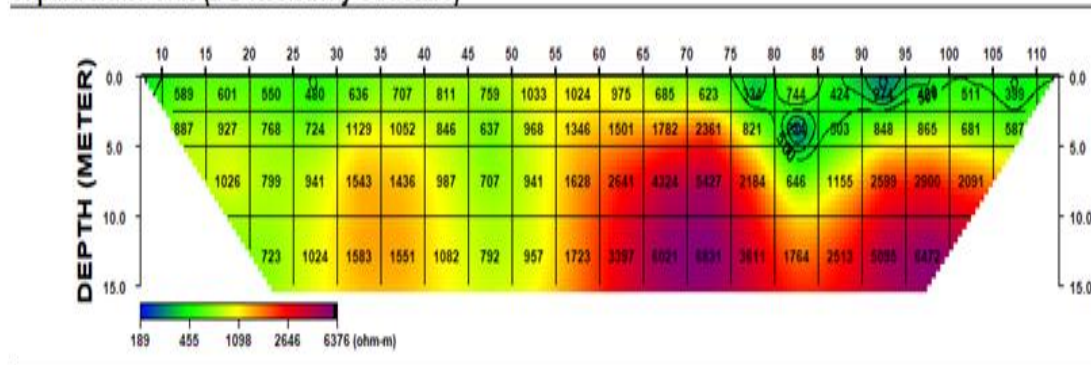
Fig. 4: 2-D resistivity structure along Okpara Waterside 2.

Figure 4 represents the 2-D resistivity map from the obtained apparent resistivity size (magnitude). It shows topsoil resistivity ranged from 194 Ωm to 1033 Ωm and surface thickness of 2.5 m, the second layer contains sand and clay composition with resistivity ranged from 189 Ωm to 2381 Ωm and thickness 5m depth from 2.5 m, the third layer contains sand formation with resistivity ranged from 606 Ωm to 5427 Ωm with depth of 10m from 5m and the fourth layer resistivity ranged within 723 Ωm to 6472 Ωm with thickness up to 15 m with lateral distance from 22.5 m to 97.5 m. The clayey sand present at a lateral distance of 75 m to 95 m to depth of 7 m from the surface which was observed with resistivity values of 189 Ωm and 194 Ωm account for the reason why the road segments failed since low resistivity support road failure as detected with portions shaded with blue color in the first and second layers.

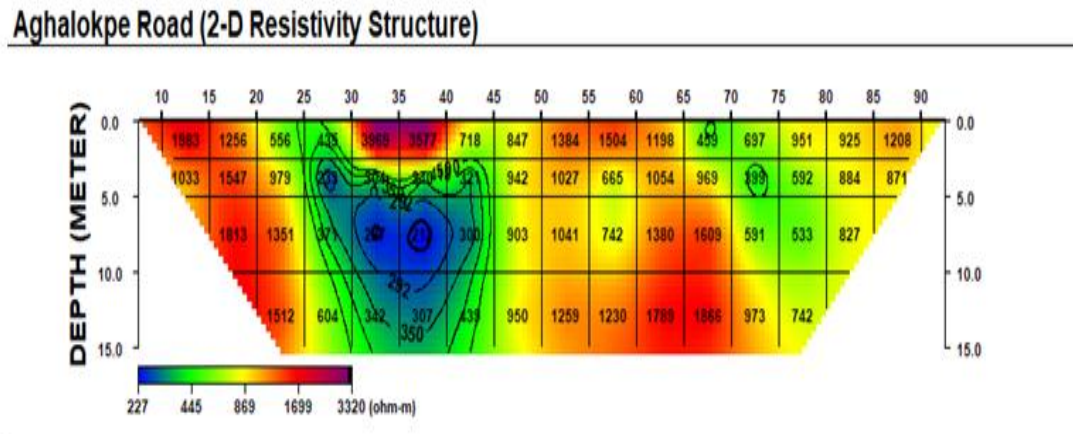
Fig. 5: 2-D resistivity structure along Aghalokpe.

Figure 5 unveils Aghalokpe 2-D resistivity structure obtained from certain resistivity metric (measurement). It exhibits topsoil resistivity ranging from 445 Ω m to 3577 Ω m to a depth of 2.5 m from the surface, the second layer contain sand(fine and medium sand) and sandy clay compacted with resistivity varying from 253 Ω m to 1547 Ω m and at depth 2.5m to 5.0m. The third layer contains both clay and sand mixture with resistivity numerical quantity ranging from 227 Ω m to 1813 Ω m at depth of 5.0 m to 10.0 m and the fourth layer

resistivity ranging within 342 Ω m to 1866 Ω m with thickness up to 15 m from 10.0 m. The failed portions at lateral distance of 25 m to 45m for second, third and fourth layers underneath the topsoil is characterized by low resistivity in the 2D structure varying from 227 Ω m to 307 Ω m with the confinement of sandy clay which can fail without reaching the designed age. The stable regions have moderate resistivity obtained to be within 459 Ω m and 1866 Ω m.

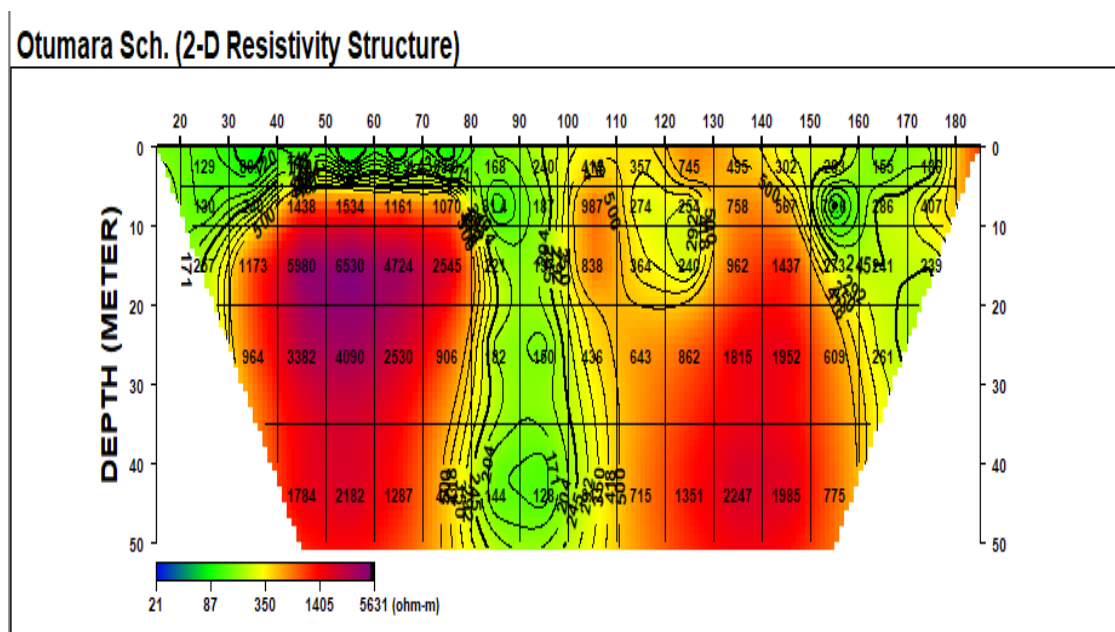
Fig. 6: 2-D resistivity structure along Otumara Primary School.

Figure 6 also discloses the 2-D resistivity structure divulging resistivity section at Otumara. It unveils topsoil resistivity range of from 56 Ωm to 745 Ωm and thickness of 2.5 m near the surface, the second layer contains lateritic clay, sand and clay depositions with resistivity changing within 87 Ωm to 1534 Ωm and at 2.5 m thickness. The third stratum contains both sandy clay and sand formation with resistivity numerical quantity ranging from 158 Ωm to 6530 Ωm at depth of 20 m from 10.0 m and the fourth layer resistivity intervals from 160 Ωm to 4090 Ωm with thickness of 35 m from 20.0 m. The fifth stratum vary with resistivity from 128 Ωm to 2247 Ωm with formation of clayey sand and medium to coarse sand. Some domains outlined with blue shades have slightly low resistivity values with most area having resistivity greater than 140 Ωm . Three distinctive zones marked with blue colour with very low resistivity values were viewed at various distances within 20.0 m – 79.50 m, 80.5 m – 100.50 m and 150.50 m – 170.50 m at a depth of 2.54 m - 15.0 m, 3.00 m-50 m and 12.25 m- 25.0 m respectively. The lateral road distance of 80.5 m-100.5 m will fail intermittently due to huge underlying clay formation mixture present from the surface to

depth of 50 m compared to other lateral distances. Thus, the stable portions are characterized with low conductivity (high resistivity values). The unstable or failed sections of the road are due to clay sub grade formation at significant depths than the stable sections with shallower or no depth of formative clay.

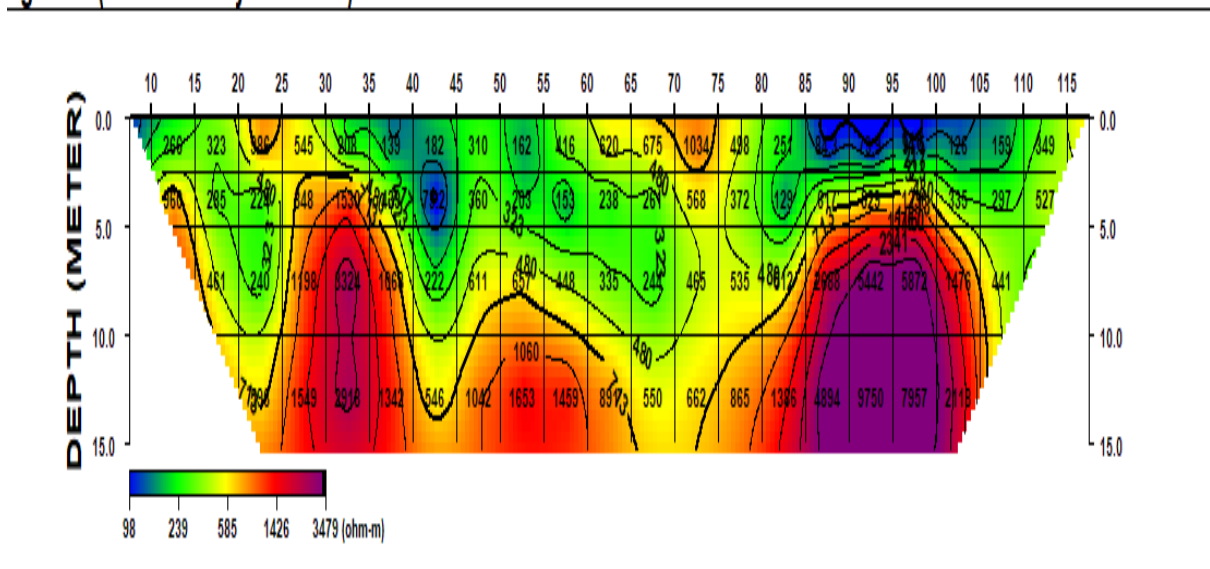
Fig. 7: 2-D resistivity structure along Igun

Figure 7 gives 2-D resistivity form lengthwise along Igun road. It exhibits lateritic/clay topsoil resistivity values spreading between 98 Ωm to 1034 Ωm with 2.5 m thickness from the surface, the second layer enclosed clay and sand composition with resistivity varying from 102 Ωm to 1504 Ωm at thickness of 2.5m . The third layer contains both clayey sand and sand formation with resistivity numerical point values ranging from 222 Ωm to 5872 Ωm at depth of 5.0 m from the second layer depth and the fourth layer with only sand formation with resistivity interval from 546 Ωm to 9750 Ωm at thickness of 15 m from 10.0 m. The unstable sections of the Igun road point out a low resistivity (< 140) values from 102.0 Ωm – 139.00 Ωm , distinguished with two major regions at lateral distances of 35 m to 45 m and 85 m to 105 m to a depth of 2.5 m – 7.20 m and 2.0 m – 2.52 m respectively. These low

resistivities of the clay materials threaten the integrity of the road causing road failure as a result of distress place on the road.

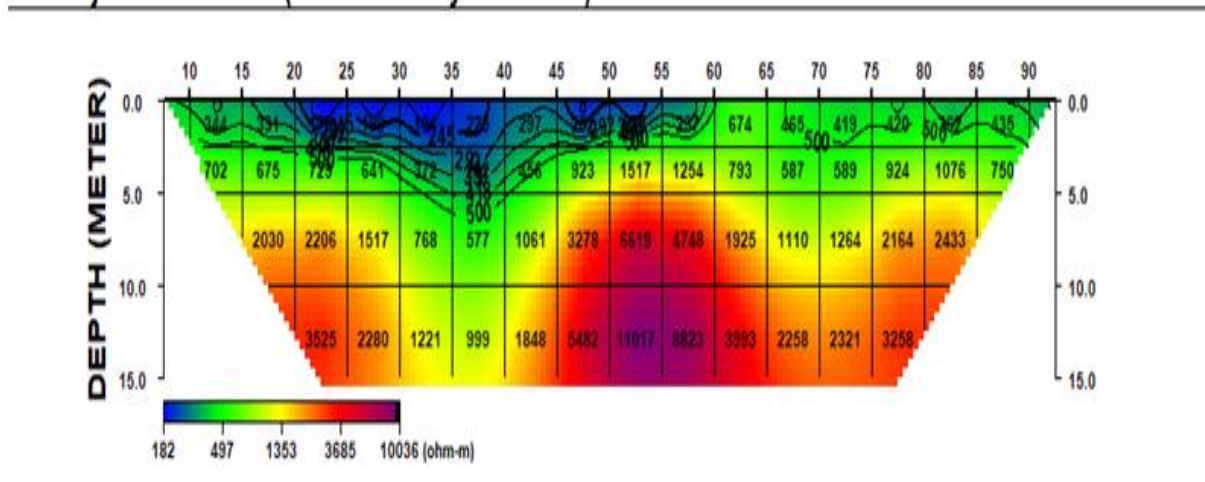
Fig. 8: 2-D resistivity structure along Eku.

Figure 8 is the 2-D inverted model at Eku shows four subsurface layers. The resistive topmost layer constitutes of laterite/clayey sand in addition to resistivity and thickness values varying between 168 – 674 Ωm and 2.5 m thickness respectively. The topsoil layer accounts also for highway road integrity (uprightness) due to soil types present. The second layer show both stable and failed sections of the road with clayey sand and sand formation with resistivity varying from 206 Ωm to 1517 Ωm at depth of 2.5 m. The

succeeding third layer which is a stable zone account for sand formation with resistivity values between 577 Ωm and 6619 Ωm with depth 2.5 m - 5.0 m. The fourth stable layer contain medium to coarse sand formation with resistivity ranging from 999 Ωm to 11017 Ωm to a depth of 5.0 m from the preceding layer. An indication of resistivity value from 105.0 Ωm – 500.0 Ωm , between lateral distances of 19.50 m – 55.50 m along Eku road to a particular depth of 5.50 m through the profile surface show a signal that the road segments would definitely fail in future due to the existence of clay and clay formation in the road subsoil formation to a particular depth of 6 m.

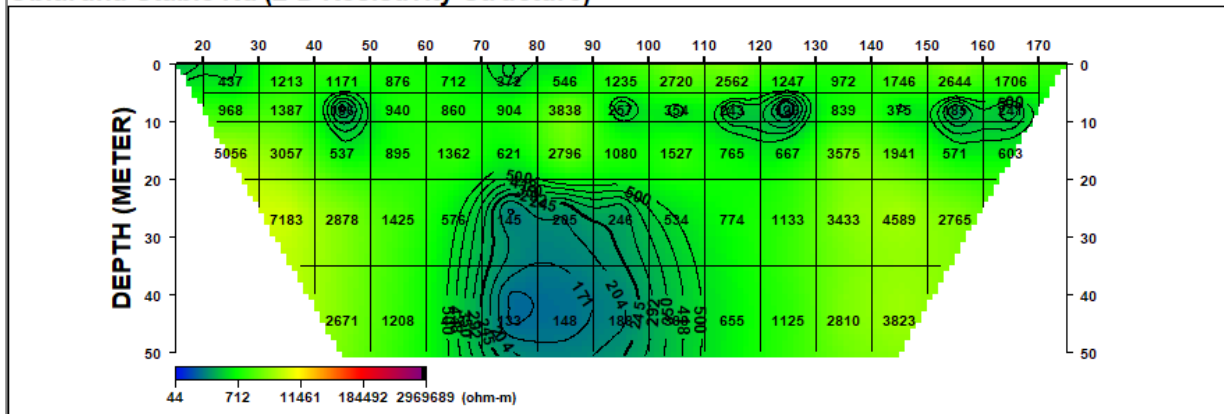
Fig. 9: 2-D resistivity structure along Obiaruku road 1.

Figure 9 is a 2-D Resistivity Image of the resistivity plot identified along Obiaruku road sections in a stable road. The result consists of four formative layers. The foremost (first) layer has a resistivity value of 372-2720 Ωm with a thickness of 2.5 m is a topsoil lateritic layer. The next (second) layer has a resistivity value of 270-3830 Ωm with lateritic and sand lithology with a thickness of 2.5 m. The third layer is distinguished with a resistivity value

of 537-5056 Ωm with a layer depth of 10 m and is suspected to be a layer of sand formation. The fourth layer which is both clay and sand formation has resistivity value of 185-7183 Ωm at a thickness of 15 m and is allegedly comprising of sandy clay and fine to coarse sand. The fifth layer which is also an embodiment of clay and sand deposit is group with resistivity of 133-3823 Ωm to a thickness of 50 m from 35 m depth.

It only displays a low resistivity beginning from 106.0 Ωm – 500.0 Ωm and at 68.50 m – 102.0 m distances to a unique depth of 49.60 m from 22.0 m depth of the sub grade. This is the only distinct zone mapped in this stable road that may fail after long usage of the road since the clay formation occur at a deep depth of 50 m from 22 m sub grade depth.

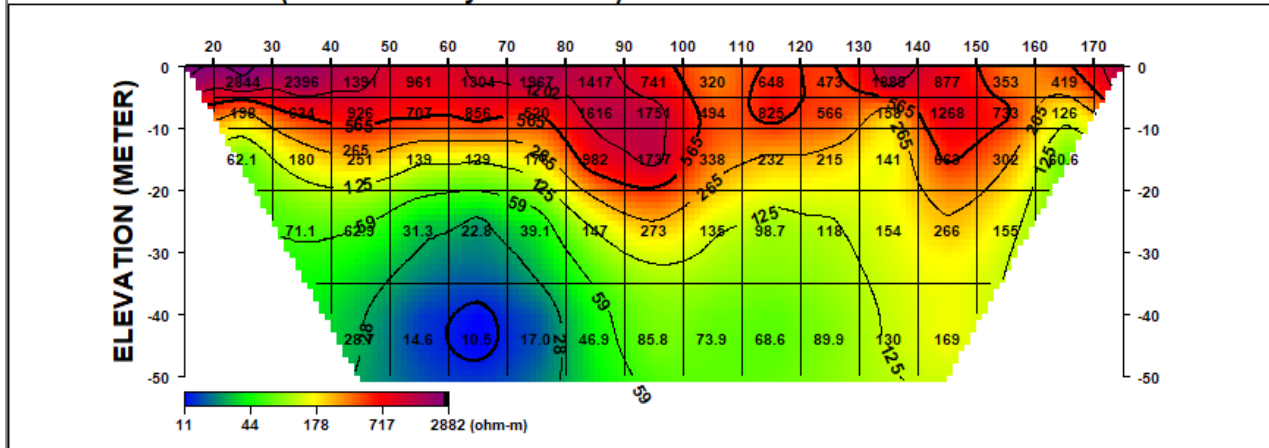
Fig. 10: 2-D resistivity structure along Obiaruku road 2.

Figure 10 represents the 2-D Resistivity formation (structure) along Obiaruku road on a failed section. The first three consecutive layers generally contain moderate resistive subsoil materials and beneath are low resistive clay settlements layers which give a signal of failure in the future. The reoccurring rehabilitation of the road in this Obiaruku failed portions are due to poor drainage system, clayey filling materials and the occurrence of compacted clay structure underneath the earth surface. It depict high resistive topsoil range of 320 Ωm to 2844 Ωm and 5 m thickness near the surface, the second layer contain mainly laterite and sandy clay with resistivity varying within 126 Ωm to 1764 Ωm and at another 5 m thickness. The third substratum contains clay, clayey sand, sandy clay and fine to coarse sand with resistivity assigned value ranging from 60.6 Ωm to 1737 Ωm at a depth of 20 m from depth 10.0 m and the fourth layer (stratum) resistivity ranged from 22.8 Ωm to 273 Ωm with 35 m thickness from 20.0 m. The fifth substratum varied with resistivity between 10.5 Ωm to 169 Ωm with clay formation (clay, clayey sand and sandy clay). It shows a very low resistivity features with first steps from

10.50 Ωm to 125.0 Ωm , beneath the topsoil at lateral length of 20 m to 160.8 m within a depth range of 9.80 m – 50.00 m of the failed (unstable) portions of the road shaded with blue and green color band. At lateral length of 50-80m contain clay formation with very low resistivity of 10.5 Ωm to 39.1 Ωm at the fourth and fifth strata and these are proves of subsurface structures that precipitate to incessant failure due to inability of sufficient sub grade strength to support heavy vehicle.

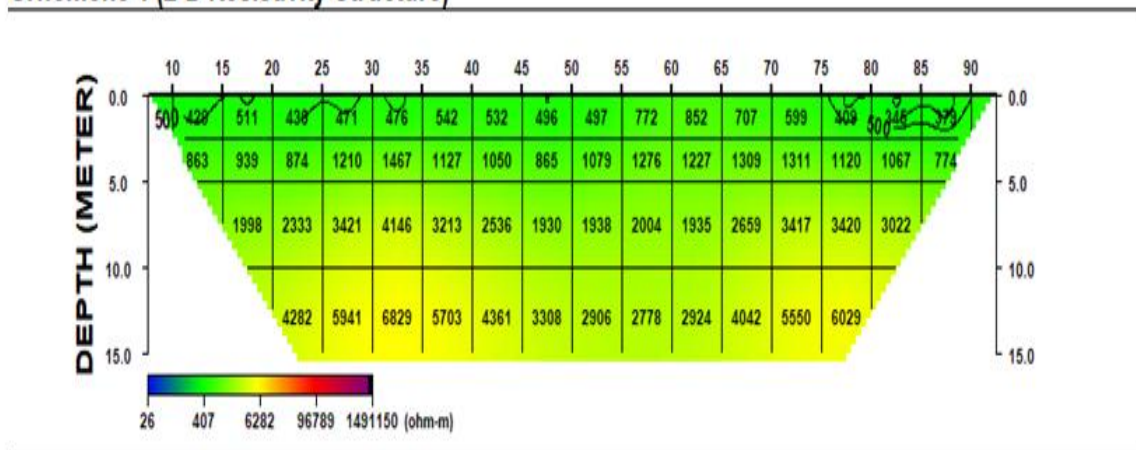
Fig. 11: 2-D resistivity structure along Urhomehe road.

Figure 11 is a 2-D resistivity picture denoted along Urhomehe road. It figure out topsoil resistivity values starting from 348 Ωm to 772 Ωm from the surface to a particular depth of 2.5 m, the second sand formation layer resistivity varying within 774 Ωm to 1467 Ωm at 2.5m deep is a stable portion. The third layer also embrace sand formation with resistivity beginning from 1930 Ωm to 4146 Ωm at vertical distance of 5.0 m from preceding layer depth and the next fourth layer with sand (coarse) formation with resistivity beginning point of 2778 Ωm to 6829 Ωm with deepness of 5 m when viewed from 10.0 m. Generally, a moderately and high resistivity with initial value of 348.0 Ωm and a final value of 1467.80 Ωm , in position of 10.50 m – 90.0 m shown in figure 11 with a depth space of 5.00 m from near surface of the side. This is an apparently stable zone with increasing resistivity as depth increases. However, Failure could occur when the road constructed has elapse designed age, due to insufficient construction materials and inadequate routine maintenance.

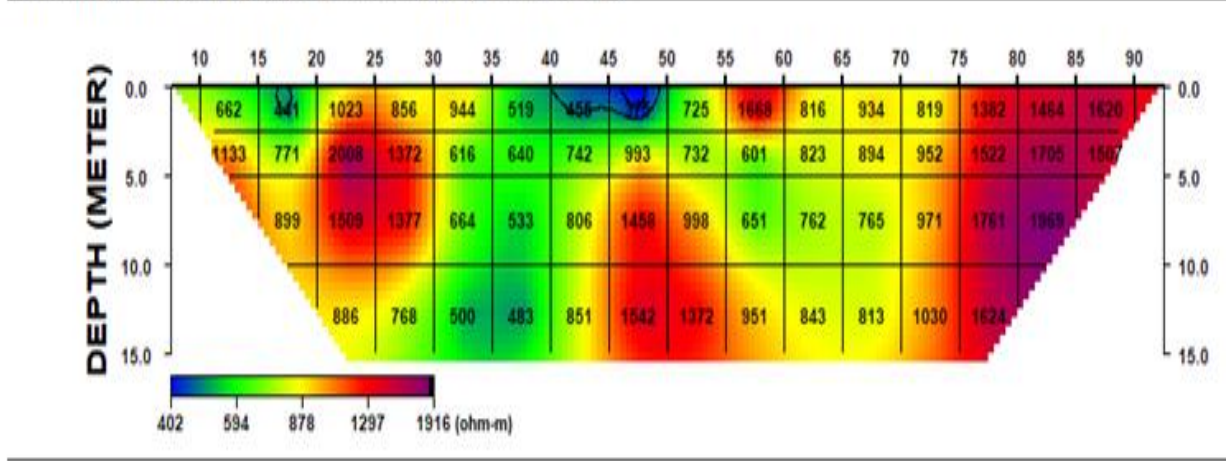
Fig. 12: 2-D resistivity structure along Urhonigbe Junction.

Figure 12 unveil the resistivity pattern of Urhonigbe profile along the road. It gives a topsoil resistivity, varying from 375 Ωm to 1668 Ωm at 2.5 m via the surface, the second layer explains fine, medium and coarse sand having resistivity values limit from 601 Ωm to 2008 Ωm with estimated thickness of 5.0 m from 2.5 m, the third layer contains the same formation with second layer with unique resistivity value pointing from 533 Ωm to 1761 Ωm with depth of 5m to 10 m and sand grain formation from borehole well log was noticed in the fourth sub-stratum with resistivity bounded within 483 Ωm and 1624 Ωm with 5 m thickness. Two fault zones were labeled out with appreciating resistivity (certain value) along Urhonigbe road. At a distance between 10.5 m – 20.0 m along the road, resistivity values ($< 800 \Omega\text{m}$) from 375.25 Ωm – 771.0 Ωm from the top soil to a depth of 5.2 m were observed. Also at 38.50 m – 75.00 m spread, resistivity values varies from 375 Ωm – 455 Ωm from the surface to a noticeable depth of 2.5 m of the profile were among the vital observations. This could be traced to poor clay subsoil filling materials that used for the failed road segment construction.

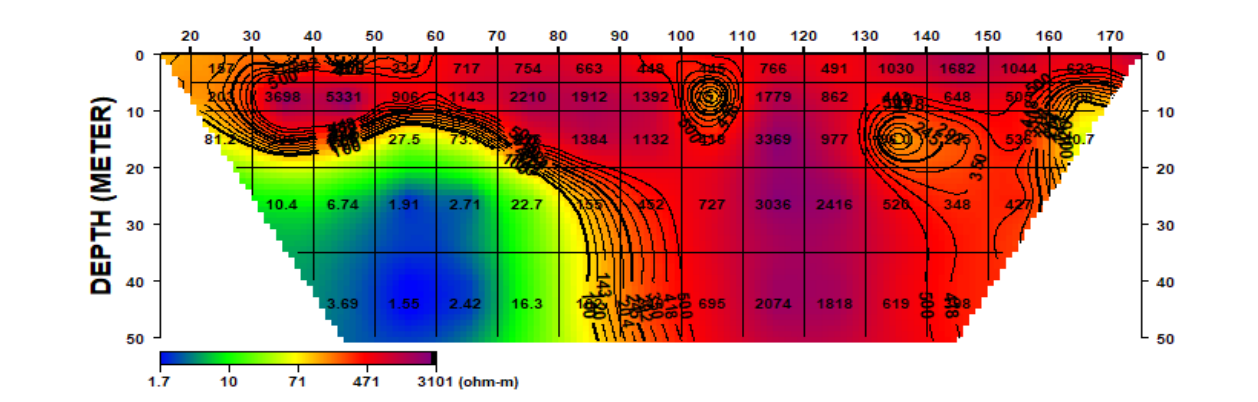
Fig. 13: 2-D resistivity structure along Abavo road.

Figure 13 also portray the 2-D Resistivity underground terrain from the changing resistivity extent categorized along Abavo road. It indicate topsoil resistivity range of from 157 Ωm to 1682 Ωm and thickness of 2.5 m via the earth surface, the second layer contain laterite and sand deposits with resistivity changing within 203 Ωm to 6331 Ωm with also 2.5m thickness. The third layer contains both clay cluster and segmented sand formation with resistivity from 27.6 Ωm to 3369 Ωm at depth of 10 m. The fourth layer contain section of relatively low and slightly moderate resistivity ranging from 1.91 Ωm to 3036 Ωm grouped at 15 m thick. The fifth

layer entails extremely low and moderate resistivity from 1.55 Ωm to 2074 Ωm which is a clear indications of clay settlement, fine, medium and coarse sand. In this profile, is a section (zone) of unstable relatively low level resistivity visualizes points ranging from 1.55 Ωm to 27.5 Ωm , from lateral spread of 28 m to 84 m to a protracted depth of 32 m thickness. There is also a distance separation from 160 m – 170 m alongside the section to a depth range of 10.0 m – 20.10 m with low values of resistivity from 40.6 Ωm - 69.50 Ωm that also posed threat on road sustenance. This observed clay zone is inappropriate to sustain (maintain) road pavement.

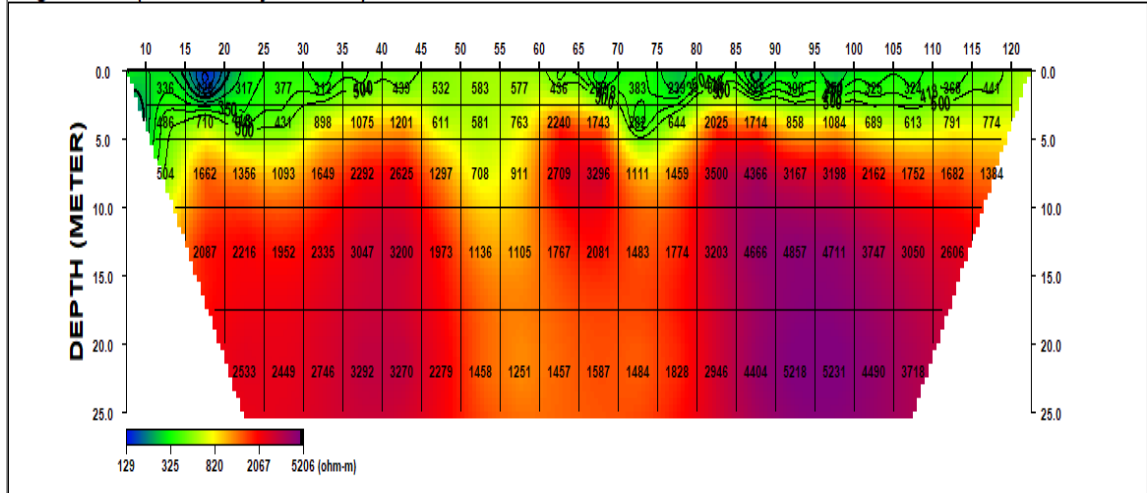
Fig. 14: 2-D resistivity structure along Agbor road.

Figure 14 typify the resistivity sections along Agbor road. It give a picture of resistivity topsoil variation of 129 Ωm to 583 Ωm from 0.0 m - 2.5 m layer thickness, the second observed layer contain mainly laterite and sand structures with resistivity that varies from 435 Ωm to 2240 Ωm and precisely at 2.5m thickness. The third to fifth layers are well established on stable zone on sand structure with reference to resistivity values between 504 Ωm to 5231 Ωm at significant depth of 20 m.

Two unique zones were detected with absolutely low resistivity values in this profile. At a sure distance between 14.5 m – 22.0 m of this profile, low computed resistivity values fall between 129 Ωm – 317 Ωm to a shallow depth of 3.0 m with respect from the top soil was noticed. Also at displacement between 60.50 m – 119.50 m, a slightly low (small) resistivity significant value from 159.25 Ωm – 382.00 Ωm to a depth of 8.0 m was observed from almost surface of profile and are both shaded with Blue and Green colors. The lithological formation of the study is in accordance with the well logging data in figure 15.

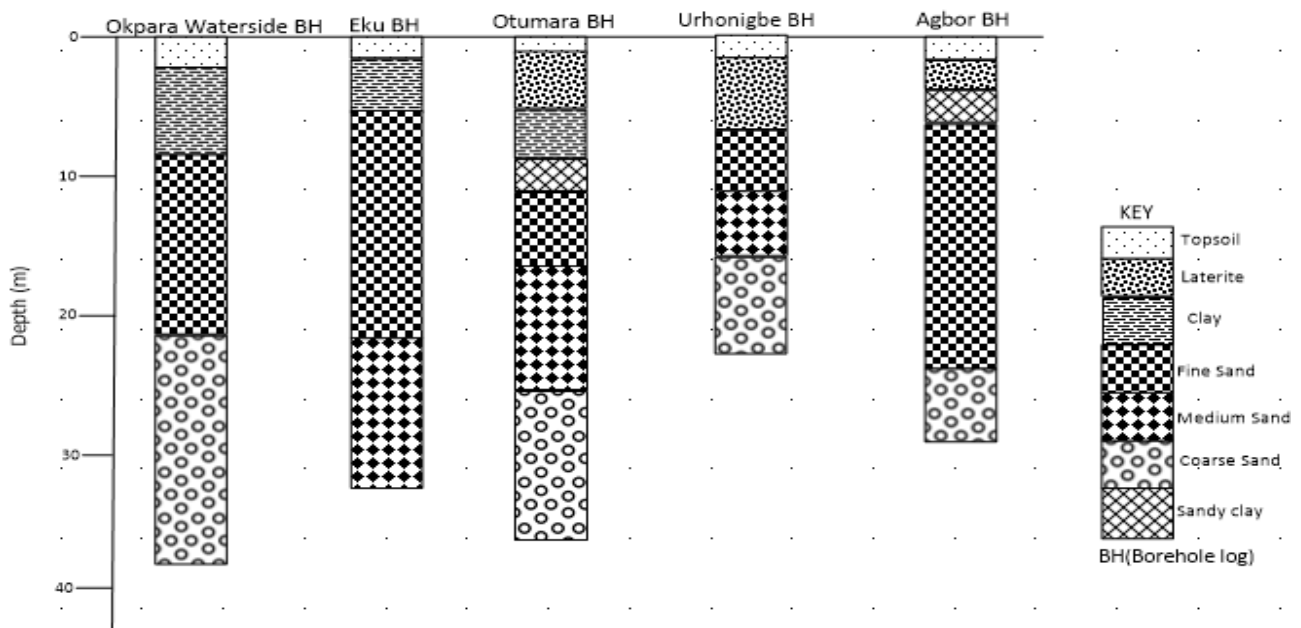
Fig. 15: Well log Data of some sections of the studied areas

It has been observed that low resistivity values observed in the study comprises of expansive, collapsible, compressible and sandy clay materials which correlate with borehole data (fig. 15) have the tendency of absorbing water. These make them to swell and eventually collapse resulting to road failure under imposed wheel load stress. The stable sections of the road are mainly characterized with high resistivity value greater than $199 \Omega\text{m}$, mostly laterite and sand materials. The low resistivity is attributable to bad (weak) zone resulting to road instability. Thus, the huge clay composition leading to water saturation of subgrade causes continuous pavement failure shortly after road repair and even reconstruction.
