## LANDSLIDE HAZARD ZONATION USING EXPERT EVALUATION TECHNIQUE: A CASE STUDY OF THE AREA BETWEEN GOHATSION TOWN AND THE ABAY (BLUE NILE) RIVER, CENTRAL ETHIOPIA

**ABSTRACT:** The area between Gohatsion town and the Abay River in Central Ethiopia is witnessing severe problems of landslides during rainy seasons. These landslides in the area affect the safe functioning of the road, which is an essential link between Addis Ababa and the northwestern part of the country. In the present study, an attempt is made to delineate the area into landslide hazard zones (LHZ). The landslide hazard zonation was carried out by “Landslide Hazard Evaluation Factor” (LHEF) rating scheme. The LHEF is an expert evaluation technique that is based on the observational past experience gained over causative factors and their contribution for instability of slopes in the area. The causative factors responsible for landslide activity, which were considered during the present study, are: relative relief, slope morphometry, geology, groundwater and land use/ land cover. The information pertaining to these causative factors was collected from the field and analyzed as per the LHEF scheme. The evaluated LHZ reve

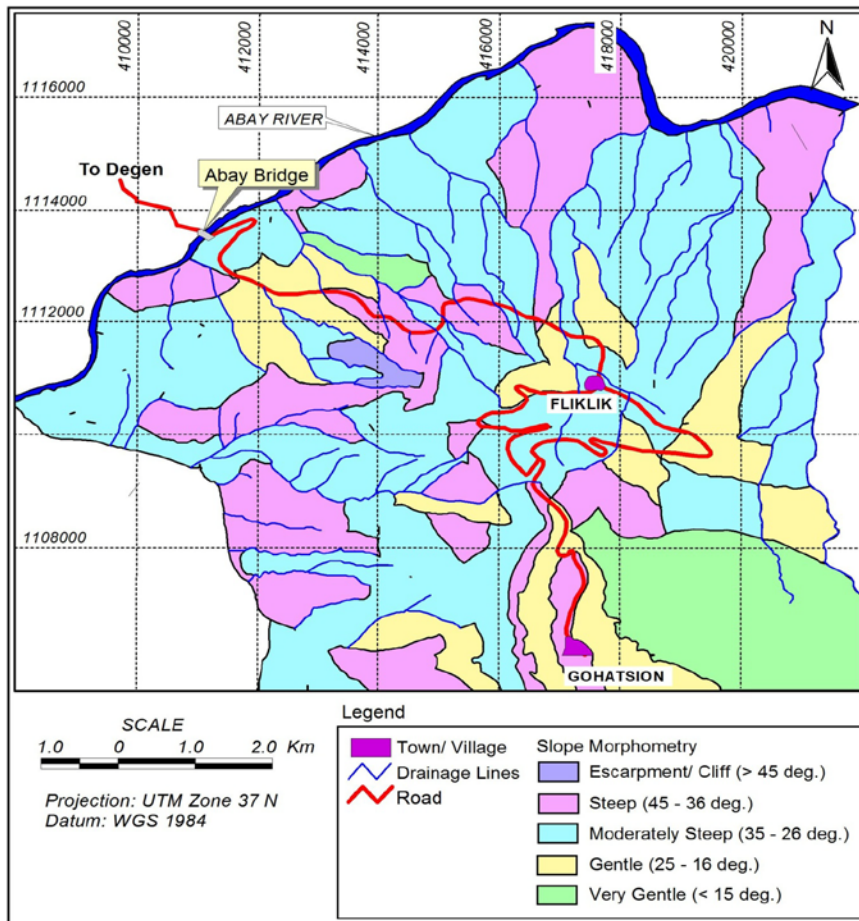
Figure 5. Slope morphometry map of the study area.

In the study area about 50% of the slopes fall under the category of moderately steep ( $26^{\circ}$ – $35^{\circ}$ ) and 25% are steep ( $36^{\circ}$ – $45^{\circ}$ ). The remaining slopes fall under gentle ( $15^{\circ}$ – $25^{\circ}$ ), very gentle ( $<15^{\circ}$ ) and escarpment ( $>45^{\circ}$ ) categories which account for 14.6%, 9.6% and 0.8%, respectively. The ratings were assigned from the standard LHEF table and the processed results, facet wise, are presented in Table 1.

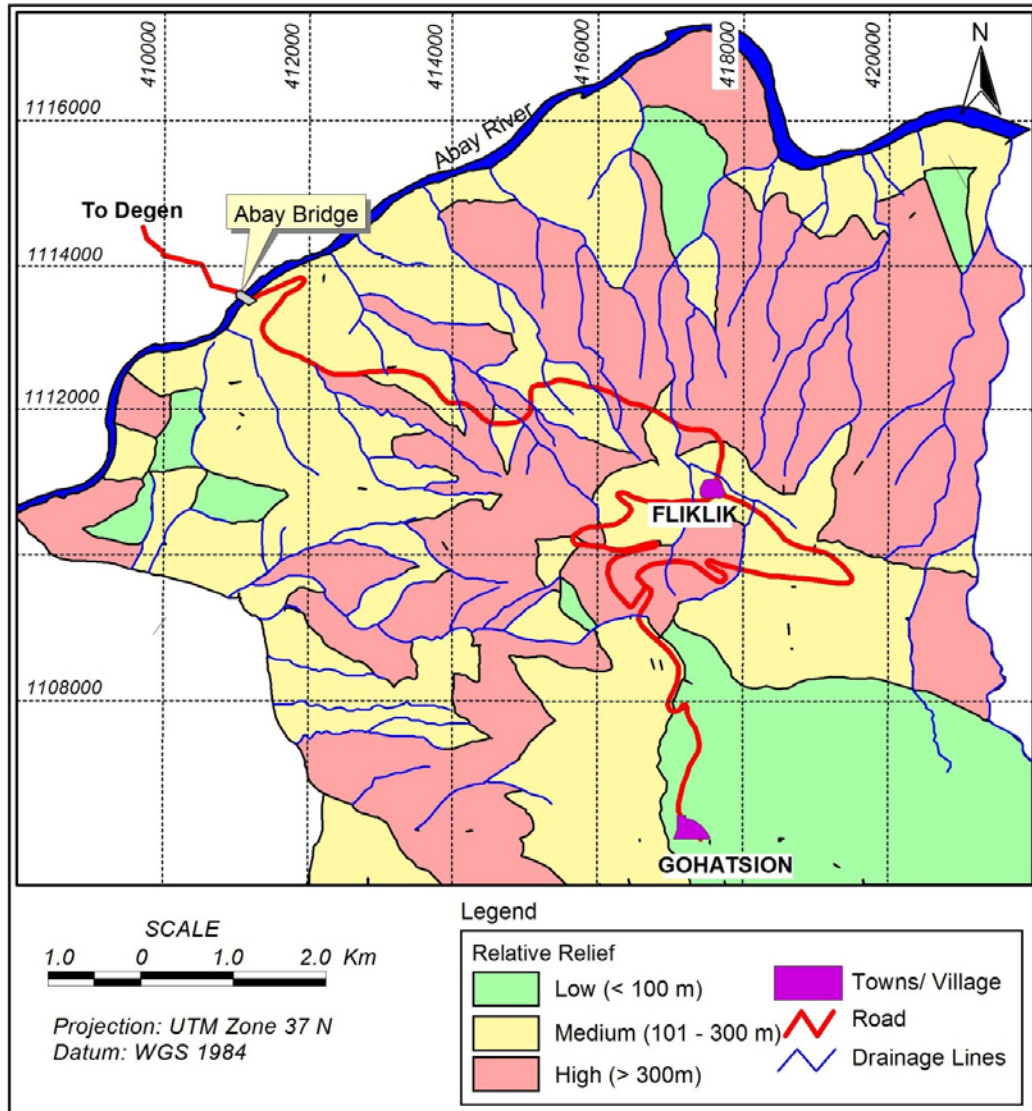
Figure 6. Relative relief map of the study area.

In the present study area, all the three categories of relative relief are found to be well distributed. A perusal of Figure 6 clearly shows that more than 55% of the area is covered with moderate relief whereas more than 36% is of high relief. Thus, this distribution of relative relief explains by itself that much of the study area is susceptible for slope instability as far as relative relief is concerned. However, as already discussed earlier, instability in slope depends upon various causative factors and it is the collective effect of all causative factors that induces slope failure. The ratings were assigned from the standard LHEF table and the processed results, facet-wise, are presented in Table 1.

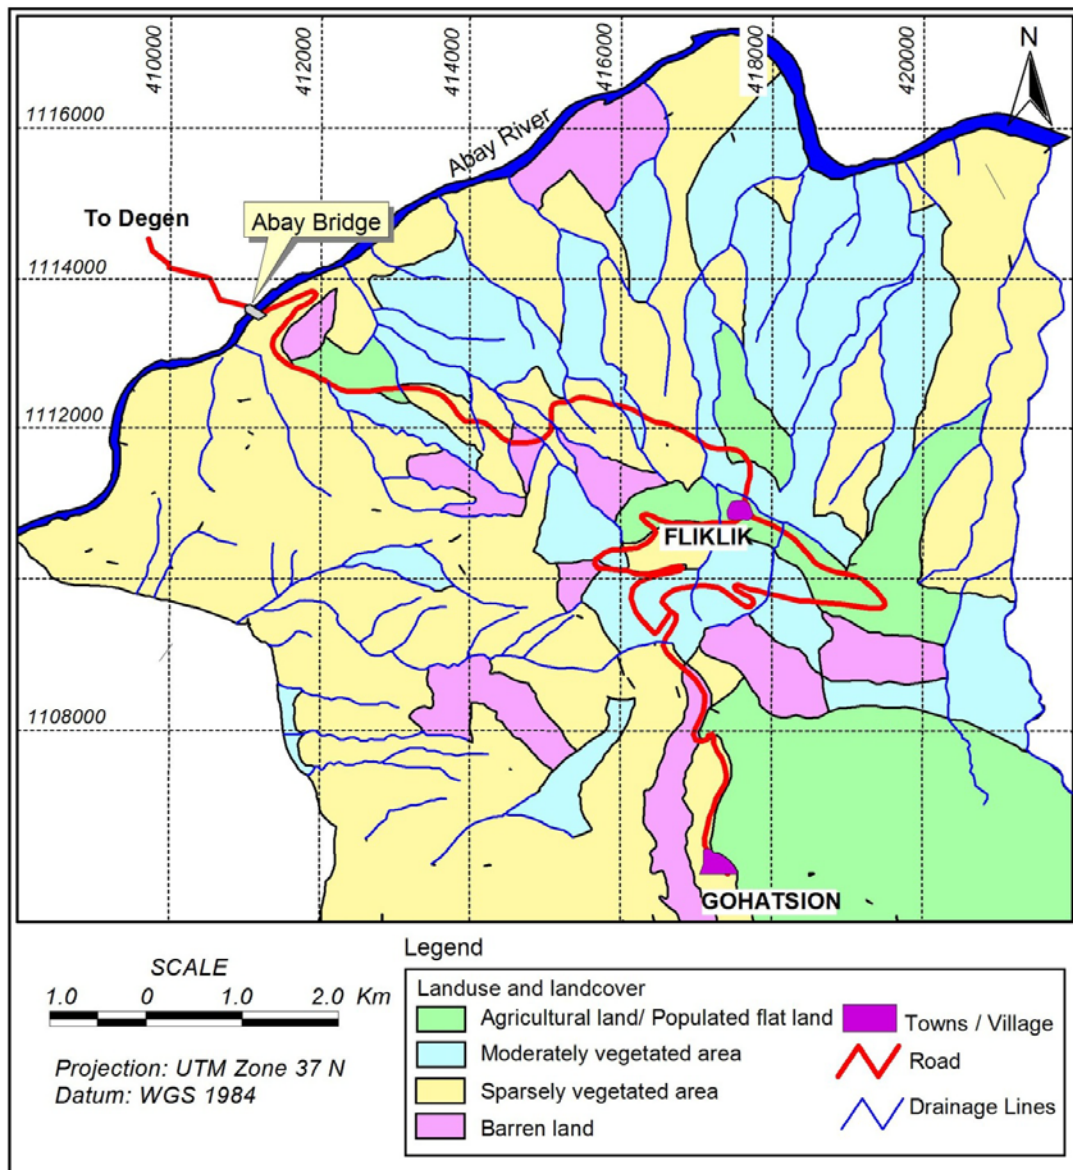
Figure 7. Land use and land cover map of the study area.

In the present study area more than 63% of the area is sparsely vegetated and about 20% area is moderately vegetated (Fig. 7). Thus, from this it is reasonable to deduce that much of the study area is susceptible to landslide events as far as land use/ land cover is concerned. Thus, based on the land use/ land cover type, facet-wise ratings were assigned from the standard LHEF table (Table 1).

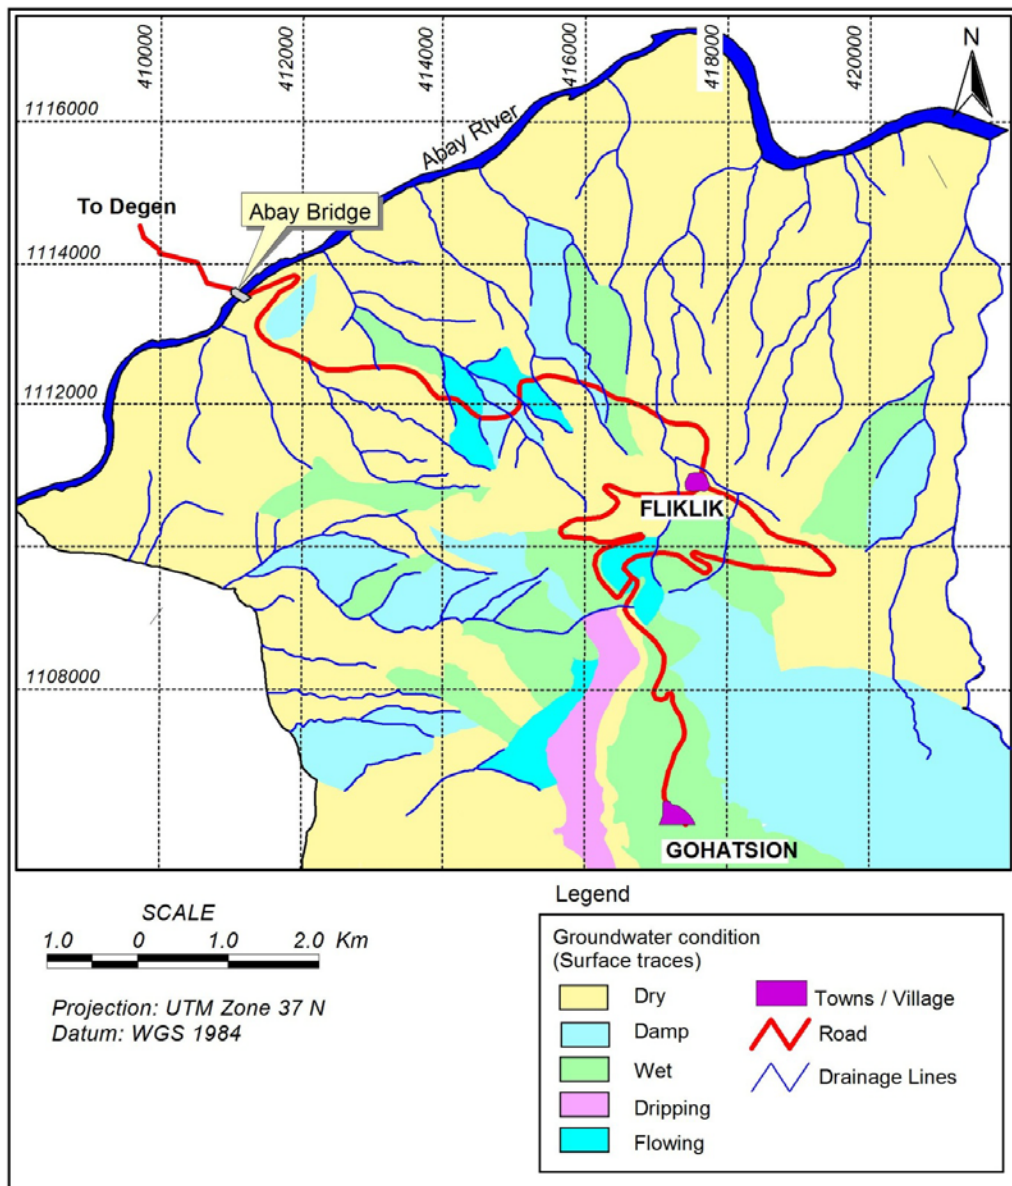
Figure 8. Groundwater conditions (surface traces) map of the study area.

Besides looking for surface traces such as; flowing, dripping, wet and damp surfaces other water marks like algal growth were also observed on the slopes. These surface traces give some idea about the degree of saturation of slope for prolonged periods of time. It may be possible that at the time of field investigation the slope demonstrates dry condition only, without any traces of water. Thus, while assigning ratings all these points were considered (Table 1). The study area dominantly shows dry and damp conditions (Fig. 8). The damp conditions were generally observed in vegetated areas whereas the flowing, wet and dripping conditions were observed at relatively fewer places.

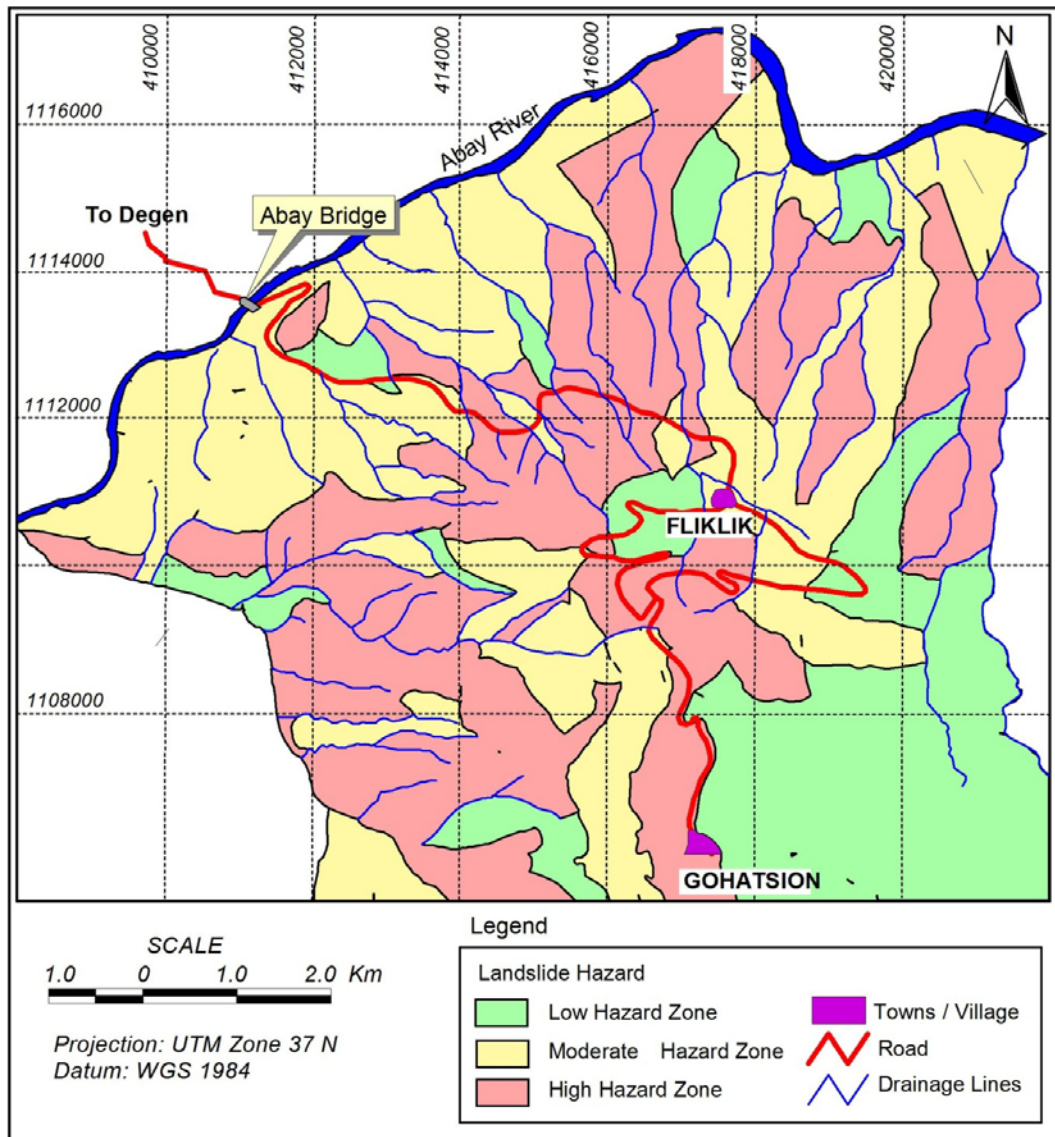
Figure 9. Landslide hazard zonation of the study area.

computed for each individual slope facet (Table 1). The entire study area falls into three hazard zones - low hazard (LH), moderate hazard (MH) and high hazard (HH) where as very low hazard (VLH) and very high hazard (VHH) zones were not at all observed in the present study area (Fig. 9).

The low hazard (LH) zones are mainly located in southern part of the study area where there is populated land and farmlands are present. The central and southeastern part of the area also falls in this hazard zone. There are wide presence of farmland and populated land. Besides, at some distributed places also this hazard zone is depicted in the study area. Thus, out of 139 slope facets only 20 facets fall in low hazard (LH) zone covering 14.4% of the total study area. These areas are relatively flat or low relief, mainly used for the purpose of agriculture and dwelling.

Moderate hazard (MH) zones are found in abundance and well distributed in the study area. The north and northwestern parts of the study area mainly fall in this hazard zone. This hazard zone is also found evenly distributed on the southwestern part of the study area. In total, out of 139 slope facets, 63 of them fall in this zone. In terms of proportion, this would be 45.3% of the total study area. From this, it is clear that almost half of the study area has a moderate potential for landslide activities.

The high hazard (HH) zones are mainly located in the central and western parts of the study area. Out of 139 facets, 56 of them are in this hazard zone that comprises 40.3% of the total area (Fig. 9). A large portion of the main road in the study area, that links Addis Ababa with the northern part of the country, falls within the high hazard (HH) zone and some of it passes through moderate hazard zone. This is one of the main reasons for the frequent failures of the road sections at various places. On the main road, it is common to find slope failures and rock falls especially after heavy rains (Lulseged Ayalew and Yamagishi, 2004; Jemal Saed, 2005; Henok Woldegiorgis, 2008; Shiferaw Ayele *et al.*, 2014). However, a given slope fails if the sum of all driving forces exceeds the resisting forces. On rock slopes the orientation of discontinuities favour sliding, either on single discontinuity or on a wedge formed by two intersecting discontinuities (Hoek and Bray, 1981). Further, even if a slope is potentially unstable, it does not mean that it is actually going to fail, until or unless there are some driving forces that trigger sliding. Triggering factors such as, rainfall that results in heavy water saturation, earthquake loading and any man-made activities near the slope could result in the failure of the slopes (Keefer, 1984; 2000; Bommer and Rodriguez., 2002; Dai *et al.*, 2002; Malamud *et al.*, 2004; Dahal *et al.*, 2006). Therefore, it is necessary to carry out further detailed slope stability studies, particularly on slope sections where the main

road passes and which fall within High hazard (HH) zone. Further, proper remedial measures for slope stabilization along the said road section could be implemented. Alternatively, the road may be realigned so that the critical slope sections, which have high susceptibility for landslide activities, may be avoided.

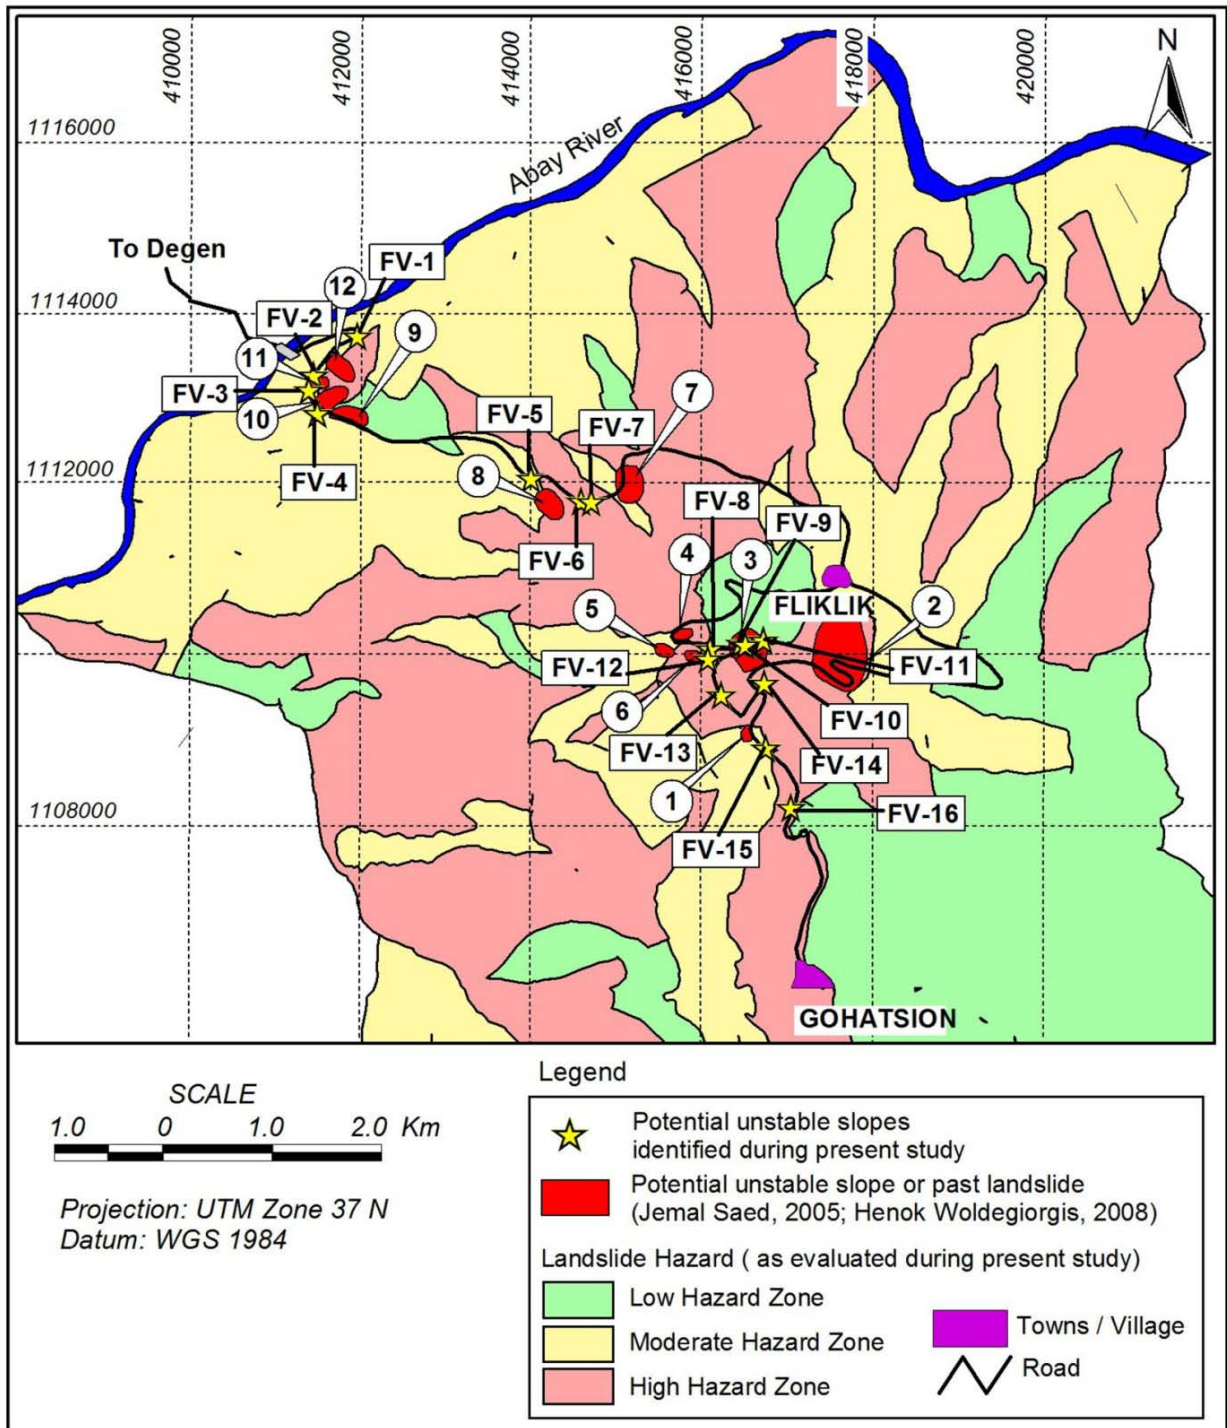
Figure 10. Relative position of critical slopes (having past landslide activities or having potential for instability) with respect to landslide hazard zonation.

In the study area a total of 12 critical slope sections having past landslide activity or having potential for instability have been reported by Jemal Saed (2005) and Henok Woldegiorgis (2008). A description of these critical slope sections is given in Table 2. These critical slope sections are mainly located along the main road. Figure 10 shows that most of these critical slope sections fall within high hazard zone while a few fall within moderate hazard zone, as delineated during the present study. Out of these 12 critical slope sections 10 (83.3%) fall within high hazard (HH) zone and 2 (16.7%) fall within moderate hazard (MH) zone. Thus, the landslide hazard zonation (LHZ) map prepared by utilizing LHEF rating scheme during the present study validates the critical slope sections having past landslide activity or having potential for instability. Further, a field visit was later undertaken to validate the landslide hazard map, the results of which are shown in Table 3. Both Table 3 and Figure 10 clearly indicate that out of 16 potential sites for slope instability, 14 (87.5%) fall within high hazard zone and remaining 2 sites fall within moderate hazard zone as depicted from LHEF scheme during the present study. Thus, the LHZ map prepared during the present study is in close agreement with the actual sites, which have potential instability problems. Further, it can be concluded that those areas, which are delineated under high hazard zone, may pose problems of instability in the future. Therefore, it is strongly recommended that more detailed investigations must be carried out in these areas for the safe functioning of the existing road.
