## Corrosion evaluation of glass fiber reinforced plastic (gfrp) Tanks & pressure vessels using acoustic emission technology

Mathias André<sup>1</sup>, Denis Siguret<sup>2</sup>, Anthony Foulon<sup>3</sup>, Salim Benmedakhene<sup>1\*</sup>, Pierre Mékarbané<sup>2</sup>, Abdelouahed Laksimi<sup>3</sup>, Christian Lemaitre<sup>4</sup>, Jérôme Favergeon<sup>3</sup>

<sup>1</sup> Technip: Parc Technologique des Rives de l'Oise, COMPIEGNE Cedex, France.
 <sup>2</sup> ARKEMA-Centre de Recherches Rhône-Alpes, PIERRE BENITE, France.
 <sup>3</sup> Université de Technologie de Compiègne, Laboratoire Roberval, COMPIEGNE cedex, France.
 <sup>4</sup> Université de Technologie de Compiègne, Equipe Avenues-GSU, EA 7284, COMPIEGNE cedex, France.

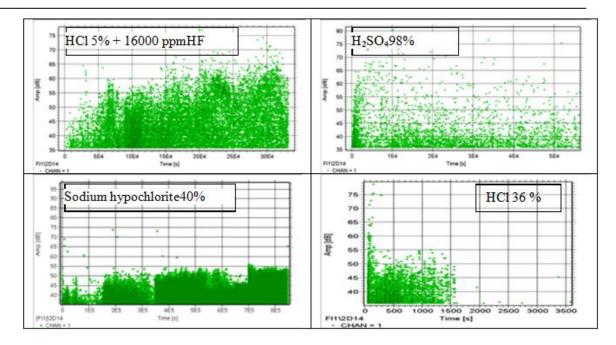
We see on the figure 2 that the different environments will create different acoustic emission activity.

Figure 2. Different acoustic emission activity due to different aggressive environments

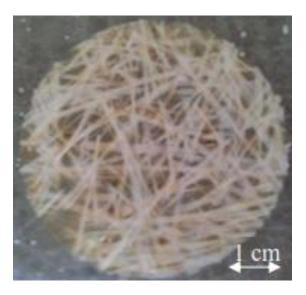
Figure 3. Picture of consequences of the corrosion on GFRP

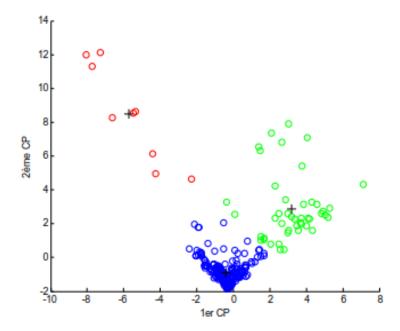
Figure 4. Result of k-mean algorithm on hits in the principal component vector space

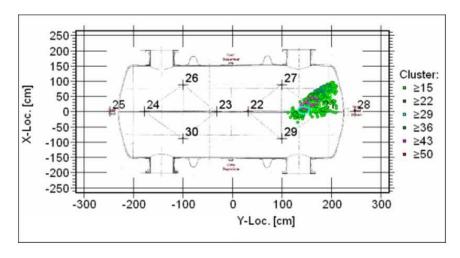
The analysis of the data from the 2 hour passive monitoring was based on classical methods like amplitude distribution, activity chronology and source localization. The figure 8 shows the planar localization of the AE events, using an algorithm based on the arrival-time differences. The events are localized in the developed plan of the tank structure. One can identify an area highly concentrated in AE events, close to the sensor C21 (more than 50 events in a 25cm x 25cm section). In addition, the chronologic trend of these events is consistent with a natural phenomenon (non-linear but continuous phenomenon). The analysis has led to the conclusion that the localized area close to the sensor C21 is probably related to corrosion of the tank structure.

Figure 8. Planar localization of AE events during the passive monitoring.

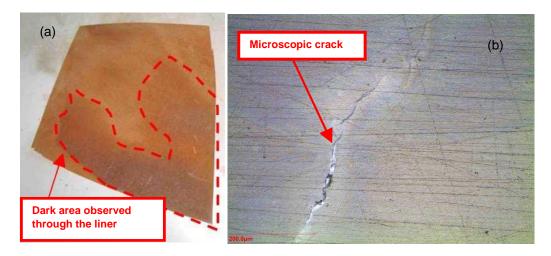
After AE measurements, the tank was removed from service, dissected and inspected. The inspection was focused on the emissive area detected and localised during the AE passive monitoring. The figures 9(a) and 9(b) illustrate the observations performed on the internal PVDF liner. The visual inspection, figure 9(a), shows that the internal surface of the liner is colored because of the bromine migration, but no macroscopic crack or blister is visible. Micrographic examination, figure 9(b) reveals some micro-cracks, close to the weld seams.

Figure 9. Inspection of the PVDF liner (a) visual (b) micrography.

The PVDF liner is fixed to a synthetic fiber fabric which provides the adhesion between the liner and the GFRP laminate. In the emissive area, the liner is easily detached from the laminate; some bromine spots are visible at the interface liner/laminate. In the non-emissive area, the liner is well attached to the laminate. No bromine spot is visible at the interface liner/laminate.

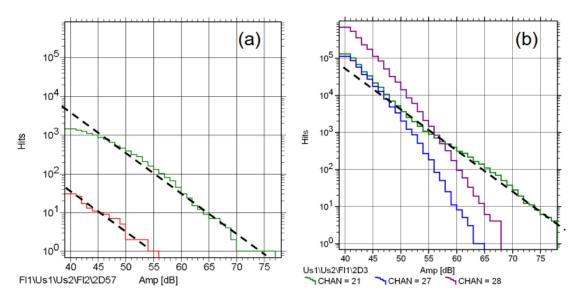
AE data from this test were compared with the AE data from the passive monitoring on tank. Cumulative amplitude distributions are shown in the figure 12 (Pollock plots). The slopes of these curves are similar for the laboratory test and for the field test. According to Pollock theory, this similarity confirms that the same failure mechanism is detected for both laboratory and field measurements. Other AE parameters were compared to corroborate this similarity.

Figure 12. Cumulative amplitude distributions (a) for the test on specimen (b) for the test on tank.
