APPLICATION OF ELECTRICAL RESISTIVITY TOMOGRAPHY TO INVESTIGATING GEOLOGICAL CAUSES OF ROAD FAILURE IN TARABA STATE, NIGERIA

ABSTRACT

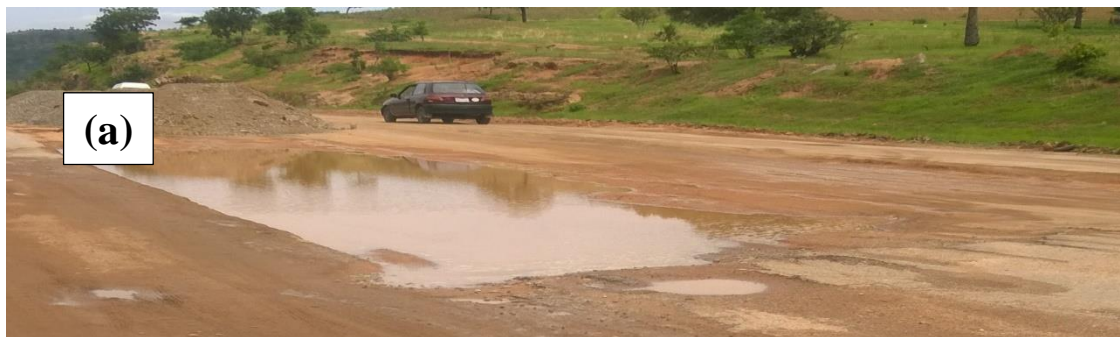
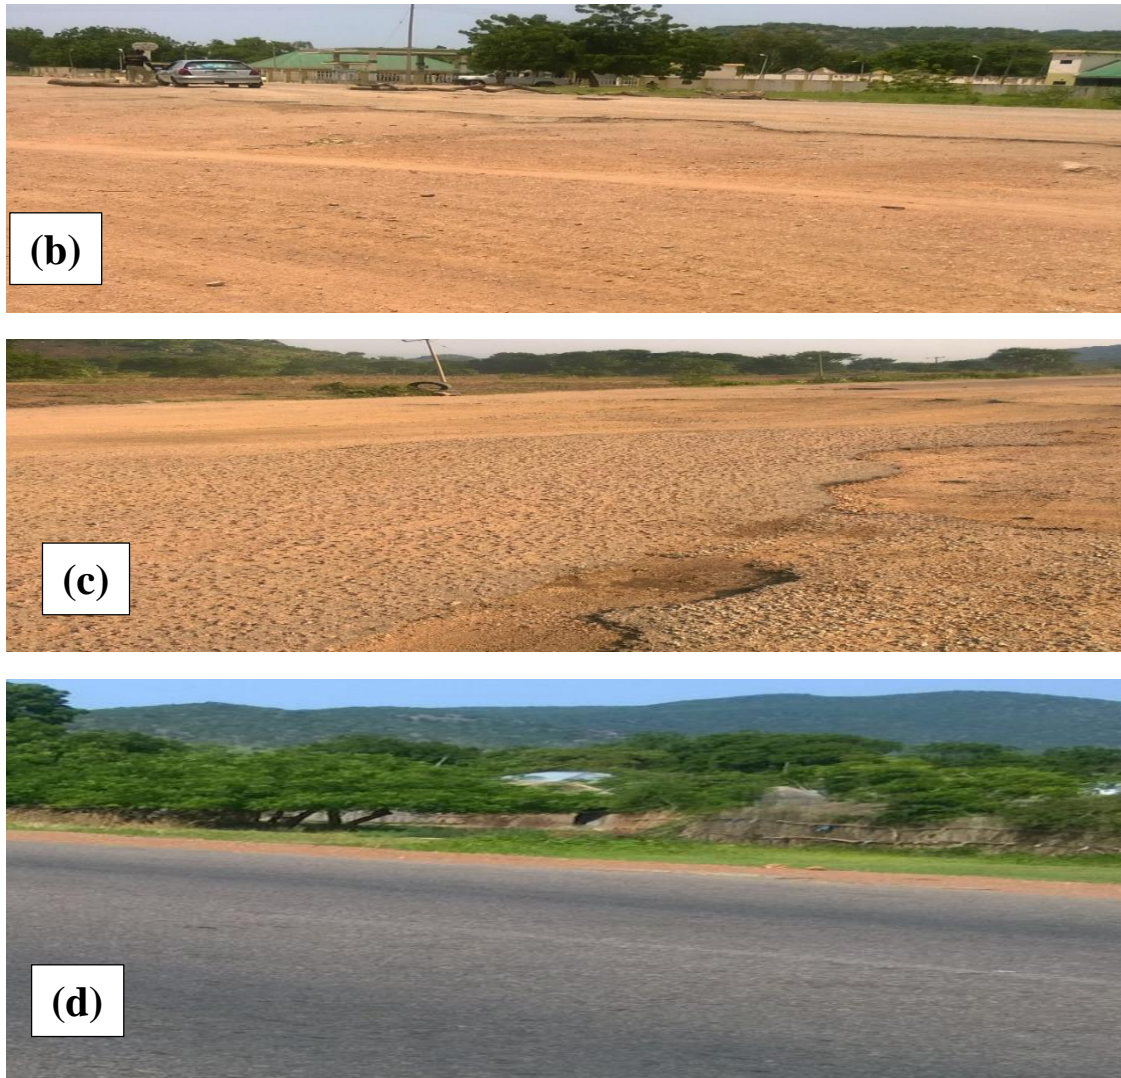
Fig. 3. Condition of the Investigated Jalingo – Zing Road. (a) – (c) are failed portions located at Lankaviri 2, Lankaviri 1 (near Custom office) and Pupule. (d) is a control road located at Mararaban Kunini

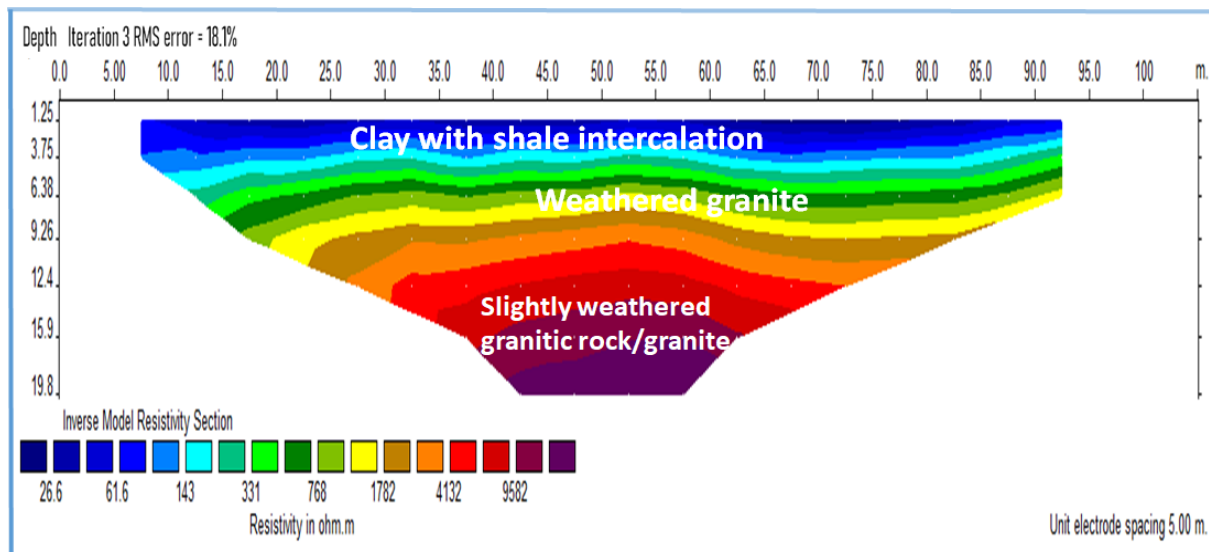
Fig. 4 ERT1 Lankaviri 1

The 2D inverted resistivity of all the profiles are presented in Figs. 4 to Fig.13. The pseudo sections reveal features that may be responsible for the cause of road failure. Fig.4 shows three conductive zones in the profile and low resistivity zone (deep blue) layer with resistivity between 26.6 and 61.6 Ω m across the entire profile at a depth of 3.75 m. Underlain this layer is a moderate resistivity zone (light green) with resistivity from 331 Ω m to 768 Ω m at a depth between 3.75 m and 9.26 m. This can be interpreted as weathered granite. Below this is a very high resistivity layer (yellow to pink) with resistivity from 1782 Ω m to 9582 Ω m at a depth between 9.26 m and 19.8 m.

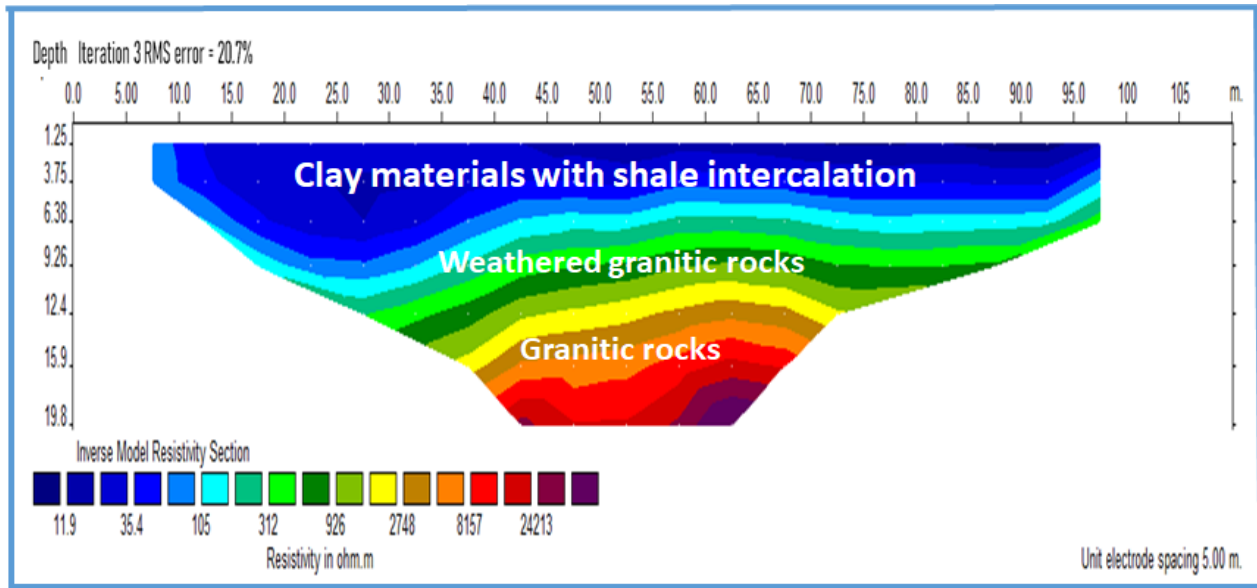
Fig. 5 ERT 2 Mararaban Zing

Fig.5 shows three pronounced zones across the profile with low resistivity zone (deep blue) with resistivity values between 11.9 and

35.4 Ω m across the entire profile at depths 9.26 m and 6.28 m. Below this layer is a moderate zone (light blue to yellow) with resistivity ranging 105 Ω m to 2748 Ω m at a depth between 9.26 m and 15.9 m and a high resistivity zone (red to pink) ranging from 8157 Ω m to 24213 Ω m at depths between 15.9 m and 19.8 m.

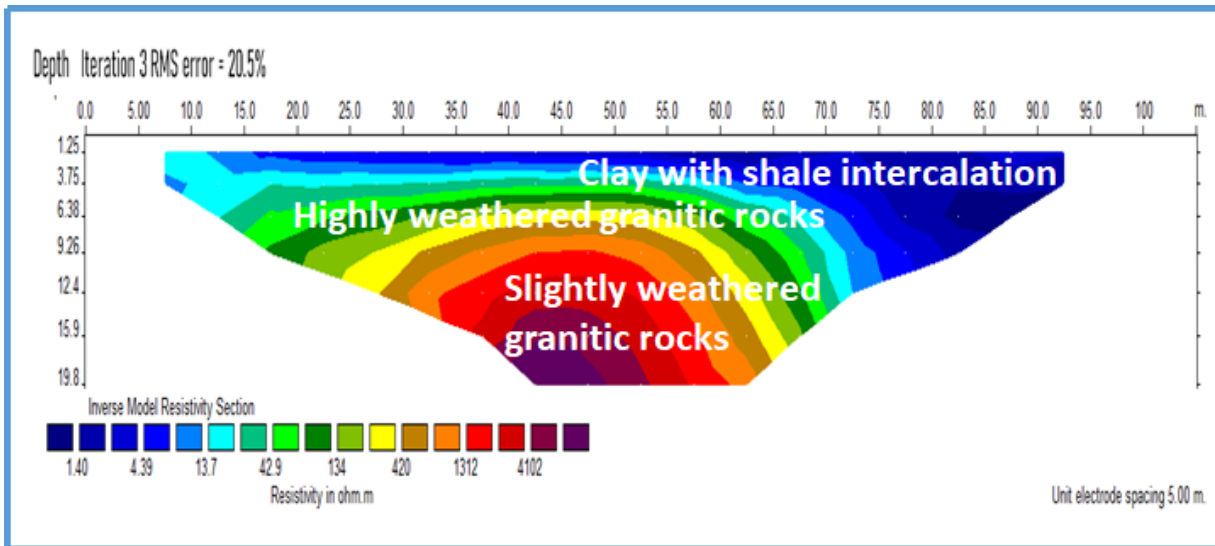
Fig. 6 ERT 3 Apawa

Fig.6 reveals three zones with low resistivity zone (deep blue) with resistivity values ranging from 1.40 to 4.39 Ω m occurring across the profile at depths 3.75m at surface points between 5.0 m and 60 m and at depth 12.4 m between the surface points 60.0 m and 95 m. Underlain this is a moderate resistivity zone (light blue to yellow) ranging from 14.0 Ω m to 420 Ω m and a high resistivity zone (red to pink) with resistivity ranging 1312 Ω m to 4102 Ω m at depths between 9.26 m and 19.8 m.

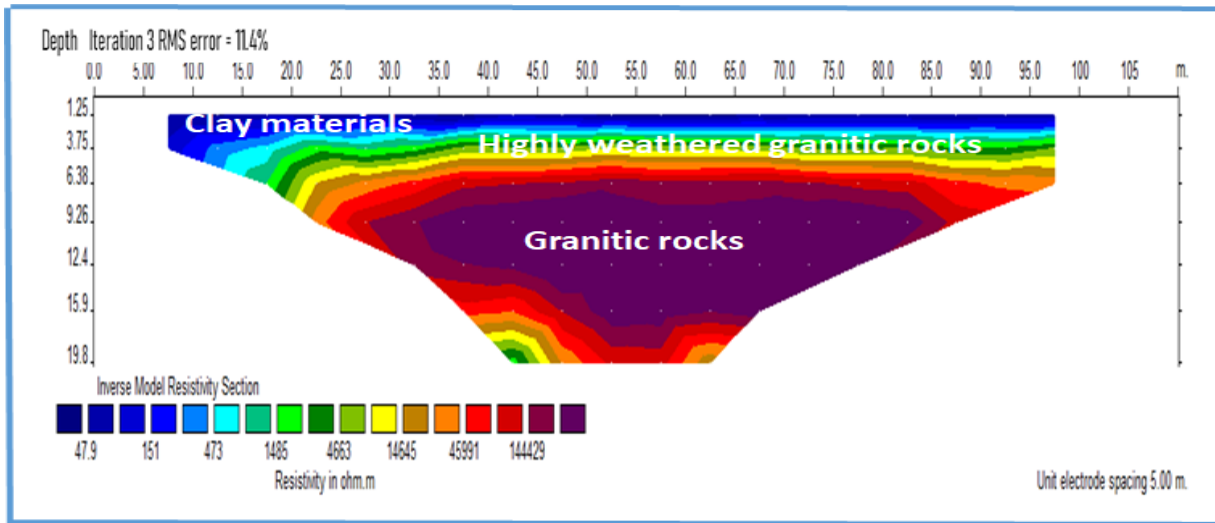
Fig.7 ERT 4 Mararaban Kunini (Control)

Fig.7 shows three conductive zones with low resistivity zone (deep blue) less than having values from 47.9 to 151 Ω m at a depth of 1.30 m across the entire profile. Below this layer is a high zone (light blue to yellow) with resistivity ranging from 473 Ω m to 1465 Ω m at depth between 1.30m and 6.38m. Underlain this layer is a very high resistivity zone (red to pink) with resistivity ranging from 45991 Ω m to 144429 Ω m at depths between 6.38 m and 19.8 m.

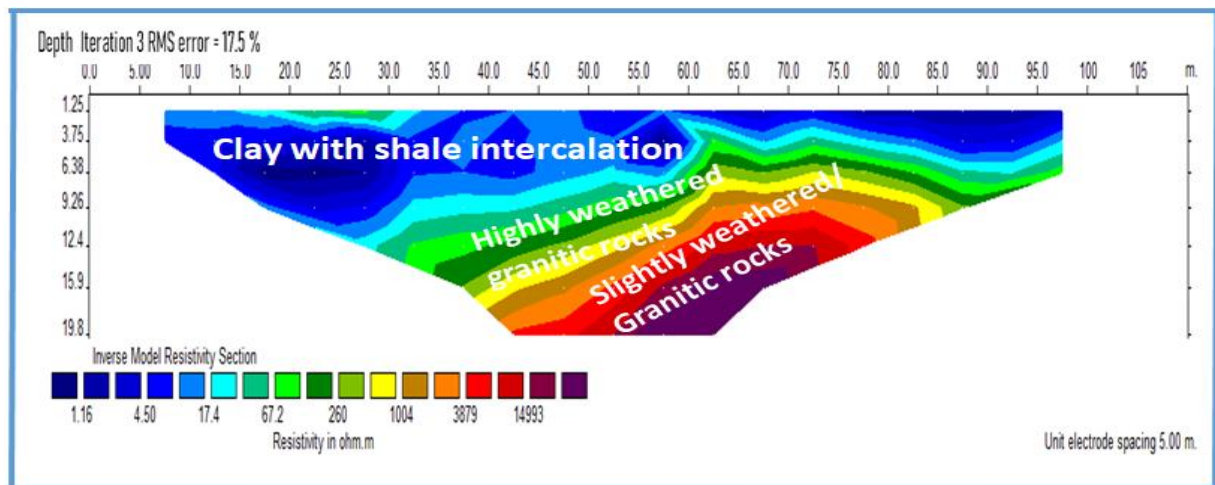
Fig. 8 ERT 5 Lankaviri 2

In Fig.8, three pronounced zones with very low resistivity zone (deep blue) with resistivity varying from 1.16 to 4.50 Ω m across the top of the profile at depths 12.4 m, 9.26 m and 6.38 m were revealed. Underlain this is a low resistivity zone (light blue to lemon green) with resistivity ranging from 17 Ω m to 260 Ω m at depths between 12.4 m and 15.9 m, 6.38 m and 9.26 m. And a high resistivity zone (yellow to pink) with resistivity ranging from 1004 Ω m to 14993 Ω m at depths between 15.9 m and 19.8 m, 12.4 m and 19.8 m.

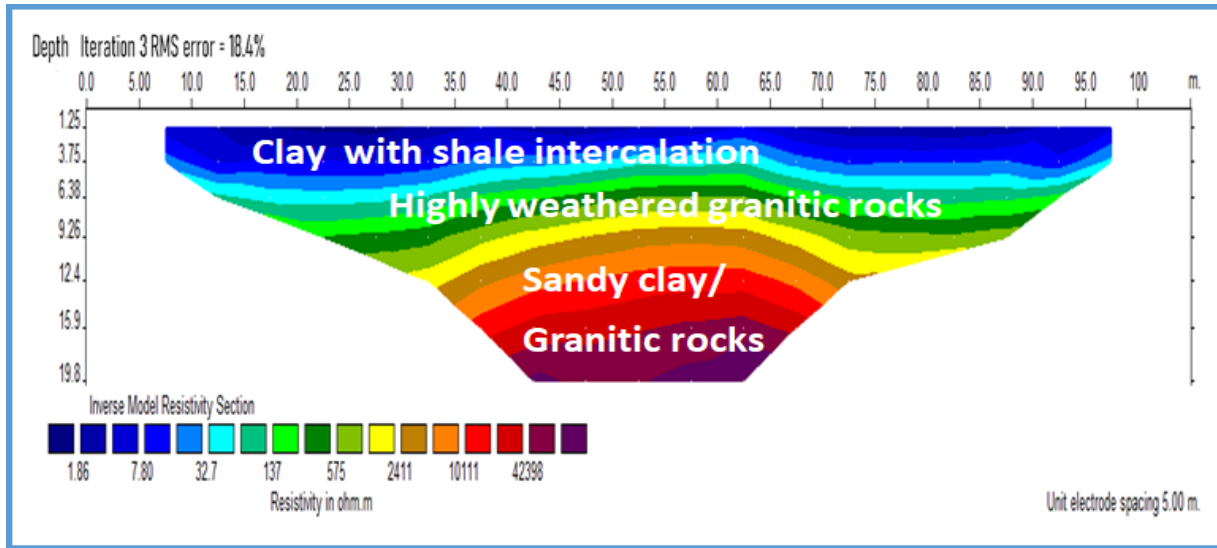
Fig. 9 ERT 6, Jimlari

Fig.9 shows three zones with very low resistivity (deep blue) with resistivity varying from 5.83 to 7.30 Ω m at the surface points 5.0 m and 100.0 m at depths 1.25 m and 3.75 m. Underlain this is low resistivity zone (light blue to lemon) with resistivity ranging from 33

Ω m to 575 Ω m at depths between 3.75 m and 9.26 m. And a high resistivity zone (yellow to pink) with resistivity ranging from 2411 Ω m to 42398 Ω m at depths between 15.9 m and 19.8 m.

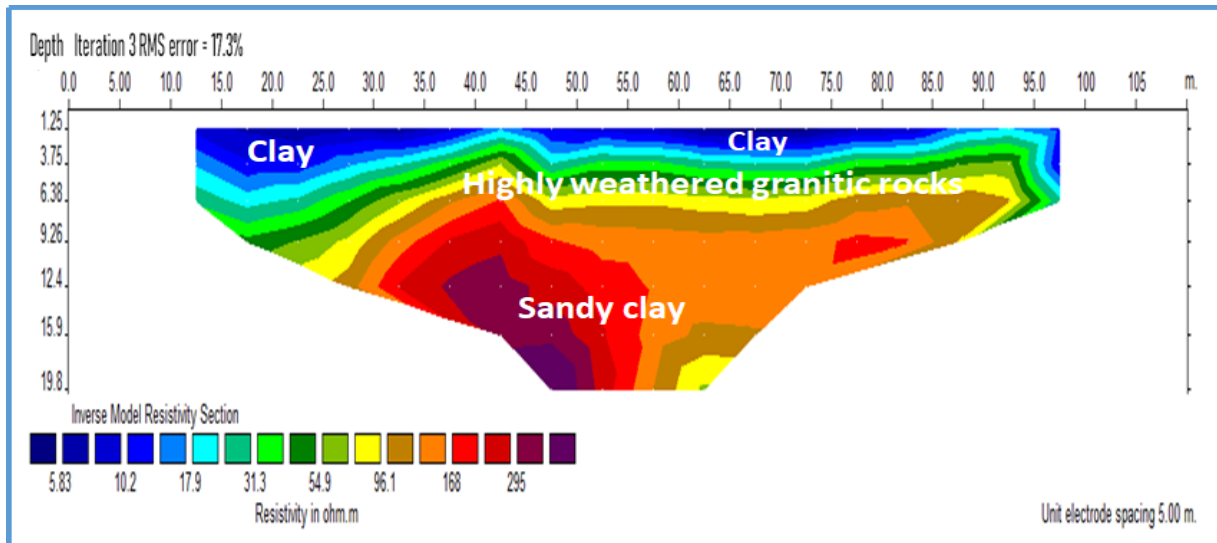
Fig.10 ERT 7 Appawa Gadda

ERT 7 (Fig. 10) reveals three resistive zones with a very low resistivity (deep blue) having resistivity varying from 5.83 to 10.20 Ω m at a depth of 3.75 m across the profile. Underlain this layer is a low resistivity zone (light blue to lemon green) with resistivity

ranging from 18 Ω m to 55 Ω m at depths between 6.38 m and 9.36 m. Below this is a high resistivity zone (yellow to pink) with resistivity ranging from 96 Ω m to 295 Ω m across the profile at depths between 9.26 m and 19.8 m.

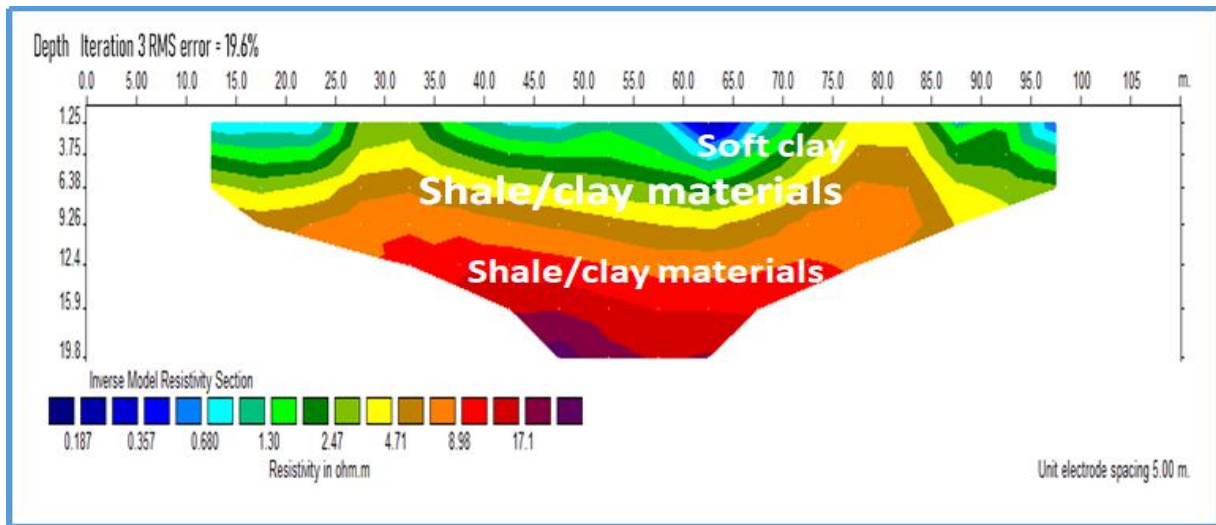
Fig. 11 ERT 8 Pupule Zing

ERT 8 (Fig. 11) shows two pronounced resistivity zones with very low patches of resistivity zone (deep/light blue) at surface points 10.0 m to 25.0 m, 40.0 m to 50.0 m and 58.0 m to 69.0 m with resistivity ranging from 0 Ω m to 1 Ω m. Below this zone is a low resistivity zone (lemon/yellow colour) with resistivity values ranging from 1 Ω m to 3 Ω m. Underlain this zone is a moderate zone (red/pink) with resistivity ranging from 9 Ω m to 17 Ω m.

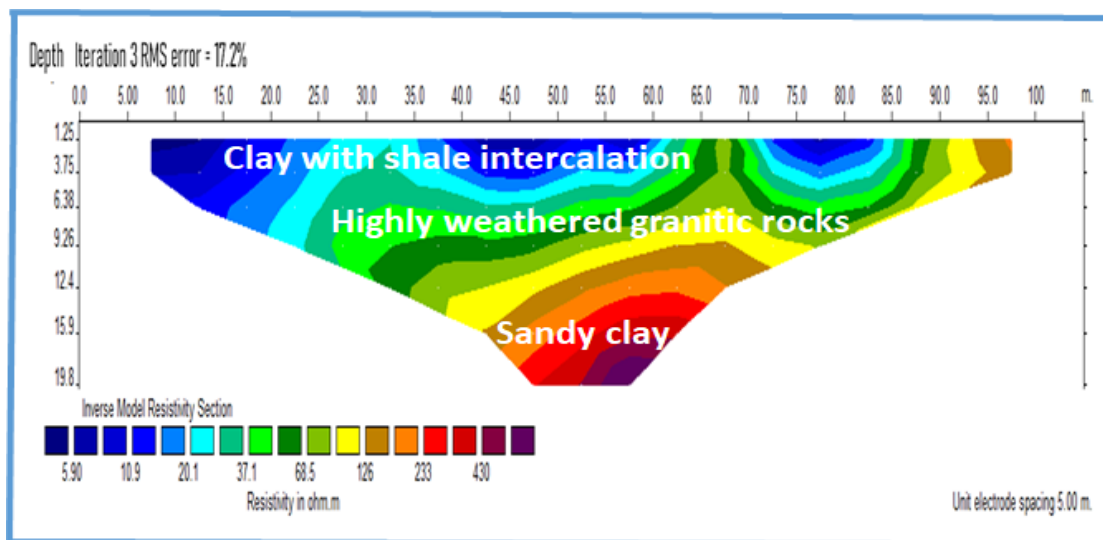
Fig. 12 ERT 9 Zing Town by College of Education

Fig.12 shows low resistivity values (deep blue) with resistivity varying from 5.90 to 20.1 Ω m at surface points 5.0 m and 60.0 m with depths 9.0 m and 6.38 m between surface points 70.0 and 85.0 m at depth 5.0 m. This can be interpreted as clay with shale intercalation. Beneath this layer is moderate resistivity zone (lemon colour) with resistivity values ranging from 37-69 Ω m with a portion at surface points between 63.0 m and 70.0 m. Underlain this layer is a high resistivity zone with resistivity ranging from 126 Ω m to 430 Ω m.

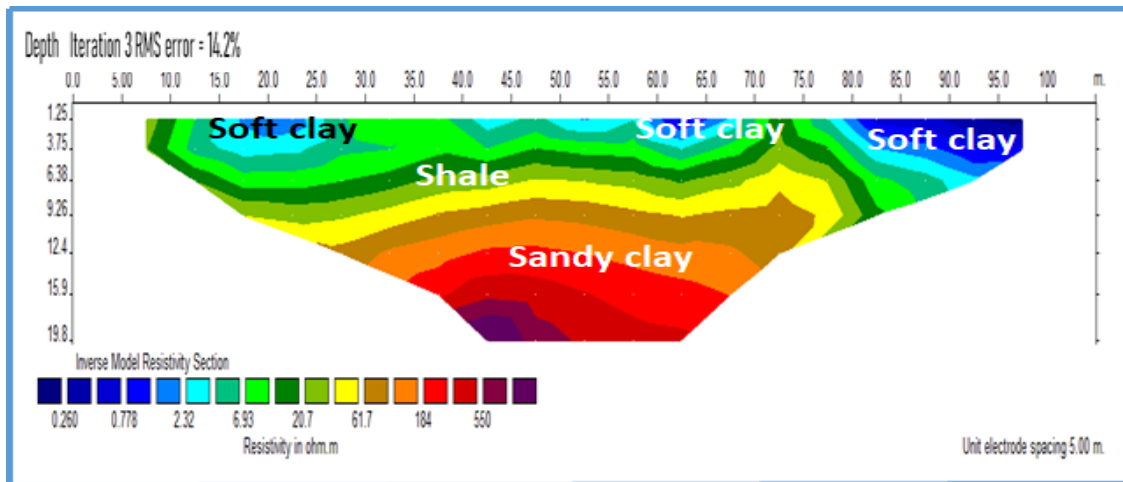
Fig. 13 ERT 10 Zing Town by immigration office

Fig. 13 displays patches of very low resistivity zone (deep blue) at surface points between 15.0 m -25.0 m, 40.0 m-70.0 and 77.0 m-100 m. In between and beneath this layer is low resistivity layer (lemon colour) with resistivity ranging from 6 Ωm to 21 Ωm. Underneath this layer is moderate resistivity zone (yellow to pink) with resistivity values ranging from 60 Ωm to 550 Ωm.

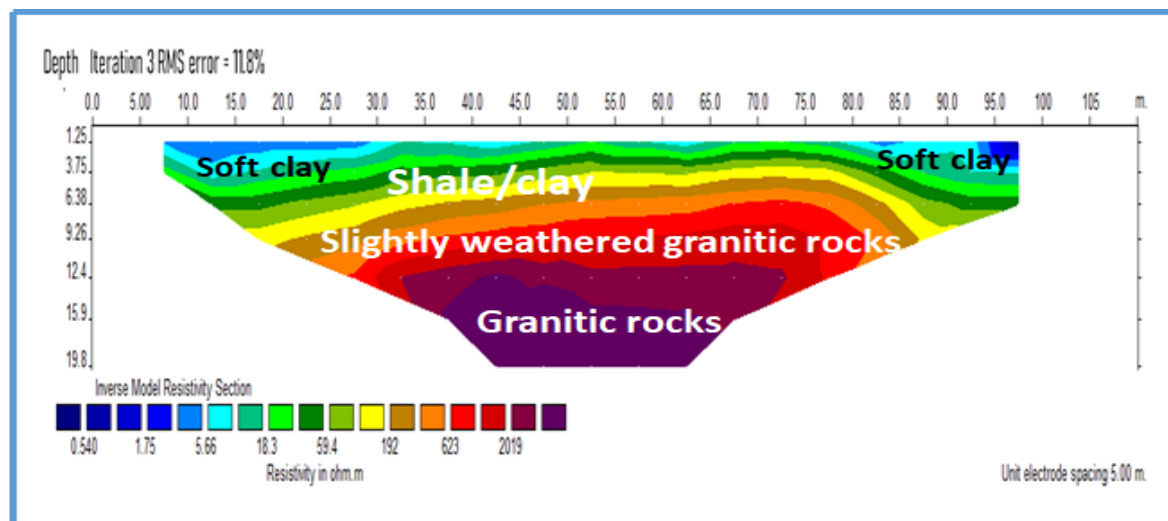
Fig. 14 Zing road after PHC ERT 11 (Control)

Fig. 14 shows a very low resistivity zone (blue) with patches at

surface 5.0 m to 30.0 m and 80 m to 100 m with resistivity ranging from 0 - 6 Ωm. In between and beneath this layer is a low resistivity zone (lemon colour) with resistivity ranging from 18.0 Ωm to 59 Ωm at depths 9.0 m and 6.0 m. Underlain this layer is a high resistivity zone (yellow to pink) with resistivity values ranging from 192 Ωm to 2019 Ωm.
