# GEOPHYSICAL INVESTIGATION OF PAVEMENT FAILURE ALONG JONATHAN BY-PASS - AKANSOKO AND ATIMBO - PARLIAMENTARY ROADS IN CALABAR METROPOLIS CROSS RIVER STATE, NIGERIA

Bisong S.A., \*Abong A.A. and Egor A.O.

Department of Physics, Cross River University of Technology, Calabar, Nigeria

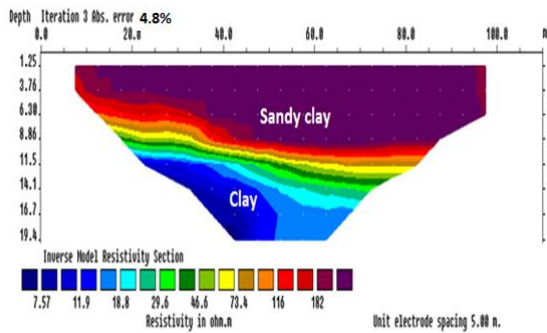
Fig.2 shows the inverted resistivity tomogram at Akansoko. The profile has a horizontal distance of 105m with a maximum depth of 19.4m with resistivity ranging from 8.0  $\Omega$ m to 182.0  $\Omega$ m and is a stable segment of the road. There is a moderate resistivity value ranging from 116 $\Omega$ m to 182 $\Omega$ m at the top of the profile to a depth of 8.86m which represents sandy clay across the entire profile. Beneath this is a low resistivity layer with resistivity ranging from 8.0 $\Omega$ m to 73.0 $\Omega$ m which represents clay. Though there are no failures in this profile, but the area is vulnerable to failure in future because the competent layer is seated on an incompetent layer. The moderate resistivity values are indication of moderately competent soils, while low resistivity values are indication of incompetent soils (Weltime et al, 2022).

**Figure 2** Inverted image of ERT 1 at Akansoko Calabar stable road section (control segment)

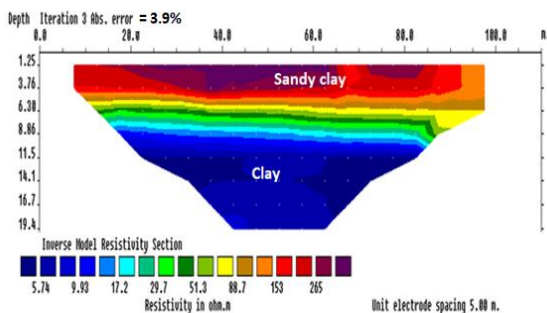
In Fig.3, the profile has a horizontal distance of 105m with apparent resistivity values ranging from  $\leq 6.0\Omega m$  to  $265\Omega m$  at a depth of 19.4m. The top layer has moderate resistivity values which represent clay ranged from  $153\Omega m$  to  $265\Omega m$  to a depth of 6.38m. Below the top layer is a low resistivity that lies in the range  $\leq 6.0\Omega m$  to  $17.0\Omega m$  at depths from 8.86m to 19.4m. This indicates clayey clay. This implies that the road pavement is founded on an incompetent layer and is responsible for the road failure. Also it was observed that drainage was poor in this profile.

**Figure 3:** Inverted image of ERT 2 at Ukwia Itiat Calabar (failed segment)

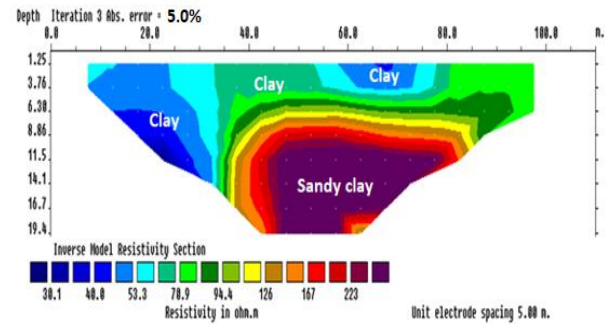
Fig.4 shows the electrical resistivity tomogram at Idundu market road section, failed section.

The resistivity values ranged from  $\leq 30.0\Omega m$  to  $223.0\Omega m$  and an approximate depth range of 19.4m. The layer is characterized with low resistivity ranged from  $\leq 30.0\Omega m$  to  $94.0\Omega m$  which is clay and is an indication of weak zone having approximate depths at about 14.1m and 8.86m and a lateral spread distance between 0.0m to 98.0m. A moderate resistivity occurred below the top layer with resistivity in the ranged  $125.0\Omega m$  to  $223.0\Omega m$  which is represents sandy clay between the horizontal distance of 38.0m and 85.0m between the depths 8.86m and 19.4m. Since the area is dominated with clay, it is an indication of poor subgrade. The poor construction materials may have been the cause of the failure of the road, and also poor drainage system may have attributed to the failure of road.

**Figure 4:** Inverted image of ERT 3 at Idundu market Calabar (failed segment)

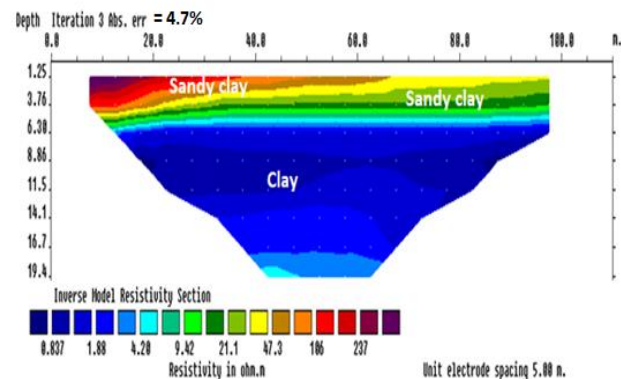
Fig.5 shows the electrical resistivity tomogram at Jonathan by-pass close to the bridge road, failed section. The area has resistivity values ranged from  $\leq 1.0\Omega m$  to  $237\Omega m$  and a depth range of 19.4m. The competent layer has moderate resistivity in the range of  $106.0\Omega m$  to  $237.0\Omega m$  and it represents sandy clay at depths of about 3.76m and 2.51m at a lateral distance of between 0.0m to 65.0m. The incompetent layers are characterized with low resistivity range of  $1.0\Omega m$  to  $47.0\Omega m$  which represents clay with depth range of 6.30m to 19.4m. Since the area is predominated with clay, this may have been the causes of the road failure due to infiltration between the two layers.

**Figure 5** Inverted image of ERT4 at Jonathan by- Pass close to bridge Calabar (failed segment)

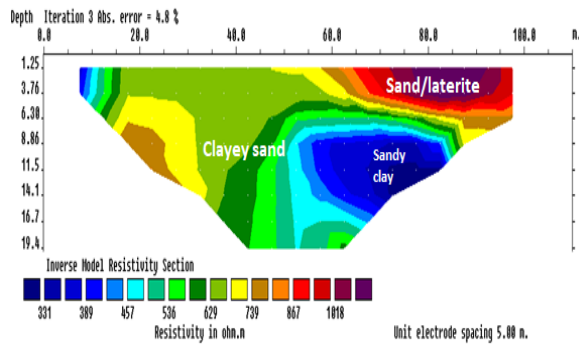
Fig.6. shows the tomogram at Federal Government Girls' College, Calabar which served as a control. The profile has a lateral distance of 105m with electrical resistivity characterized by electrical resistivity ranged from  $331.0\Omega m$  to  $1018.0\Omega m$ . The subsurface below the ground in the control is characterized by moderate resistivity values from  $331.0\Omega m$  to  $739.0\Omega m$  which represents clayey sand and high resistivity  $>739.0\Omega m$  to  $1018\Omega m$  which represents laterite /sand across the profile. The moderate and high resistivity values are indicative that there are no failed portions or sections of the road at the control. This implies that the soils at the control are competent and good for construction of pavement roads.

**Figure 6** Inverted image of ERT 5 at Federal Government Girls College Calabar by Airport (Control segment)

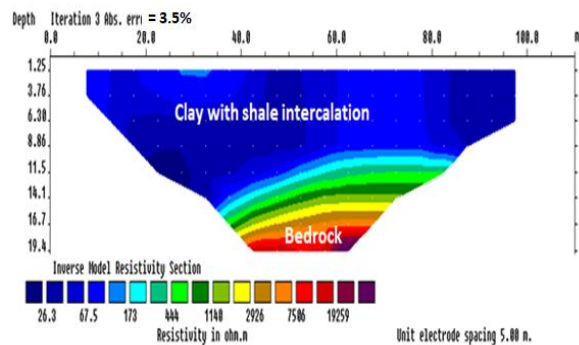
Fig.7 shows the tomogram at rice seedling site, Calabar where there was a big pothole (failed segment). The profile has resistivity in the range of 26.0Ωm to 19259.0Ωm at a lateral distance of 105m and a depth of 19.4m. The top layer has a low resistivity ranged from 26.0Ωm to 68.0Ωm which represents clay with shale intercalation at depths 16.7m, 14.1m and 11.5m respectively across the entire profile. Beneath the top layer is the second layer with moderate resistivity values ranged from 173.0Ωm to 444.0Ωm and represent sandy clay/clayey sand at depths 14.1m and 16.7m and the third layer with very high resistivity values ranged from 1140.0Ωm to 19259.0Ωm which represents laterite/sand. The low resistivity value is an indication of clay with shale intercalation which may be responsible for road failure. The moderate and high resistivity layers are indications of competent materials such as sandy clay, clayey sand, laterite/sand and lateritic soils which are good construction materials.

**Figure 7.** Inverted image of ERT 6 at rice seedling site Calabar (failed segment)

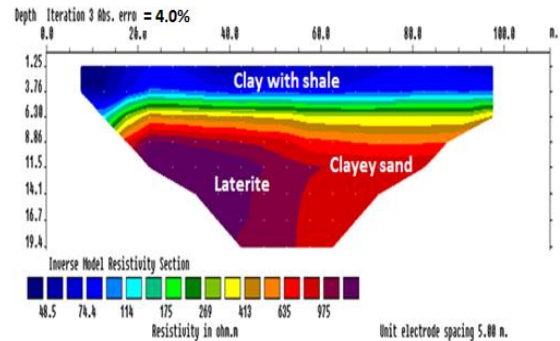
Fig.8 shows the inverted resistivity tomogram at Message Point Assembly Church, Calabar where there was a big pothole (failed segment). The profile has a resistivity in the range 49.0 Ωm to 975.0Ωm at a lateral distance of 105m and a depth of 19.4m. The top layer has a low resistivity ranged from 49.0Ωm to 74.0Ωm which represents clay with shale intercalation at depths 3.76m and 6.30m respectively across the entire profile. Beneath the top layer is the second layer with moderate resistivity values ranged from 114.0Ωm to 635.0Ωm which represents sandy clay/clayey sand at a depth between 6.30m and 8.06m and the third layer with very high resistivity values ranged from > 975.0Ωm which represents

laterite/sand. The top with low resistivity value is an indication of clay with shale intercalation which may be responsible for road failure and is seated on competent layers. The moderate and high resistivity layers are indications of competent materials such as sandy clay, clayey sand, laterite and lateritic soils which are good construction materials.

**Figure 8.** Inverted image of ERT 7 at Message Assembly Church Calabar (failed segment)
