## UNDERPINNING AND EROSION PROTECTION AT THE UNIVERSITY ROAD BRIDGE, DAR ES SALAAM

# BRIDGE AT DARAJANI ON UNIVERSITY ROAD

UNIVERSITY ROAD BRIDGE  
UDSM, DEPT. OF CIVIL ENGINEERING

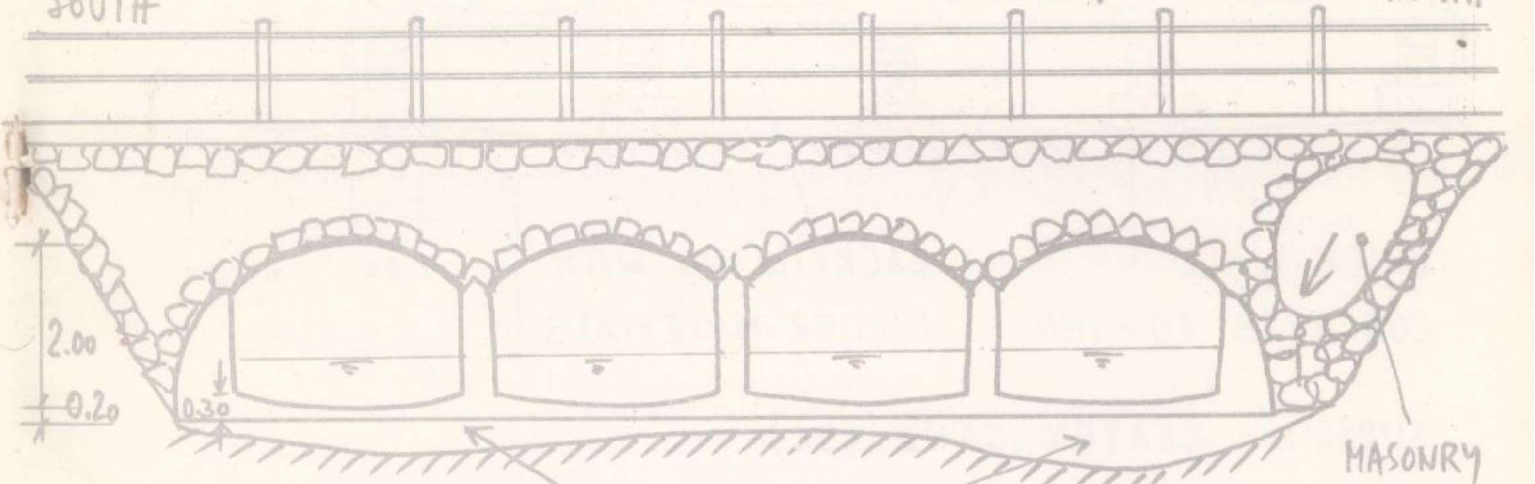
## ELEVATION FROM DOWNSTREAM FACE

40-50% UNDERMINED

MASONRY BROKEN OUT

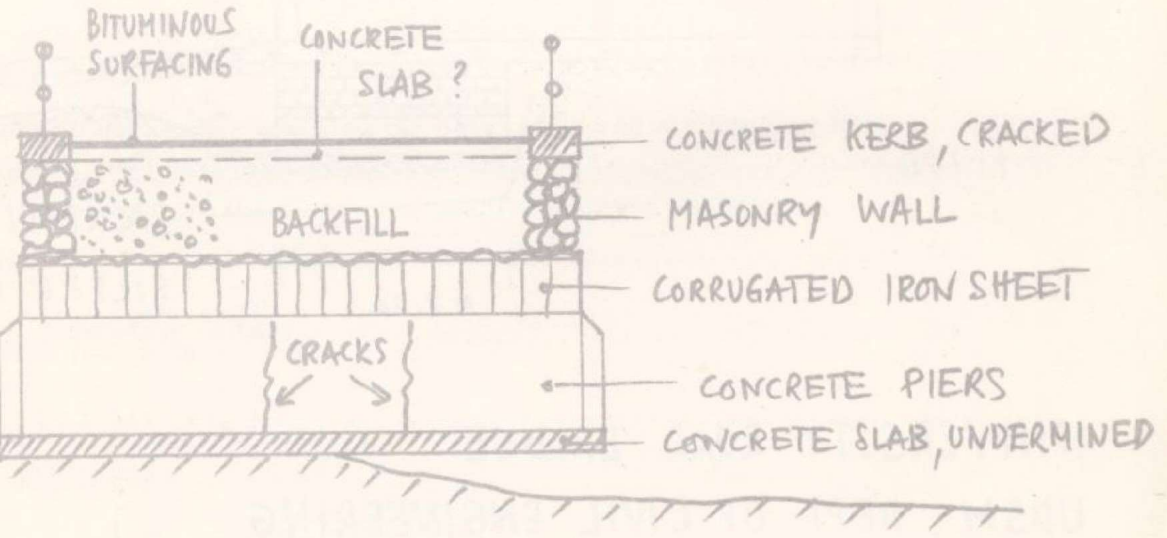
### A-A

OPENINGS OBSTRUCTED BY SOIL, WOOD, CONCRETE BLOCKS

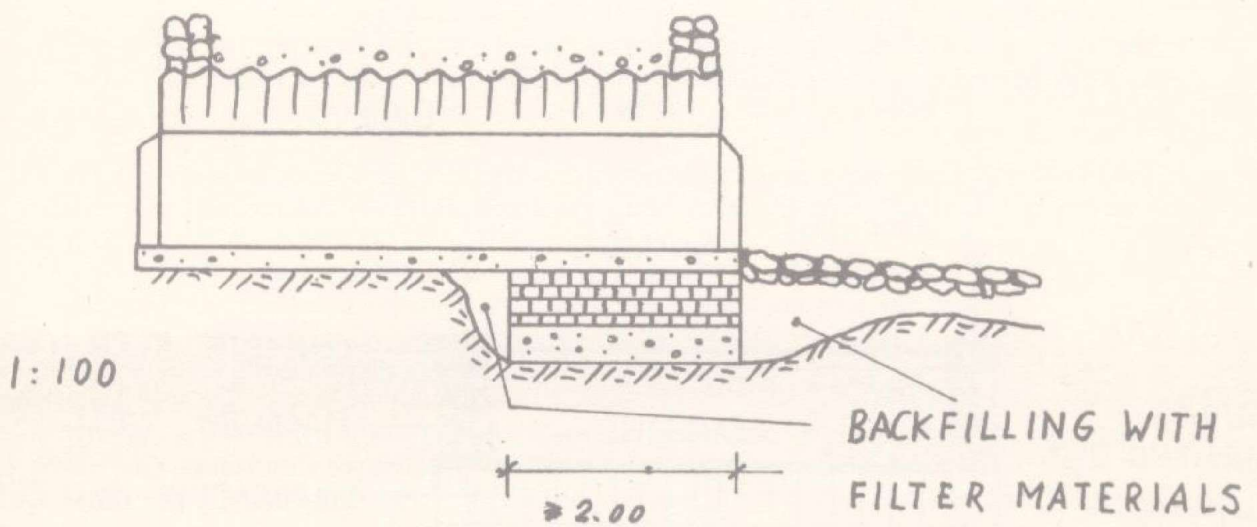
A-A :

SUBSOIL: CLAYEY SAND (SC)
