Degradation of Waterfront Reinforced Concrete Structures at the Port of Dar es Salaam

I. P. L. Sanga and A. M. Dubi

Key words: Degradation, reinforced concrete, Dar es Salaam port

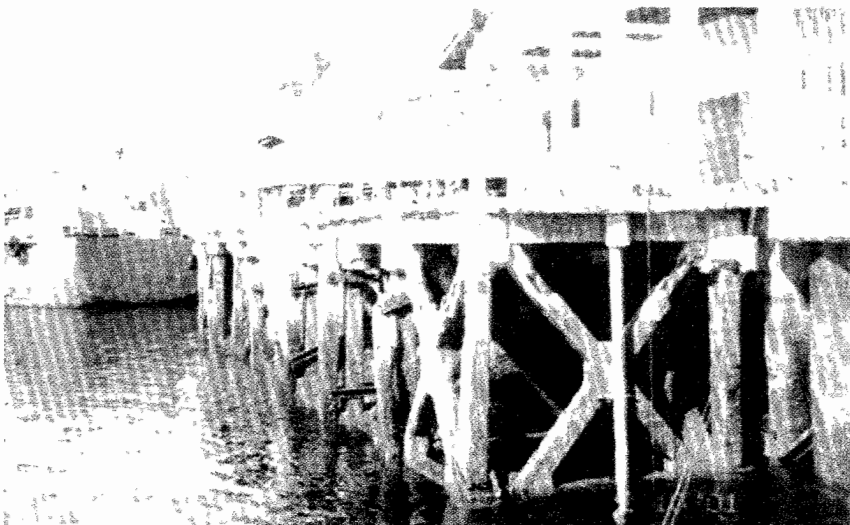
The structures at the dhow quay of the Lighter wharf are in a bad condition because the concrete has been badly damaged due to corrosion. Some of the elements of the structures have very wide cracks along the line of reinforcement bars and most of the concrete on piers and struts has been substantially spalled-off and peeled off. In some places, the reinforcement bars are exposed out (Plate 1).

Plate 1. Concrete piers and struts severely corroded at Lighter quay

The piers at Lighter Quay are in desperate need of a major rehabilitation and with the present condition it is very dangerous for the quay to be in use. Piers at main quay (berths 4 - 11) need renovation to prevent the continuation of corrosion of the reinforcement. The fender system is wearing out and therefore needs an immediate repair to restore its structural capacity.

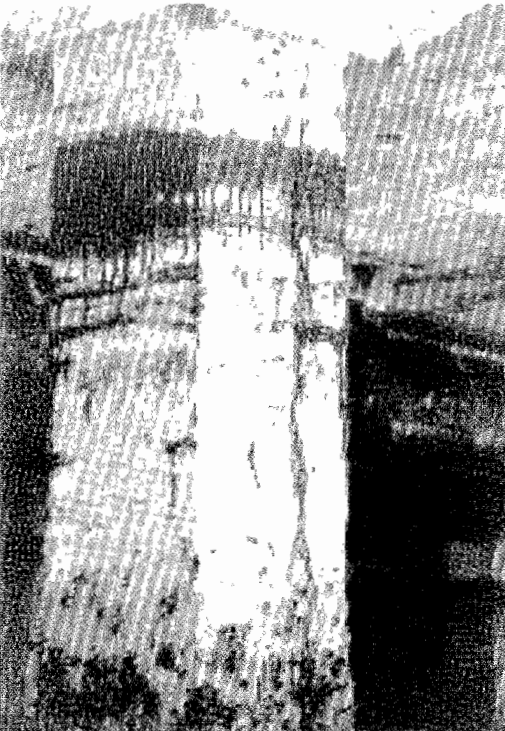
Berths 4 to 11 at the main quay are concrete piers. Small to wide cracks up to 20mm were observed on concrete piers of all berths and some few piers were severely corroded especially Berth 4 through Berth 8 (Plate 2). Corrosion of the reinforcement steel is very significant such that a few elements of the concrete structures have been spalled-off and peeled off, thus exposing out reinforcement steel (Plate 3). If left without repair, they may lose the designed load bearing capacity and structural strength. Concrete cover ranges between 20mm and 30mm.

Plate 2. Typical cracks on concrete piers found on berth 4 through 8

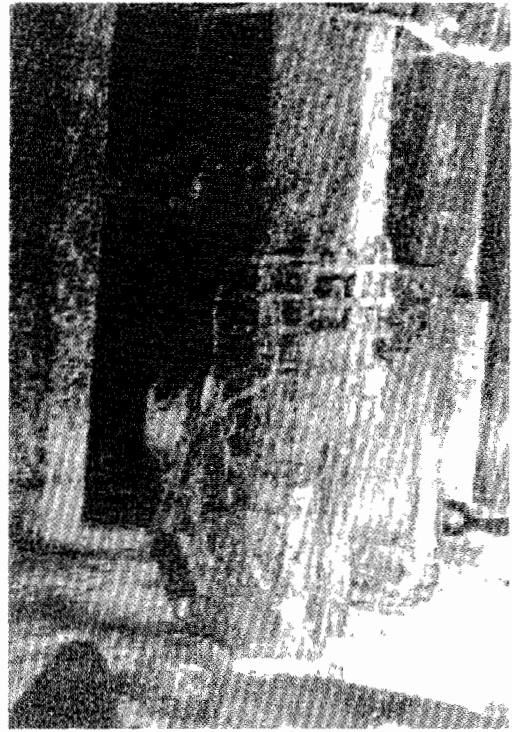
Plate 3. Exposed reinforcement in one of the piers at main quay

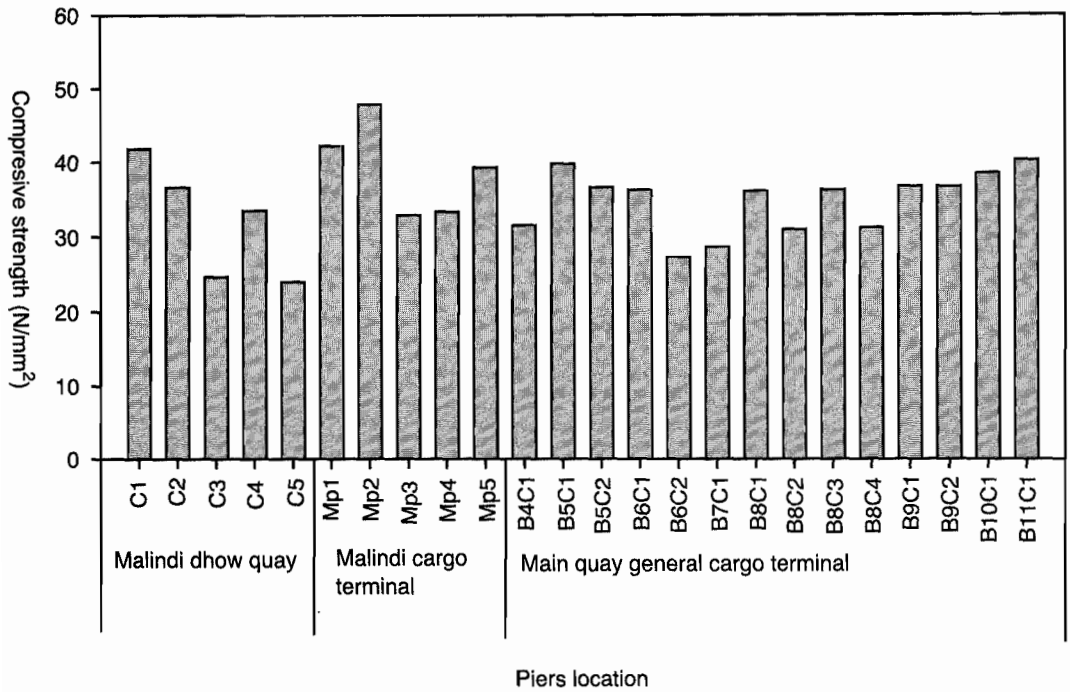
(1977) at Lighter quay was 47.97 N/mm² and 24.01 N/mm² for Malindi cargo terminal and Malindi dhow quay respectively (Fig. 2). The mean compressive strength at Malindi cargo terminal was 39.13 N/mm² while at Malindi dhow quay was 32.13 N/mm². At the Main Quay the mean compressive strength was found to be 35.38 N/mm² (Fig. 2). Fig. 3 shows the comparison of compressive strength at different terminals. Concrete piers at Malindi cargo terminal are the strongest of all with a maximum compressive strength of about 50N/mm² while a minimum compressive strength of approximately 25N/mm² was found at Malindi dhow quay.

Fig. 2. Insitu compressive strength on concrete piers at the port of Dar es Salaam

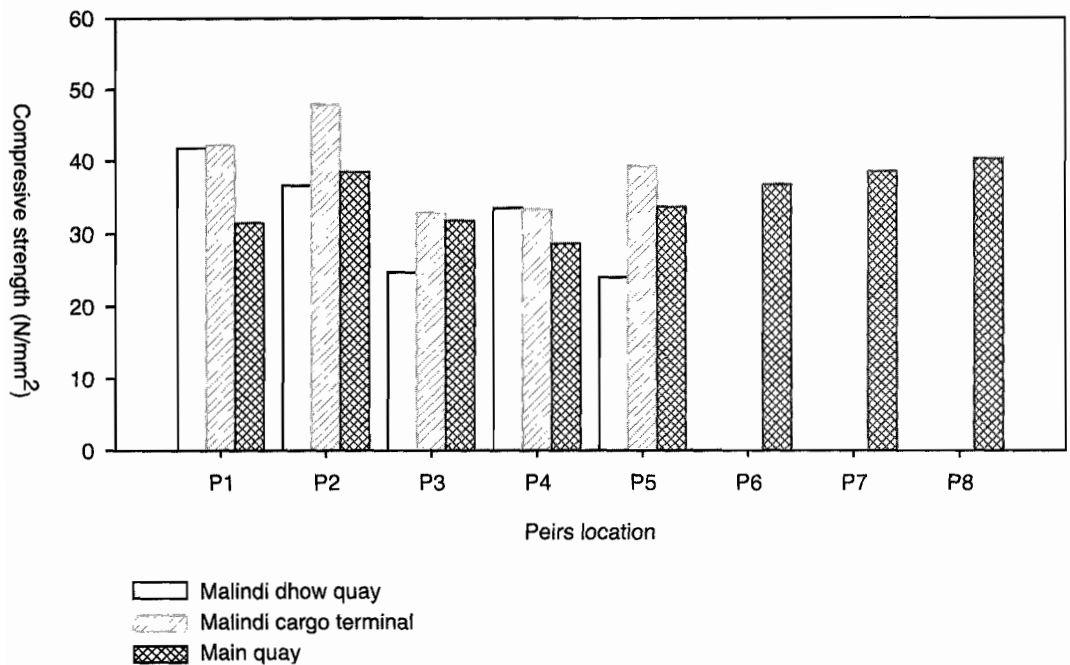
Fig. 3. Comparative insitu compressive strength for concrete piers as measured by rebound hammer at the port of Dar es Salaam
