JOURNAL OF THE ASSOCIATION OF RADIOGRAPHERS OF NIGERIA

Vol 28, Issue 1, December, 2014

Artefactual Behaviour of Fluid in Radiographic Darkroom Practice

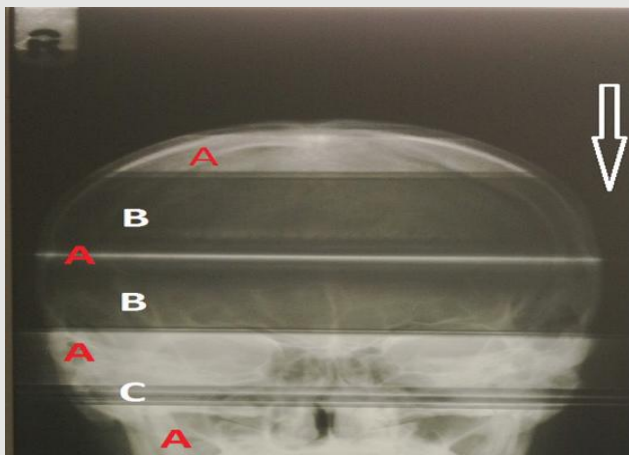
Figure 1: Developer artefacts from roller marks

In the postero-anterior (PA) skull radiograph shown in Figure 1, (A) is evidence of completion of development. (B) represents region of film in contact with developer-wet exit rollers in developer compartment. (C) represents film in contact with developer-wet cross-over roller. White arrow shows film movement through the automatic processor. Figure 2 is evidence of contact of fixer solution with (i) a radiation-sensitized but not-yet-processed film which results irredeemably in a white smooth-edge mark on the radiograph; (ii) a processed film does not discolor or affect the image; (iii) a non radiation sensitized film has the same effect as (i) but such films should not be used anymore due to the risk of screen stains and developer neutralization during processing. The white patch is evidence of silver halide erosion. This image was simulated in the darkroom.

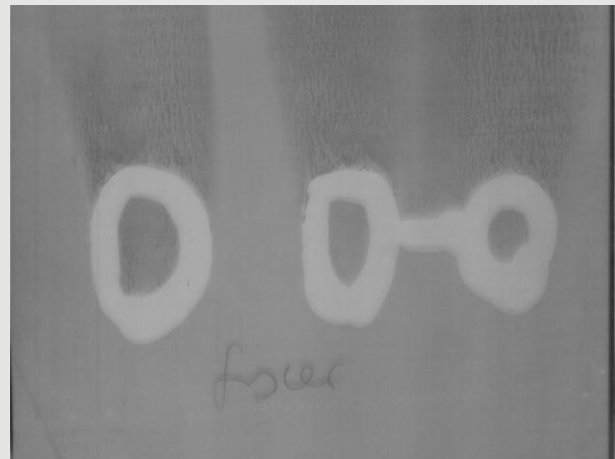
Figure 2: Fixer stain artefacts

Film stasis in fixer-wet rollers lead to excessive fixing and the formation of uniform straight line areas of reduced density across the film. If drops of fixer interact with the film however, smooth-edged, minus density areas should be expected (Figure 2). When films are stuck in the automatic processor, the efficiency of the squeegee action of rollers is compromised and subsequently, even drying is not so perfect anymore. When stuck radiographs are separated manually the area of adhesion show distinct, zigzag greyish water mark artefacts.

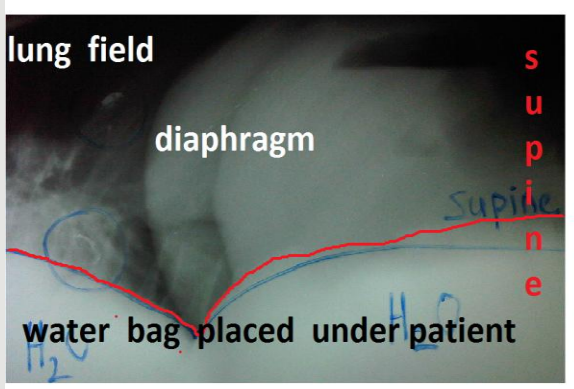
Figure 3: Water as an artefact

Figure 3 gives an insight of the artefacts caused by water on radiographs. The image represents an attempt to perform a lateral chest x-ray on a quadriplegic patient brought to the department on a waterbed made of multiple 60cl cellophane sachets of drinking water converted to bed to avoid bedsores. The inferiorly-located (below curved lines) greyish homogenous opacity represents the waterbags. It is almost iso-dense with the diaphragm located superiorly to it. This water artefact could be a source of confusion to the reporting radiologist oblivious of its origin.

A serendipitous encounter in this work was the behaviour of water(bag) as a foreign body. It presented as greyish homogenous opacity that was almost iso-dense with the diaphragm. This water artefact could be a source of confusion to the reporting radiologist oblivious of its origin (Figure 3). Grease has adhesive and cohesive properties [10]. This is detrimental to the archival longevity of radiographs as multiple radiographs in a film jacket may stick together thereby accelerating deterioration of the images. The probability of culturing bacteria is also there. However, in this present study, grease was noted to stain the radiographs with a dirty, conspicuous and constantly expanding hue. It equally diminished the aesthetics of the radiographs.
