Assessing cervical stability: a reminder

Donald Emby, MB BCH, FF Rad (D) SA
Andrew Lancaster, MB ChB

CASE REPORT

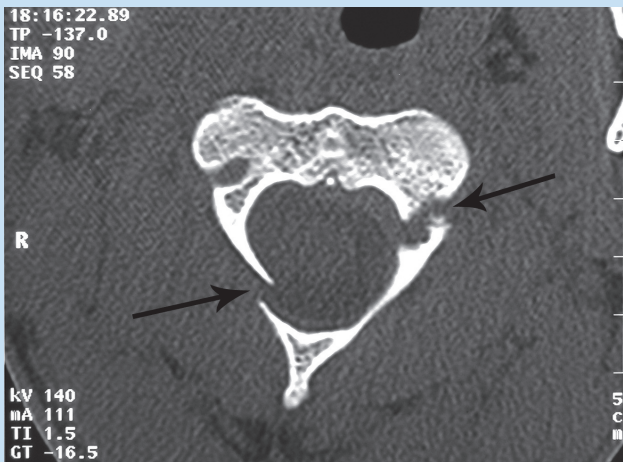
Fig. 2. CT scan through the body and dorsal ring of C2, showing fractures of the right lamina and left pedicle (arrows). (The classic hangman's fracture consists of fractures through the base of the posterior ring of C2 on both sides. As the fracture on the right side in this patient is more posteriorly situated, this could technically be described as a 'variant hangman's fracture'.)

The patient, an underground mine worker, sustained an injury to his neck in a rock fall accident. Cervical spine radiographs and a CT scan demonstrate bilateral fractures which have resulted in disruption of the bony ring of C2. This constitutes a hangman's fracture (Figs 1 and 2).

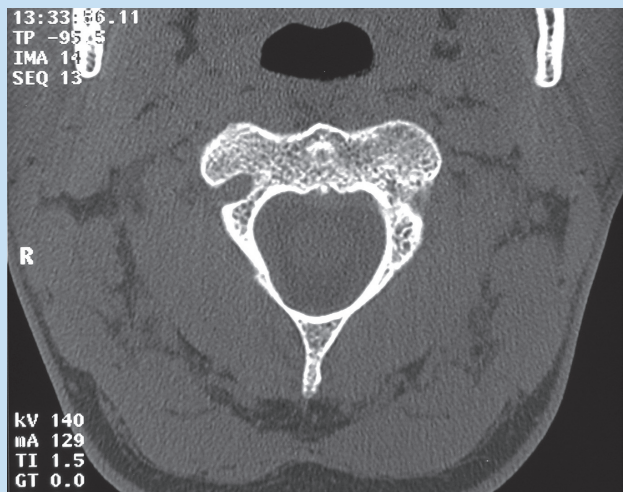
Fig. 3. CT scan through the body and dorsal ring of C2 at same level as in Fig. 2, but 6 months later. Both fractures are shown to have healed.

Our patient, who was neurologically intact, was treated with skull traction by means of cones calipers for 6 weeks and was then cautiously mobilised (out of bed) in a rigid neck brace. A repeat CT scan 6 months later demonstrates solid bony union at both the right and left C2 ring fracture sites (Fig. 3). The important question that should then be asked is: Does the demonstration of bony union mean that the injury is now stable?
