Gerhard Bosman

Acta Structilia 2017 24(1):
1-26

Ownership and care in culturally significant architecture: Three case studies

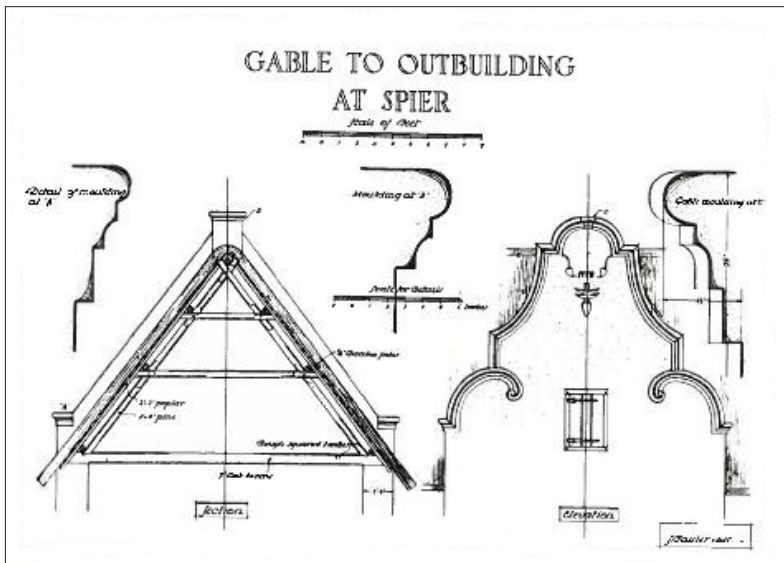
Figure 3: Details of a gable and timber roof structure of Spier outbuilding

and tiles. By the end of 1663, most of the buildings were covered with plaster. They were also whitewashed with lime burned from sea shells, while thatch was reintroduced (Potgieter, 1970a: 507). The typical Cape buildings (see Figure 3) reveal the community's detail and care toward their buildings.

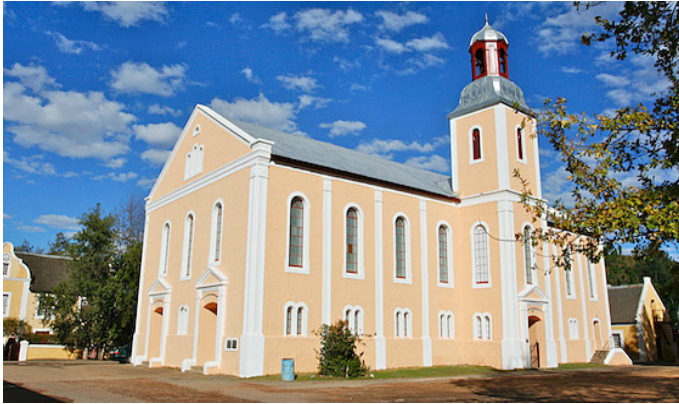
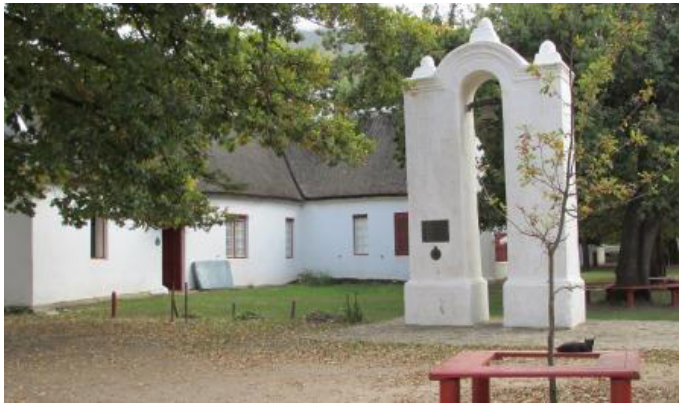
Figure 4: Photos of heritage earth-construction public building on Church Square in Genadendal

monuments (see Figure 4). Sixteen of these buildings, dating from 1737 to 1899 and built around the church square (see Figure 5), are still well maintained and cared for (Newsferret, 2013: online). These buildings can be considered CSA, built using the same earth-building techniques described in Section 2.3.

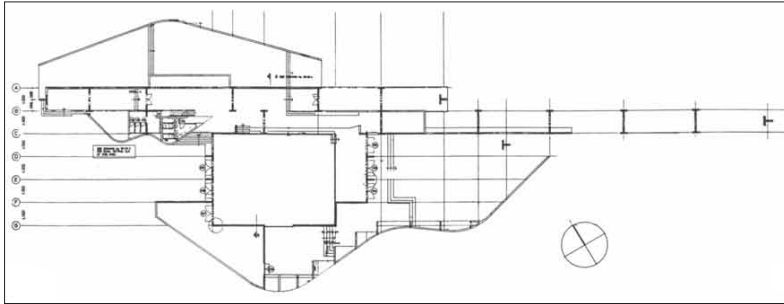
Figure 7: Steinkopf Community Centre, plan

In the Namaqualand district, approximately 50km north-west of Springbok, a Nama settlement was established near a water source in a sheltered valley. In 1818, the London Missionary Society sent Heinrich Schmelen there to found a mission station. By 1840, the town Steinkopf was well established with a church, a small school and some houses. By 1973, the settlement had 1 800 inhabitants. The discovery of copper in the area brought some infrastructure development (Kokot, 1970: 265). During 1979, a mining company commissioned the Cape Town-based architects Uytenbogaardt and Rosendal to design a community building for the extreme semi-arid climate of Northern Namakwaland (see Figures 7 & 8).

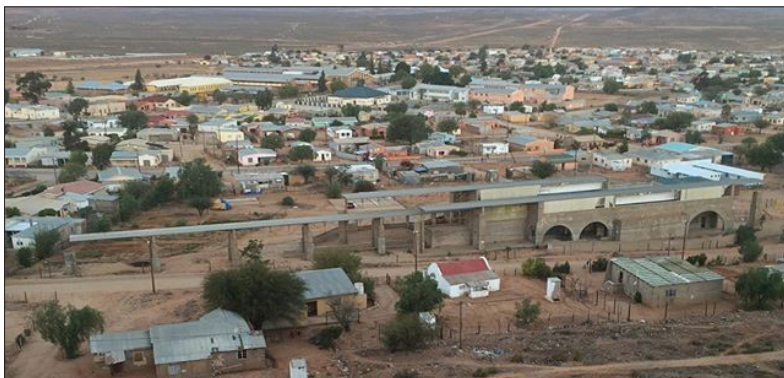
Figure 8: The context with the Steinkopf Community Centre in the foreground and another community centre in the background

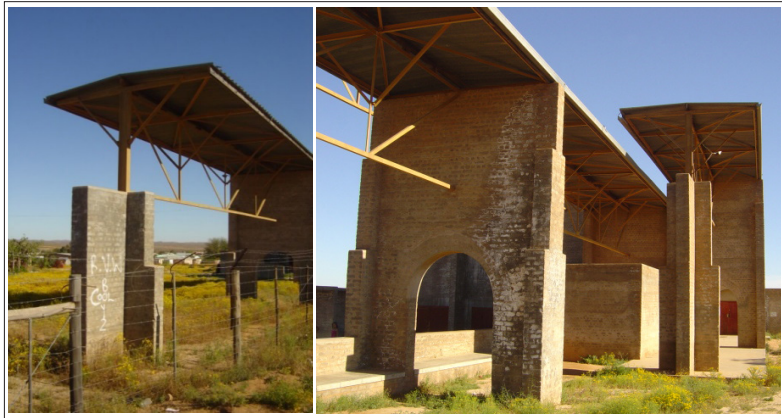
Figure 9: No maintenance on the cement brick-constructed Steinkopf Community Centre in the Northern Cape Province, South Africa

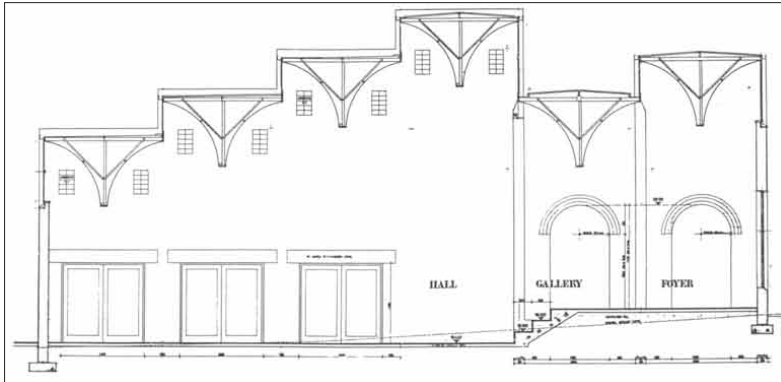
Figure 10: Steinkopf Community Centre, cross-section

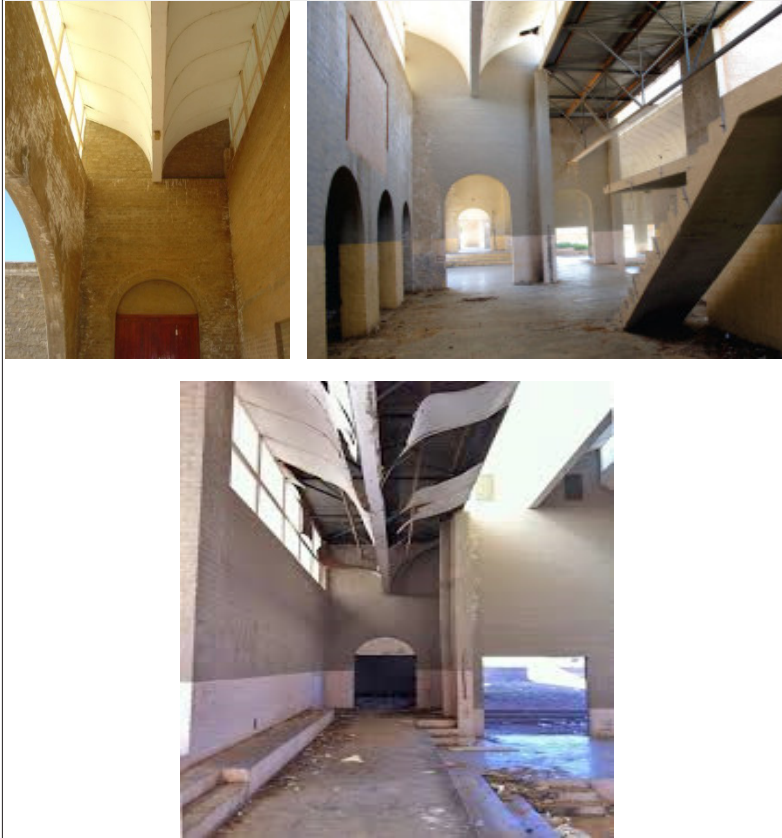
Figure 11: Steinkopf Community Centre, photo taken in 2007 (top) compared to recent photos of interior space in 2012 (bottom)

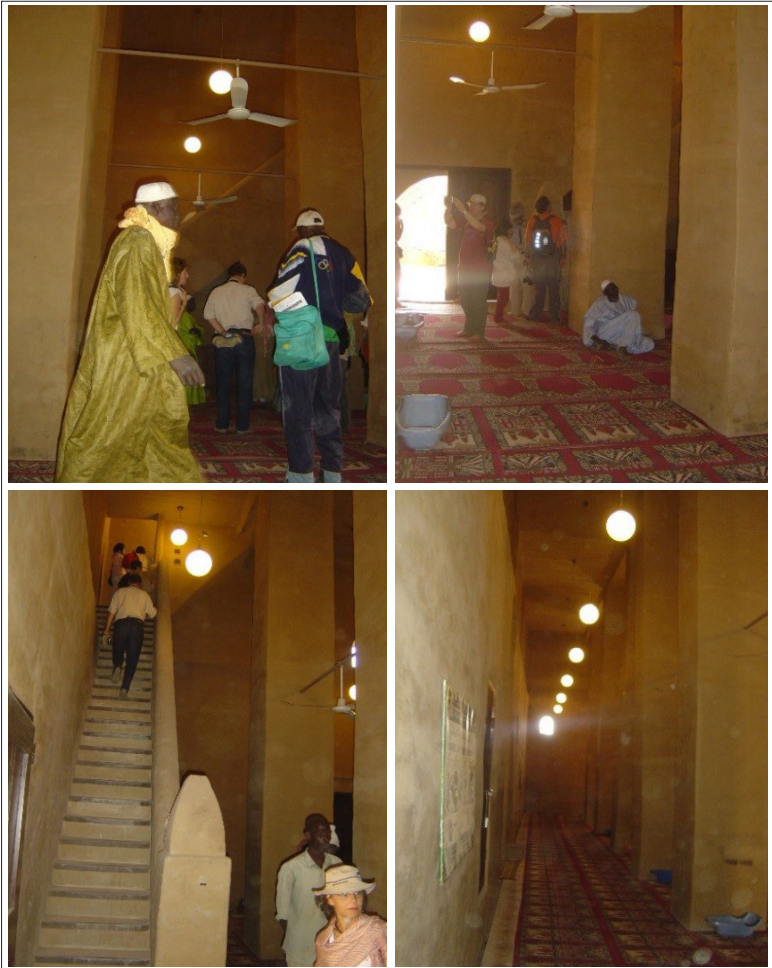
Figure 12: Interior spaces of the Great Mosque of Mopti, Mali, West Africa

2 500mm-high boundary wall. The roof is supported by massive earth-constructed sun-dried block columns (see Figures 12 & 13), parallel to the *qibla* wall (indicating the direction of Mecca).

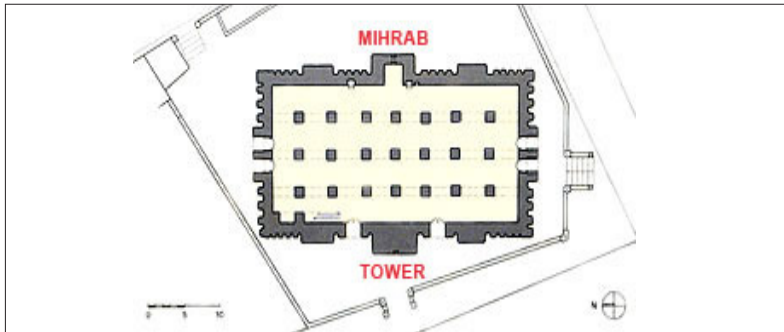
Figure 13: Great Mosque of Mopti, plan showing the main tower and *mihrab* and *qibla* wall

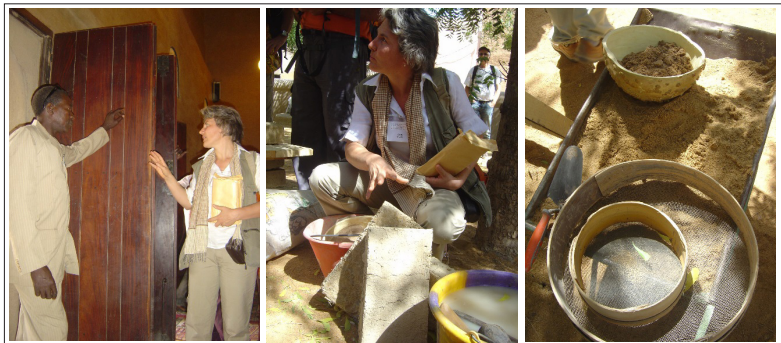
Figure 14: Architect Gisele Taxil-Wardell explains the construction process and conservation work done in the building of the Great Mosque of Mopti

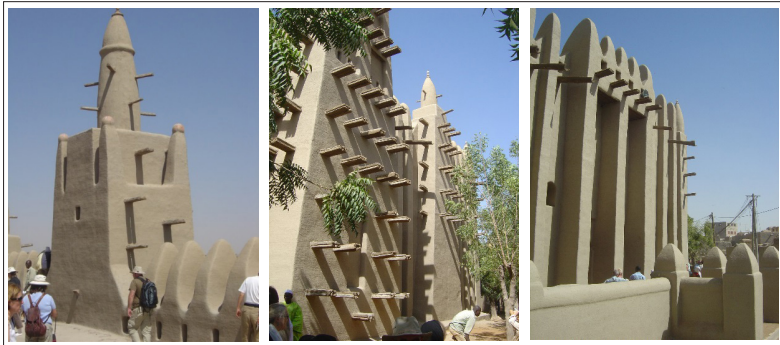
Figure 15: The restored rooftop with minarets, tower and facade of the Great Mosque of Mopti

The mosque was restored between October 2004 and June 2006, with conservation funding from the Aga Khan Trust (Taxil-Wardell, 2015). The buildings received cement-coping elements during previous restoration attempts in the 1970s. These efforts created more damage

to the earth clay plaster walls and structure. Project architects Gisele Taxil-Wardell and Wilfredo Caracas proposed an intervention of deep insertions to remove damaged structure and rebuild walls with the same earth material (*banco noir* and *banco blanc*) used decades earlier. This conservation effort also included the training of young apprentices in masonry, plastering and carpentry (see Figures 14 & 15). On completion of the project, approximately 30 apprentices received comprehensive training in related fields of caring, maintenance in the original materials of black and white earth mixes with straw and timber work (Mopti, [n.d.]: online).
