Wood-destroying Coleopteran species in the historical buildings in Kastamonu, in Turkey

The aim of this study is to identify the harmful insects causing damage in the historical wooden buildings of Kastamonu. Accordingly, 15 of those historical wooden buildings situated in the city were periodically controlled between the years 2002 and 2005. During those periodic controls, damages caused by insects were detected and additionally, dead and alive insects were collected from the damaged materials. As a result of this study, 7 species from 4 families were identified; these species are *Anobium punctatum* De Geer, *Xestobium rufovillosum* De Geer, *Ernobius mollis* (L.), *Ptilinus pectinicornis* (L.) (Anobiidae), *Lyctus brunneus* (Steph.) (Lyctidae), *Hylotrupes bajulus* (L.) (Cerambycidae) and *Rhizophora* sp. (Bostriichidae). Except *A. punctatum* and *H. bajulus*, the rest are considered as the first records gathered in Kastamonu region.

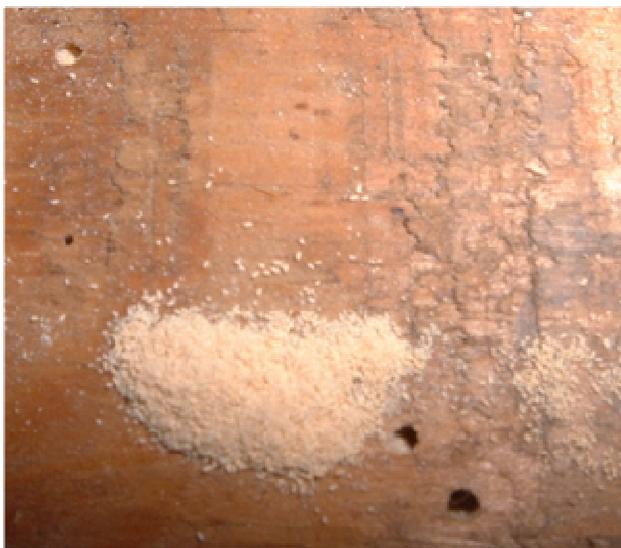
**Figure 1.** Small pile of dust accumulates near exit holes of *A. punctatum* in the wood.

domesticum (Geoffroy, 1785) and *A. striatum* Olivier, 1790. This damaging insect was detected in various parts of entrances and rooms of buildings and mainly located in carved boards, in-built bathrooms and wooden ornaments, stair carvings, shelves in kitchens, windows and frames (Table 2). An adult one was noted on the feet of a handmade piano made of walnut tree, at 75, Cumhuriyet House. In addition to this, 78 entry and exit tunnels were observed on a 10 cm × 10 cm piece of shelf obtained from the Mansion of Hacı Tahir Efendi. It was observed that a yellow-like frass or powdered wood poured out of exit holes in which some dead adults with their heads turned upside were found near the edges. The damage caused by this insect was the building of parallel short tunnels near the surface of the wood, filled with yellow-like frass or powdered wood. The diameter of exit tunnels ranged from 1 - 1.2 mm (Figure 1).

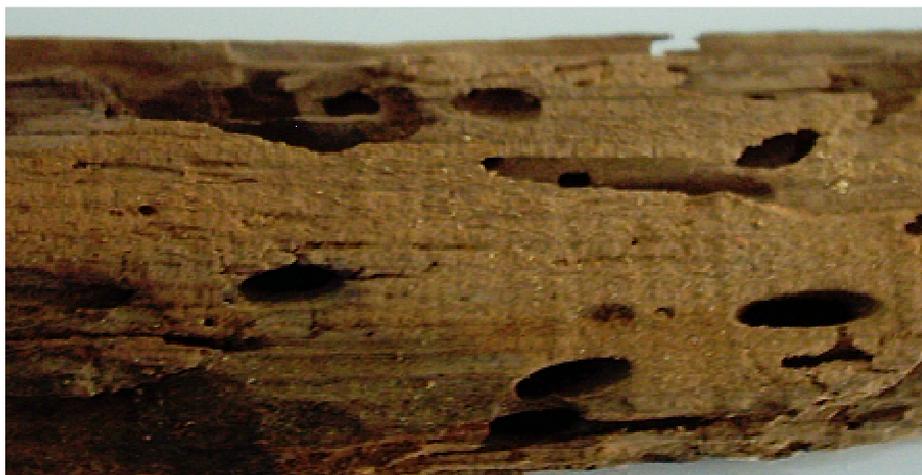
Figure 2. Damage of *L. brunneus* (Steph.).

Synonyms: *Lyctus disputans* Walker, 1701; *L. costatus* Blackburn, 1888 -*Xylotrogus brunneus* Stephens, 1830. This insect was detected in the exit tunnels of a wooden log in Vedat Tek Restoration Centre during daytime. A pile of tiny dark yellowish frass or sawdust poured out of the circular shaped exit tunnels that was 1.2 to 1.8 cm in diameter. The surface of the sample log was untouched, yet the part under the surface was covered with long, parallel and connected holes that seemed to be the remnants of rat damage (Figure 2). They feed primarily on hardwoods (Table 3).

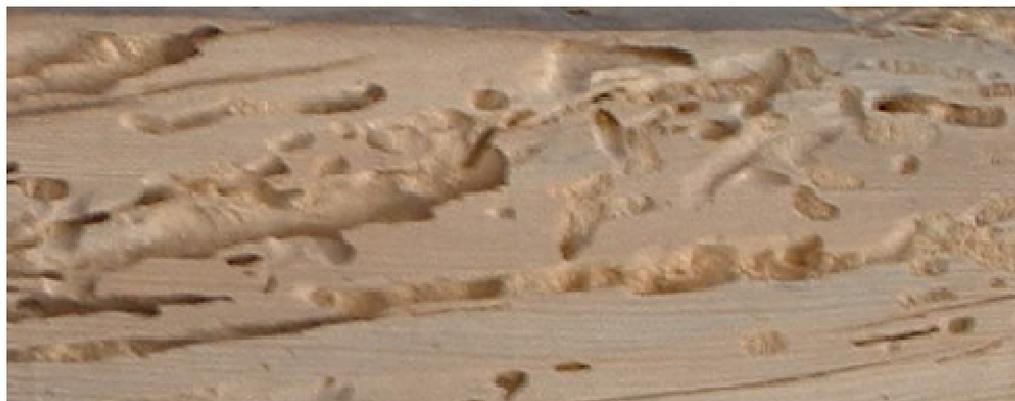
in wooden beams, floorings and roofs. The sound and solid parts of the wood affected were completely spoiled. When examined outside, the entry holes could be seen whereas insect damage was not apparent. The exit holes were similar to the ones of *L. brunneus* and the excavated tunnels which were oval shaped, short and interrelated led to the deeps of the logs (Figures 3, 4 and 5).

Figure 3. Damages of *H. bajulus* (L.).

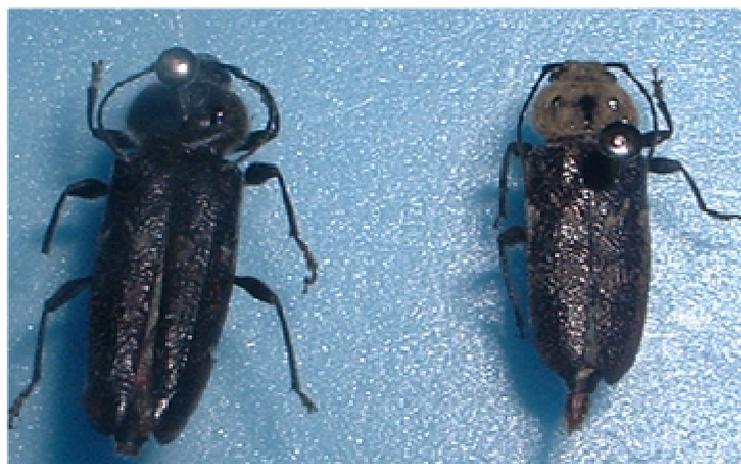
Figure 4. Adults of *H. bajulus* (L.).

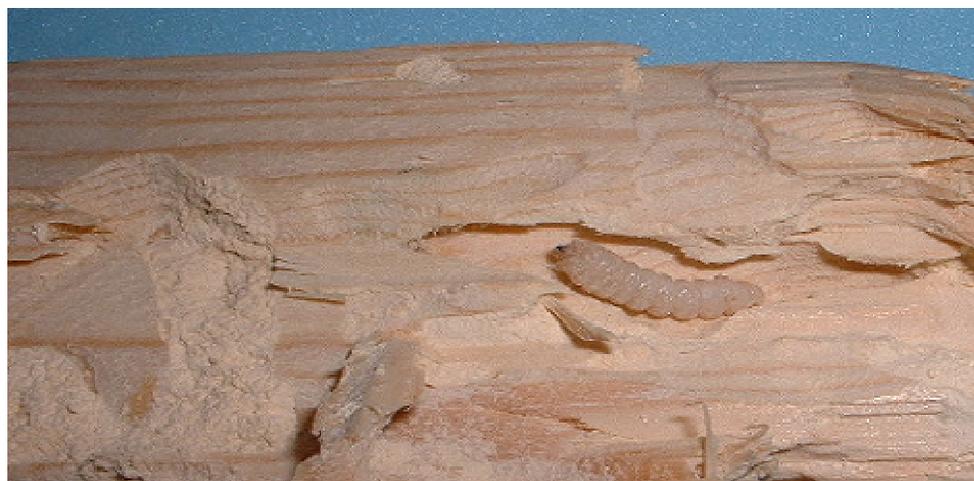
Figure 5. Larva of *H. bajulus* (L.).
