Full Length Research Paper

Evaluation of pollution status of heavy metals in the groundwater system around open dumpsites in Abakaliki urban, Southeastern Nigeria

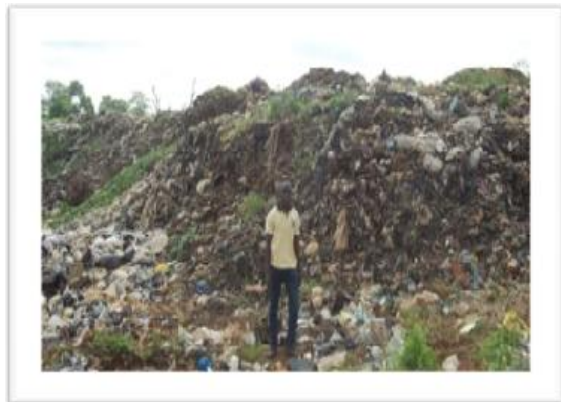
Figure 3. Pictorial view of (L4) Iyokwu dumpsite.

Cadmium and arsenic was observed to be the major pollutants around IyioKWu dumpsite. Their ranges of occurrences are cadmium (0.045-0.212 mg/l with a pollution index range of 15-70.7% exceeding the WHO standard of 0.003 mg/l) and arsenic (0.43 mg/l with pollution index of 43% exceeding the WHO standard of 0.01 mg/l). This high concentration of cadmium and arsenic were observed only at well water point around the dumpsite (Figure 10). It will be attributed to high human and industry activities going on around there such as welding, automobile mechanic workshops, car wash, shops and offices that dump solid wastes that are carried off the surface by run-offs. Other heavy metals shown from Table 1 are iron (0.014-0.107 mg/l), zinc (0.0337-0.0932 mg/l), nickel (0.001-0.012 mg/l) and calcium (30.41-32.95 mg/l) (Figure 10). However, copper, mercury, manganese, aluminum and lead were

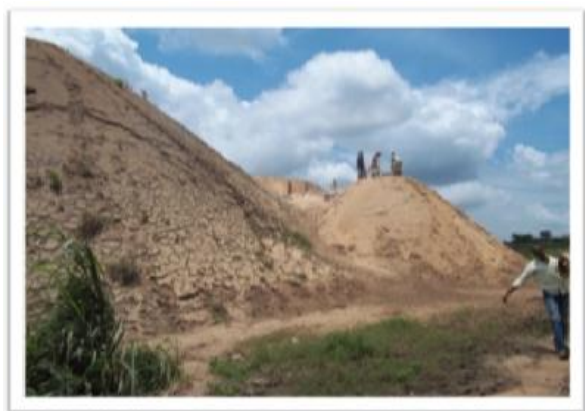
Figure 4. Pictorial view of (L3) rice mill dumpsite.

Around the rice mill dumpsite, high concentration of iron metal was observed from the water sources as a pollutant with a value of 16.236 and 4.387 mg/l with pollution indices of about 54 and 14.62% respectively (Table 1, Figure 9). These exceed the WHO standard of 0.3 mg/l, thereby making the rice mill dumpsite an iron metal contamination zone. The occurrence of iron in the water samples around this dumpsite may not necessarily be inferred based on the chemical properties of the waste dumps that are primarily rice husks. Since the rice husk which is the major component of the waste dumps do not

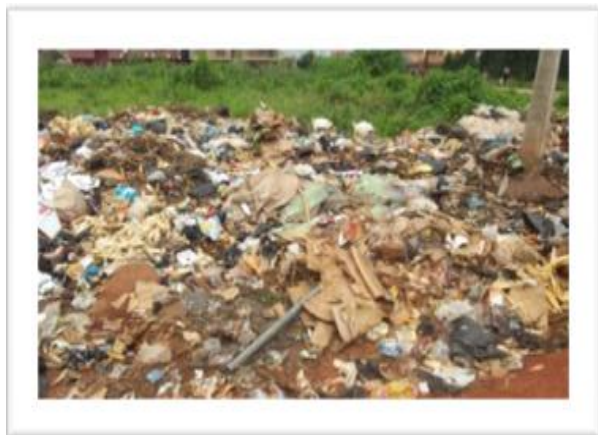
Figure 5. Pictorial view of (L2) New layout dumpsite.

Within the new layout dumpsite, majority of the heavy metals been discussed were undetected especially in the borehole water samples. At the well water point, cadmium and arsenic as contaminants showed high concentration of 0.058mg/l and 0.64mg/l with pollution indices of 19.3% and 64% as against 0.003mg/l and 0.01mg/l of WHO standard respectively. Other metals observed from the dumpsite are zinc (0.0644 mg/l), nickel (0.015 mg/l), iron (0.016-0.071 mg/l), manganese (0.134-0.379 mg/l) and calcium (27.71-31.04 mg/l) (Figure 8), which did not occur at a harmful rate. The absence of these contaminants from the borehole samples suggests the presence of an impervious geologic layer which inhibited the vertical downward percolation of the filtrates into the groundwater system. Hence, it can be inferred that the New layout waste dumpsite is good for such purpose. However, the inhabitants of the area should be advised not to use water from the hand dug wells for domestic purposes.
