Full Length Research Paper

The earthquake/seismic risk, vulnerability and capacity profile for Karonga town

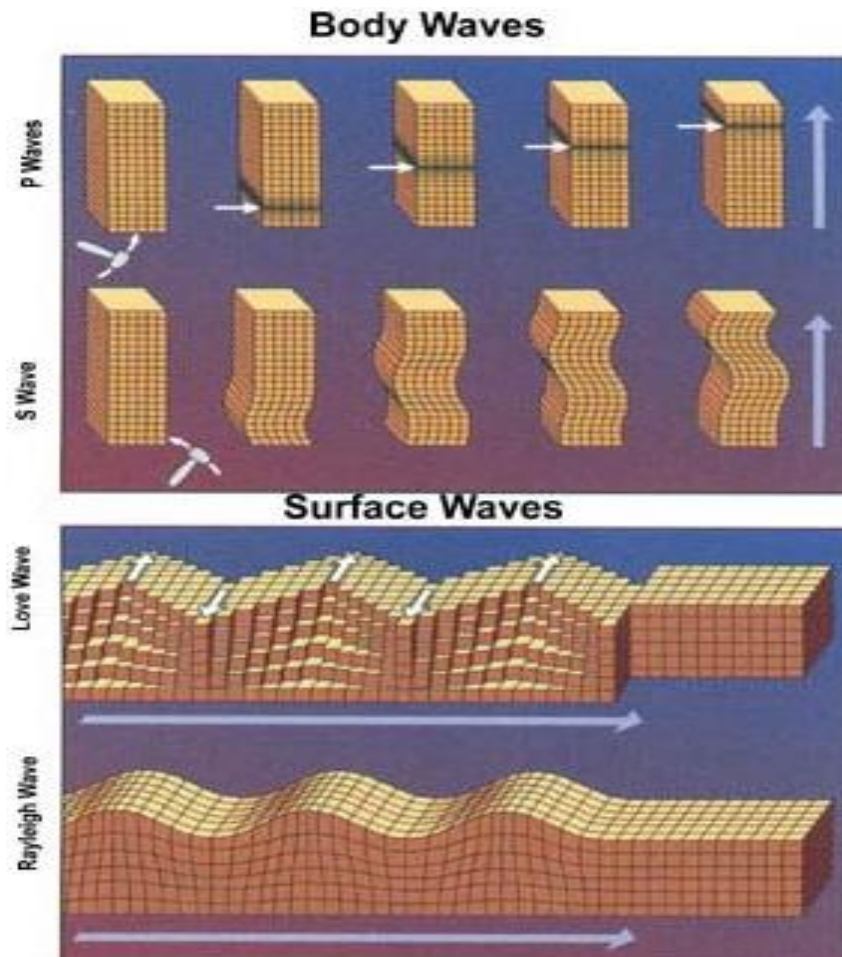
Figure 2. Types of waves generated by earthquakes (Source: Ammon, 2010).

An earthquake generates different kinds of waves each characterized by its speed and direction (Ammon, 2010). A seismic wave is an elastic wave generated by an impulse such as an earthquake or an explosion. Seismic waves may travel either along or near the earth's surface (Rayleigh and Love waves) or through the earth's interior (P and S waves) (Alexander, 2001) (Figure 1). Waves that emanate from the site of the quake inside the earth are called body waves (Ammon, 2010) (Figure 2).

The first of these are known as P waves, for primary or pressure. They are fast, traveling through rock at over 225 miles per hour (360 km/h) and through water at about one-third that speed, pushing, pulling, and compressing the earth in the direction of their travel. An earthquake also causes secondary or shear waves called S waves (Biggs et al., 2010; Ammon, 2010). These travel at about half the speed of P waves, but can be much more destructive. S waves move perpendicularly to the direction the wave is traveling. Rayleigh waves churn over and under like rolling ocean waves; Love waves shake the earth from side to side. Love and Rayleigh waves, are the ones often responsible for making buildings collapse (Ammon, 2010). The point of fracture in known as the focus of the earthquake and the point vertically above the focus on the surface of the earth is known as the epicenter (De Blij and Mullar, 1996).

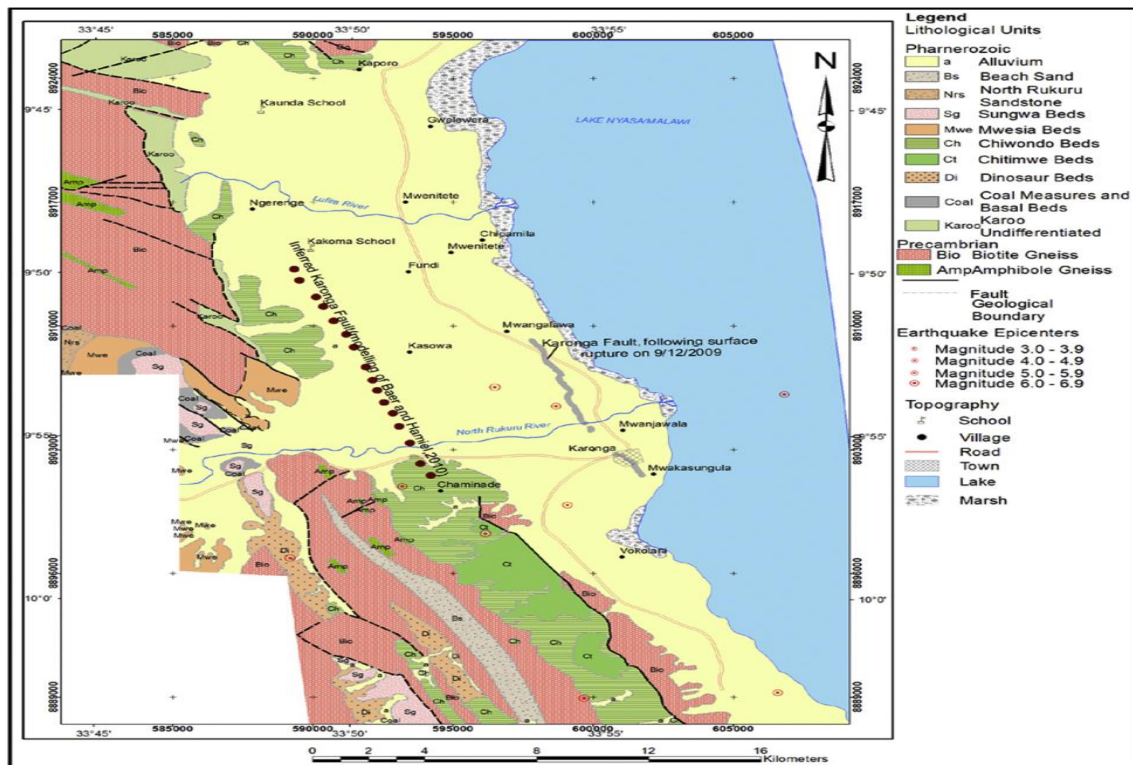
Figure 3a. Map of Karonga showing lithology and mapped fault line and a rupture (Map produced by Mdala of Geological Surveys Mzuzu, 2016).

Karonga Town is located on an irregular basin which lies on the fault line that forms part of the Livingstone fault (Biggs et al., 2010). Karonga Town is susceptible to seismic waves which are a result of the tectonic activities associated with the great east African rift valley fault, a constructive margin, which forms the Lake Malawi. A number of seismic risks are expected in Karonga Town. Flannery and Rosendahl (1990), Ebinger et al. (1999) indicate that the loading of sediments on the fault deepens to 6 km such a situation is recipe to requefaction especially with raised water table as most of the deposit form good aquifers. Flannery and Rosendahl (1990) suggest the existence of parallel faults which result in reflection of seismic waves during tremors. In contrast to the steep eastern boundary, the western shore comprises a 5 to 10 km wide coastal plain covered by Quaternary sediments (Figure 3a) (Burke and Gunnell, 2008). Further

The greater part of Malawi is underlain by crystalline Basement Complex rocks of Precambrian to Palaeozoic age, mostly consisting of gneisses and granites (Figure 3a). These rocks form what is broadly called "The Malawi Basement Complex". In some localities, the Basement Complex rocks are overlain by Karoo System rocks (Carter and Bennet, 1973). Most of the Basement Complex rocks have undergone medium to high grade metamorphism and a prolonged structural and metamorphic history that was dominated by orogenic movements, faulting, rifting and formation of the Malawi Rift Valley (Carter and Bennet, 1973).

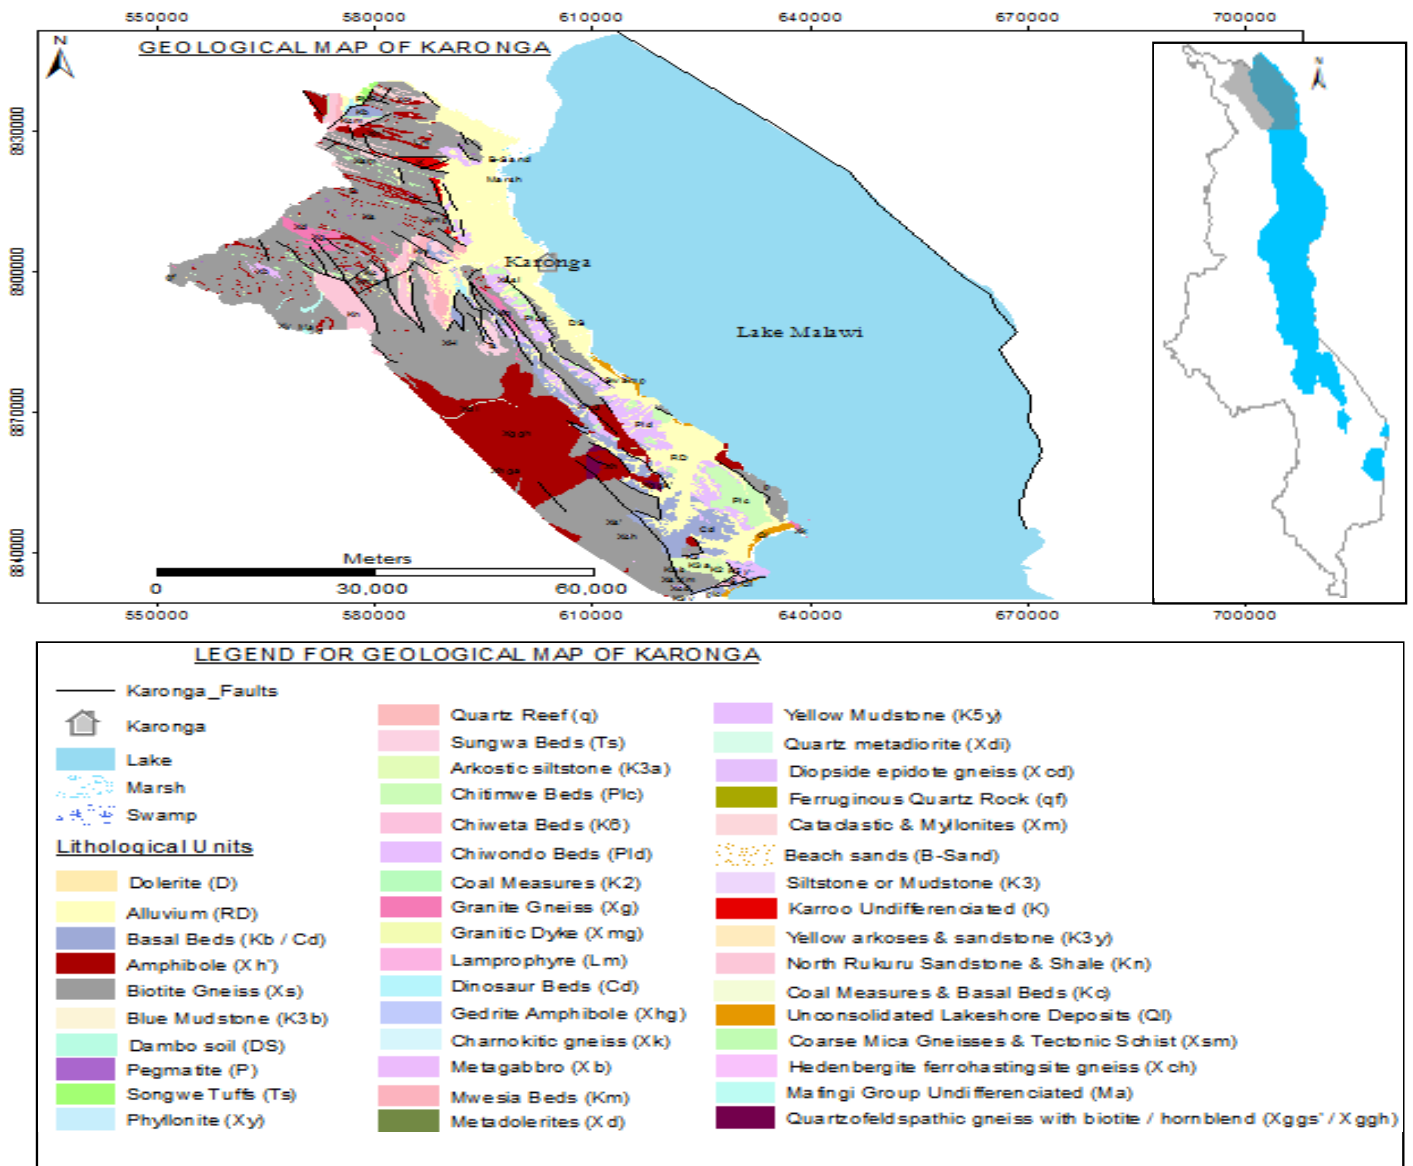
Figure 3b. Geological Map of Karonga District (insert is Map of Malawi showing location of Karonga District).

According to the Geological Surveys Department, Karonga is heavily faulted (Figure 3b) owing to its location within the East African Rift Valley (Geological Survey of Malawi, 1966; Macheyeke et al., 2014:239-244). Therefore, it was no surprise that a series of earthquake occurred in 2009. There is need for geotechnical assessment before construction of major infrastructure and buildings so that they withstand seismic hazards. Certain land use activities such as residential areas, must consider allocating land away from high risk areas to reduce exposure to hazards (Malawi Government, 2013).

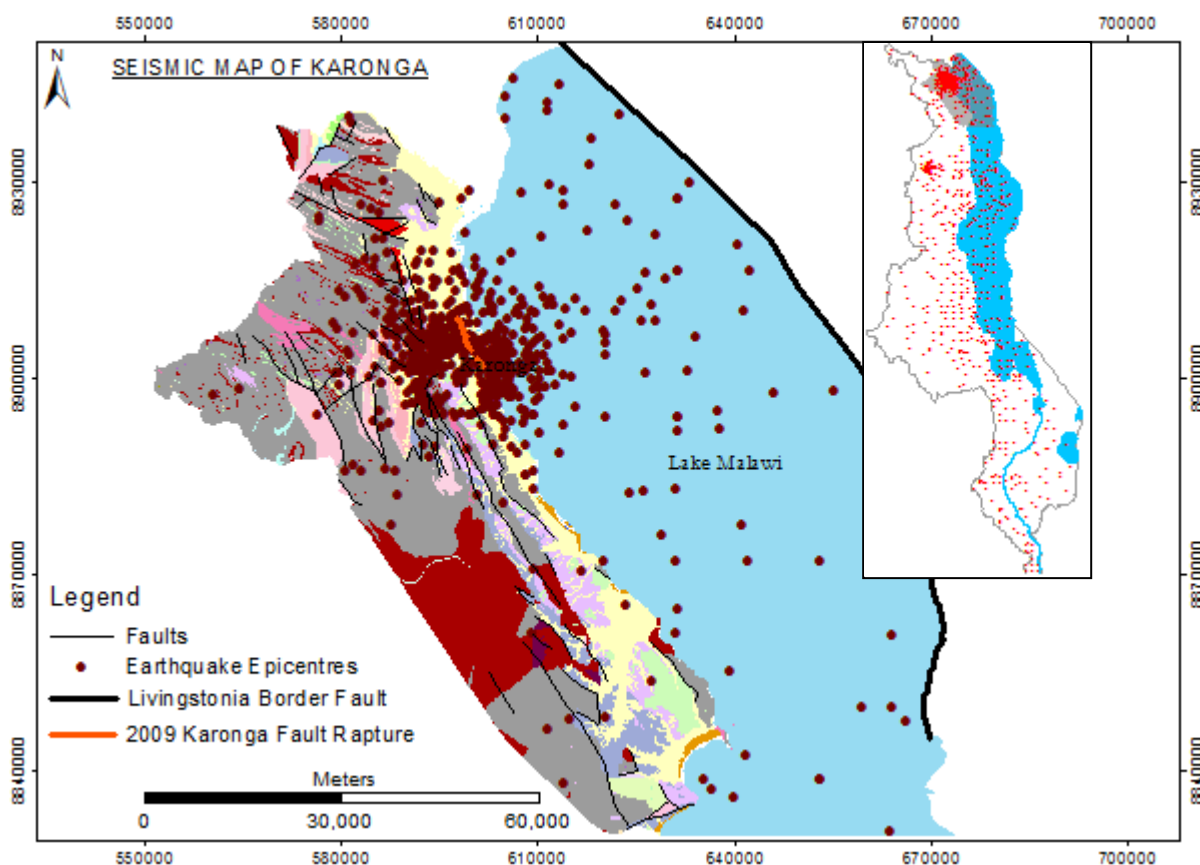
Figure 4. Seismicity of Karonga District from 1901 to 2014 (most of it occurring between 2009 to present). Insert is Seismic Map of Malawi showing location of Karonga District (Grey Area).

Data on earthquakes in Karonga has been collected since 1904 (Lunduka et al., 2010; Macheyeke et al., 2014). Figure 4 shows a number of epicentres since 1904 (Macheyeke et al., 2014). However the most reported earthquakes in the history of Malawi occurred in 2009 from 6th to 20th December (Tables 1 and 2). A post-

Going through the records it was found that Karonga Town had been experiencing seismic waves since as way back as 1904 when the town was established as a trading centre. Mostly the epicentres for most earthquakes have been along the Karonga fault and the western shelf of the Lake Malawi on Karonga coast (Figure 4).

Adequate understanding of the earthquakes in Karonga dates back from 1956 and since then information has been corrected for the seismic waves (Figure 6). Mostly the epicentres have been located on the western parts of Karonga but the Town has had the most serious readings due to the rapture which is associated with the Karonga fault (Figure 4).

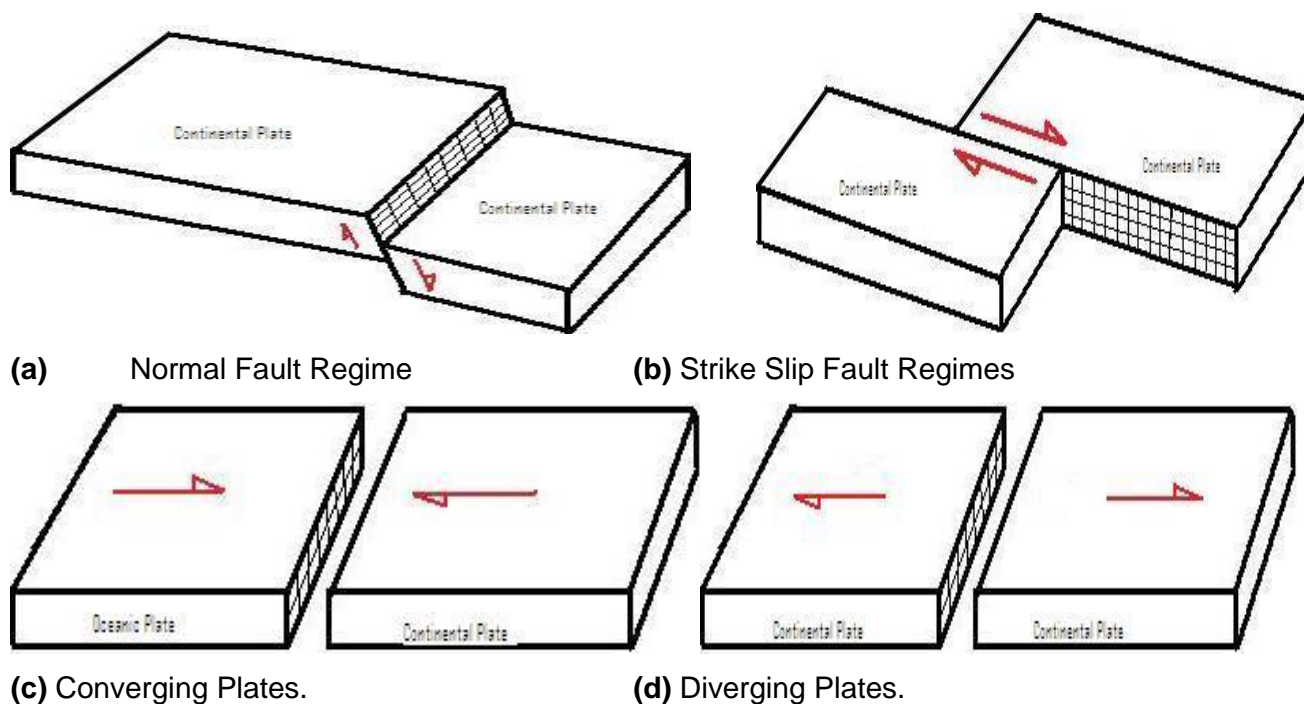
Figure 5. Diagrammatic representation of types of plate margins associated with earthquakes.

past years (and even recently) have been caused by natural geologic processes that are associated with the East African Rift System. The most destructive earthquakes are the ones that are caused / triggered by the movement along faults or fault fracturing (Mdala, 2011). Figure 5c and d are subjected to compression and tension forces respectively. Tension forces cause normal faulting

while compression forces cause reverse faulting. The rift system of Malawi has a normal fault system; this means that it might have been subjected to tension forces that resulted into the formation of the normal faults within the rift (Mdala, 2011). The escarpment to the eastern side of Chiweta Mountains (Livingstonia Basin) and in some areas along the Malawi rift is an indication that the normal faulting of the rift system in Malawi was accompanied by vertical movement / displacement of the adjacent crustal blocks. In some areas along the Malawi Rift, the escarpment is not prominent this might be as a result of denudation forces that might have eroded the escarpment (Mdala, 2011).

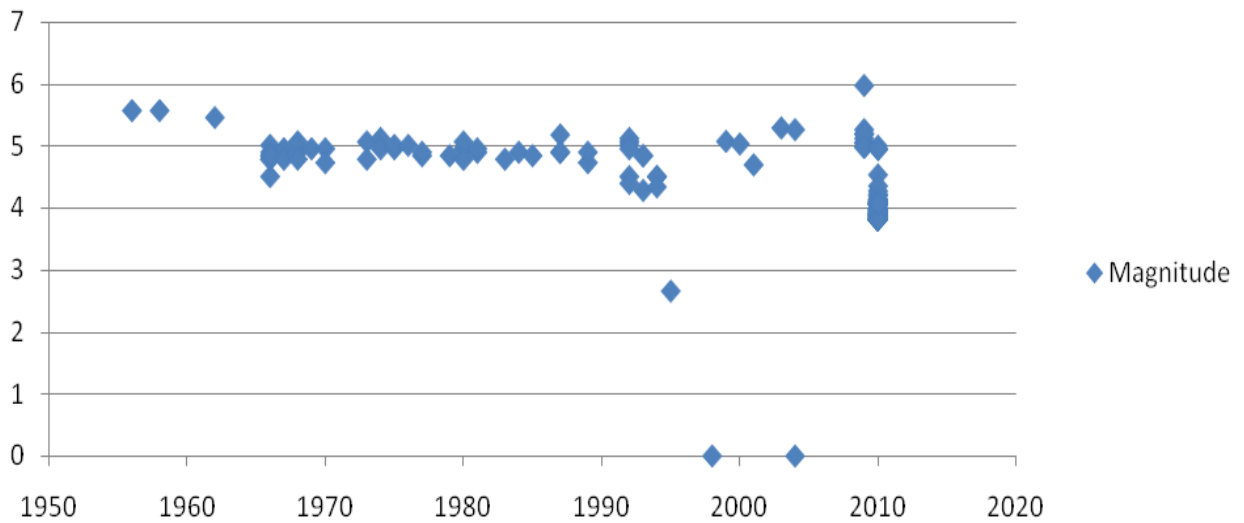
Figure 6. Recorded magnitudes of seismic waves from various places in Karonga from 1956 - 2010 (Potted from data collected from Geological Survey Office - Mzuzu).

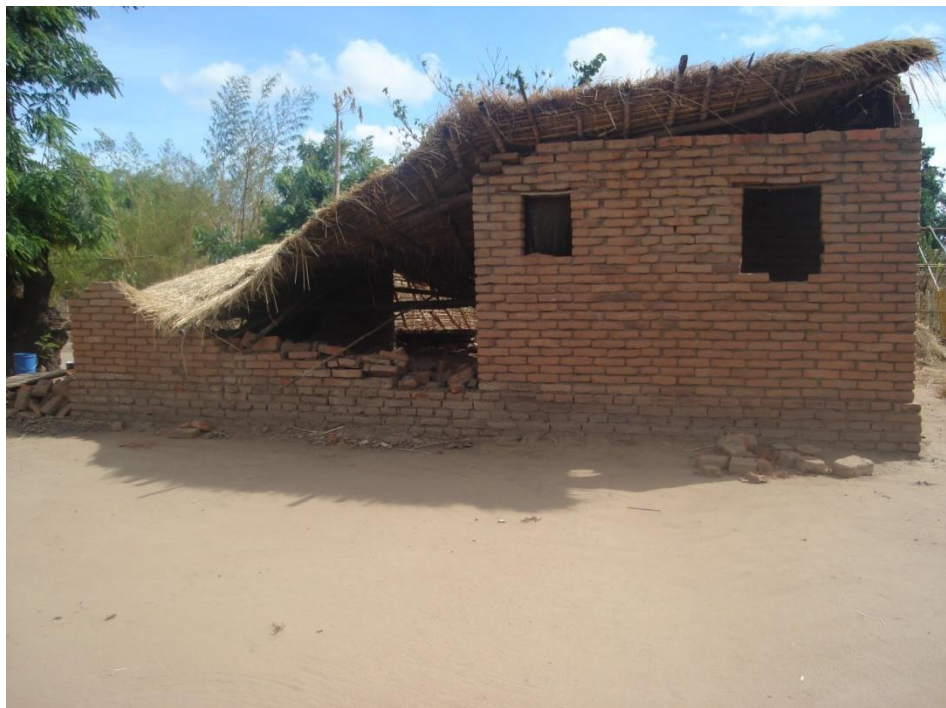
Figure 7. One of the affected houses in Karonga Town-(Picture by Kushe, 2015).

During the 2009 Karonga earthquakes field observation revealed a lot of structural failure which was mainly due to poor construction standards (Figure 7), that is, most of the structures in the area does not follow seismic standards (building codes). This poses a great risk hazard as the occurrence of a high magnitude earthquake in Karonga may result into high property damage and loss of life due to structural failure. Most of the structures / buildings in Karonga are seismically non-resilient and constructed on superficial deposits (Alluvium in Figure 1 and a profile in Figure 3B) which turn to amplify the earthquake shock thereby causing structural failure.

However, evidence on the ground shows that most houses damaged by 2009 earthquakes have low quality construction material which easily fail when earthquakes occur (Richardson, 2011). The process of rebuilding is solely left in the hands of household owners who are often undergoing economic hardships (Richardson, 2011).

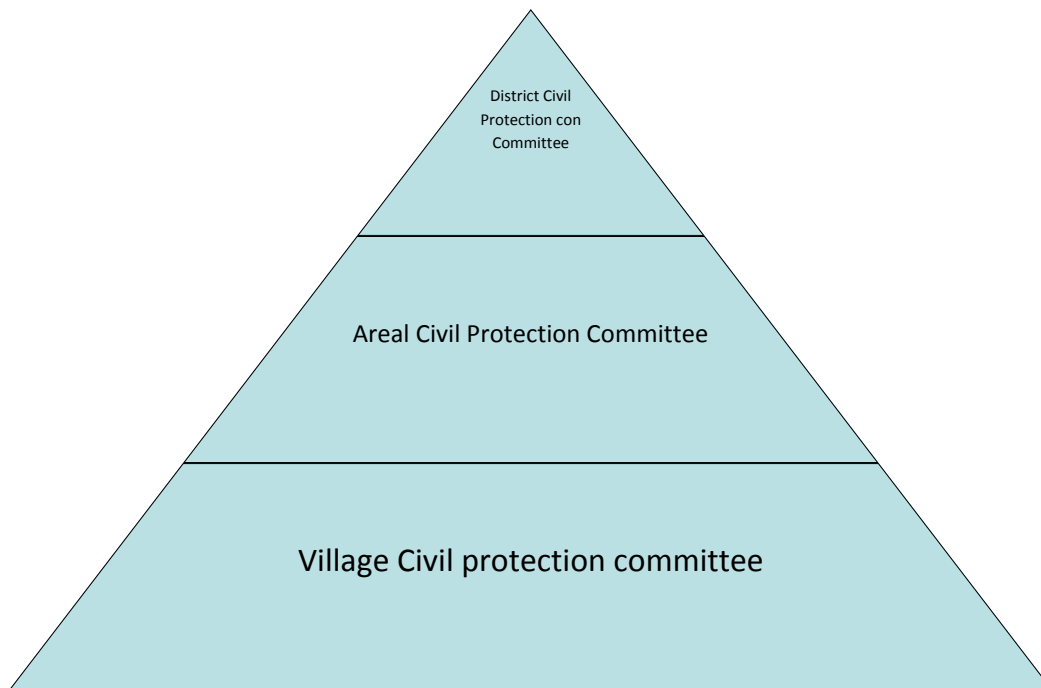
Figure 8. Hierarchy of civil protection committee at district level.

disasters from grassroots at village level which report to area and then district level which report to the national level. The village civil protection committee notes the hazardous events in the communities assess the situation as quickly as possible and report to the areal civil protection committee (Figure 8).

The areal civil protection committee receives reports from village civil protection committee assess the needs of the area reported to been affected by hazards and report to the District civil protection committee.

The district civil protection committee receives reports from the areal civil protection committee and determines the extent of the problem in the district. They determine the numbers of people affected by the hazard and determine the type and amount of support required to alleviate the problem. Such information with recommendations is presented to department of disaster risk management for consideration and support. If the situation is deemed a disaster the declaration is made and resources are pulled to the area.
