Application of Remote sensing/GIS in the Appraisal of Geotechnical Stability of Civil Engineering Structures in Cretaceous Sedimentary Units in Gombe, Northeastern, Nigeria

Abstract

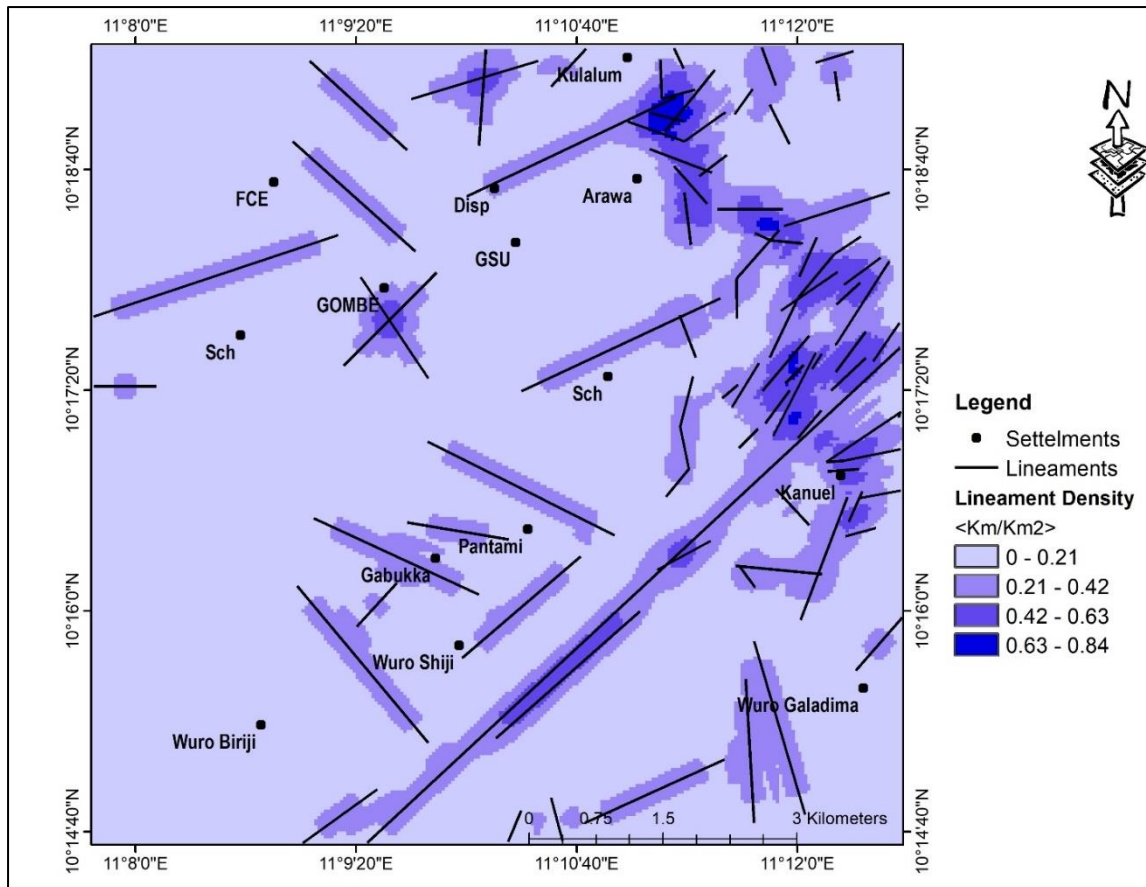
The lineament density in the study area varies from $< 0.21 \text{ km/km}^2$ in most parts of the study to 0.84 km/km^2 in the northeastern and southeastern parts underlain by the basement rocks and the Bima sandstones (Fig. 3). It is worthy of note that the northwestern and the southwestern parts of the study are generally characterised by lower lineament densities and this could be attributed to the fact that the rocks (Gombe and Kerri-Kerri) underlying these were not affected by the Santonian episode. Thus, areas with higher lineament density are classified as having poor geotechnical stability and, hence ranked lowest (1). Consequently, a higher weightage of between 3 and 4 was assigned to areas with low density of lineaments, which are mostly underlain by the Pindiga, Gombe, and Kerri-Kerri Formation.

Fig. 3 Combined lineament and lineament density map of the study area
 By and large, the lineaments ranking based on the structural stability of the rocks increased with decreasing lineament densities as follows: 0-0.21 km/km² (4), 0.21-0.42 m/km² (3), 0.42-0.63 km/km² (2) and 0.63-0.84 m/km² (1).

As can be observed from the lineament map of the study area (Fig. 3), the area is characterised by lineaments arising from the tectonic episodes that have affected the basin in the past. Studies have shown that lineaments can constitute consequential problems to the stability of engineering structures because they represent a zone of weakness in rock and through their association with fault zones, seismic activity, and groundwater flow (Gabrielse and Braathen, 2014; Wang et al. 2022). According to Gabrielsen and Braathen 2014, lineaments represent zones of an enhanced fracture frequency which usually reflects a stress-induced zone of weakness in the bedrock, as exemplified by fracture corridors and faults. Based on the above premise, diligent site investigation and characterization of lineaments in a site is vital for the safety and durability of civil engineering structures. A lineament density map is a measure of the quantitative length of linear feature per unit area which can indirectly reveal weak and permeable zones in a rock (good groundwater potentials) and such zones are detrimental to the stability of engineering structures as lineaments are mostly linked with subsurface fractures faults and faults, which can initiate differential settlement and instability in civil engineering structures (Egwuonwu and Sule, 2012).

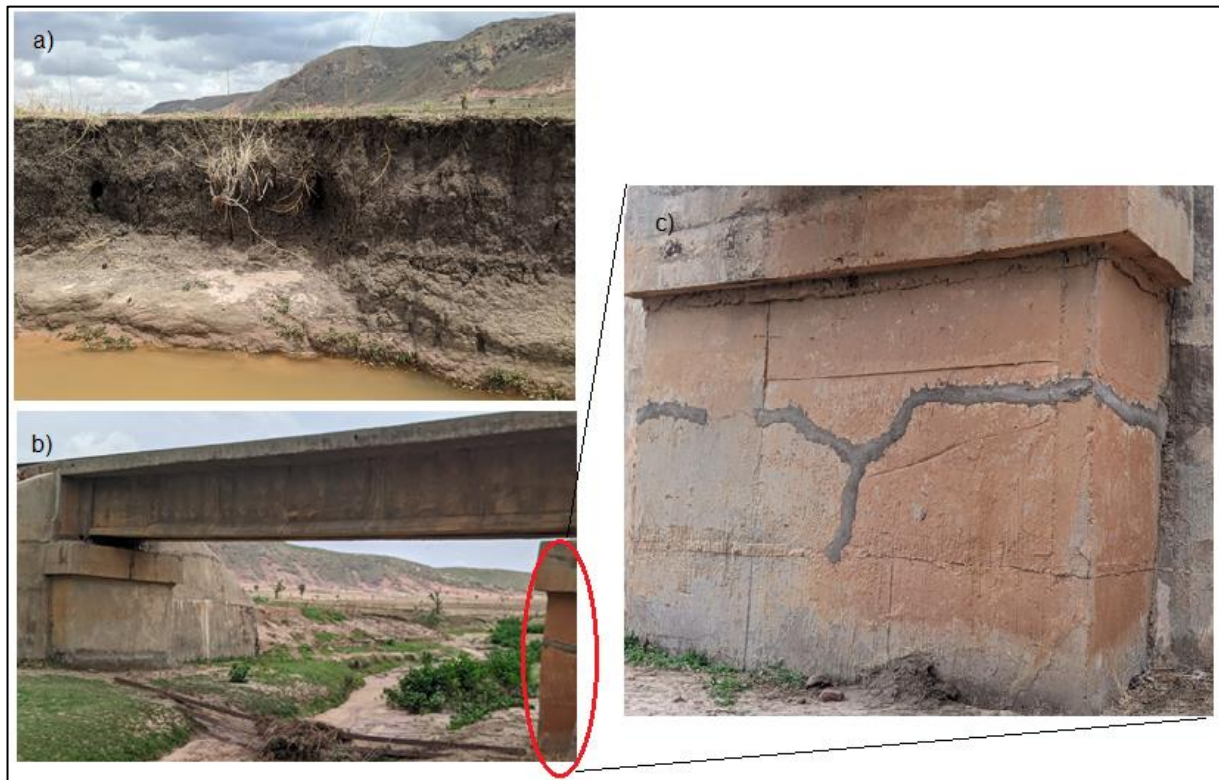
To verify and validate the generated geotechnical stability model on-site inspection of engineering structures in the stud area was conducted. The validation entailed visual inspection of buildings, bridges, and exposed soil sections in the delineated areas. The soils in the unstable zones (Fig. 7a) are generally clayey (black cotton soils) and partly silty or sandy in nature and buildings and bridges in this zone were characterised by numerous cracks as can be seen in Fig 7b. A failed bridge structure was sighted in this zone Fig 7c. This area is generally unsuitable for buildings and other engineering construction works owing to the low bearing capacity and the expansive nature of the clays (Kanawa and Fika members) in the area. According to Egwuonwu and Sule, 2012, structures built on concealed tectonic structures, exemplified by fractures, faults, karst topography, and expansive clays, are liable to fail due to settlement or heaving of subsurface soils. The moderate stability zones that predominate the study area, however, are usually underlain by massive sandstones, bedded sandstones, interbedded sandstones, and sands of the Bima, Yolde, Gombe, and Kerri-Kerri

Fig 7 (a) Weak clays of Kanawa member which underlies the unstable zones, (b) A failing bridge founded on the clays of Kanawa, (c) Enlarged bridge abutment with massive cracks

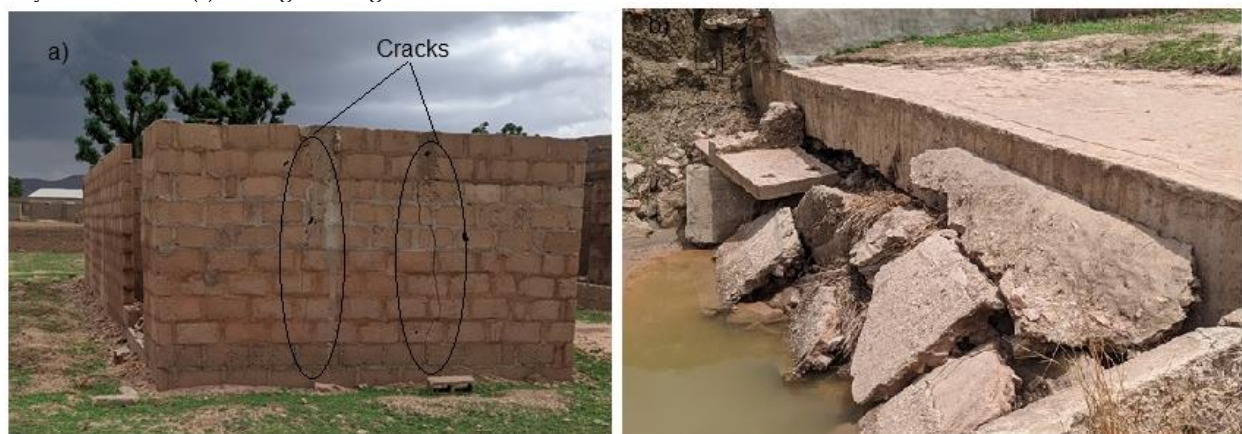
Fig 8 (a) Cracking walls of a new building in the unstable zones, (b) A collapsed bridge founded on the clays of Kanawa.

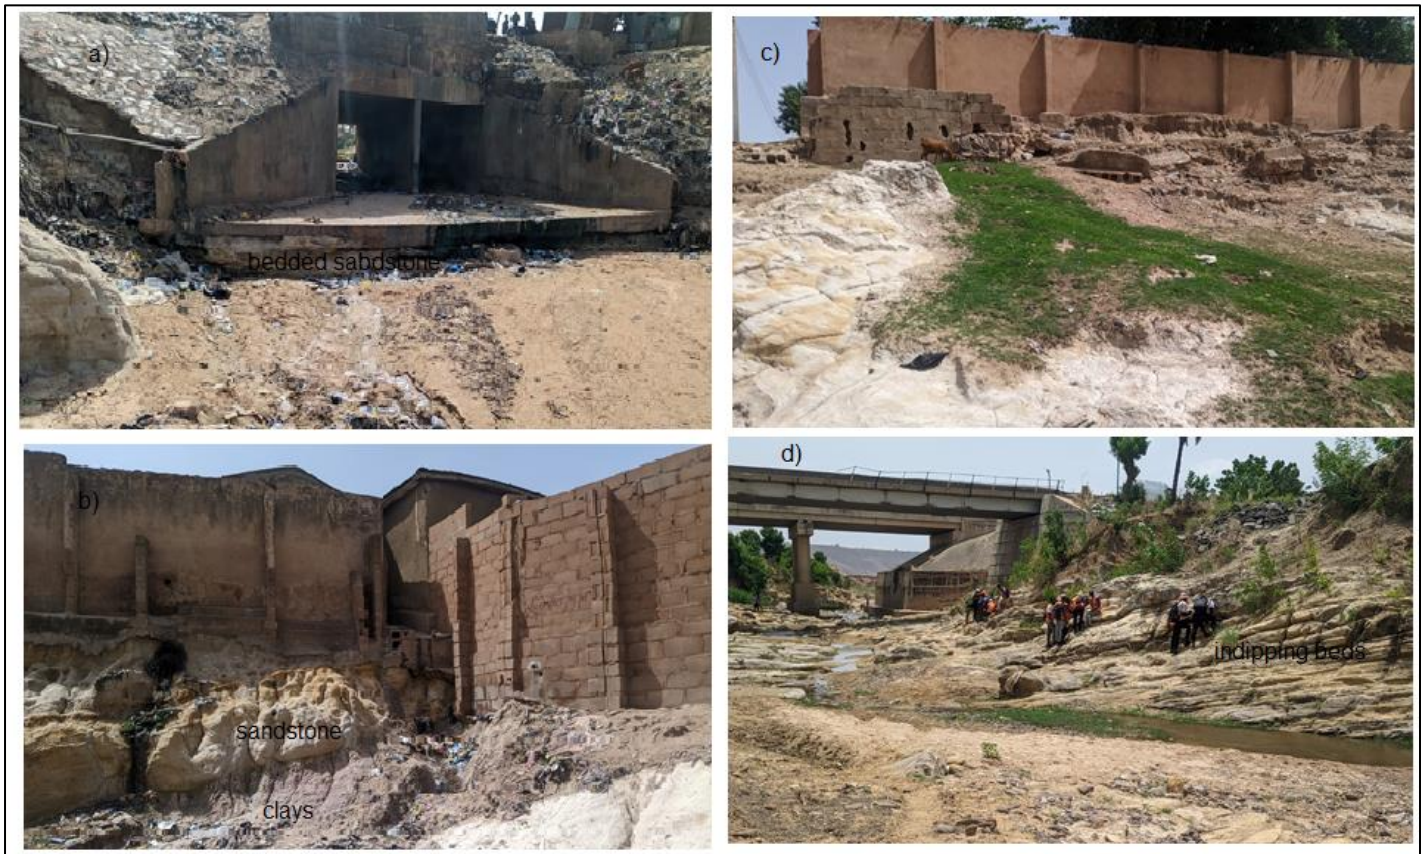
Formations. The stability of the structures in this zone largely depends on the bedrock and surficial deposits in the particular area. Massive sandstone beds provide a modest foundation for structures in this zone, while the stability of structures in areas underlain by interbedded, inclined, or bedded sandstones could suffer a mixed fortune (Fig. 8). It is important to note however, that the moderately stable areas are greatly undermined by the occurrence of gullies in parts of the study area (Fig. 9 and 10). Figure 11 shows buildings devoid of structural cracks in the stable zones around FCE, Gombe. Among the limitations of the present study is the fact that the nature of topsoil and the occurrence of gullies which are both very consequential to the stability of structures in this terrain was not factored.

Fig. 9 (a) Unstable bridge founded on a bedded sandstone foundation, (b) Unstable buildings founded on sandstone with clay interlayer, (c) Stable building founded on massive sandstone, (d) Stable bridge resting on an inclined bed of Yolde formation along Doma Stream

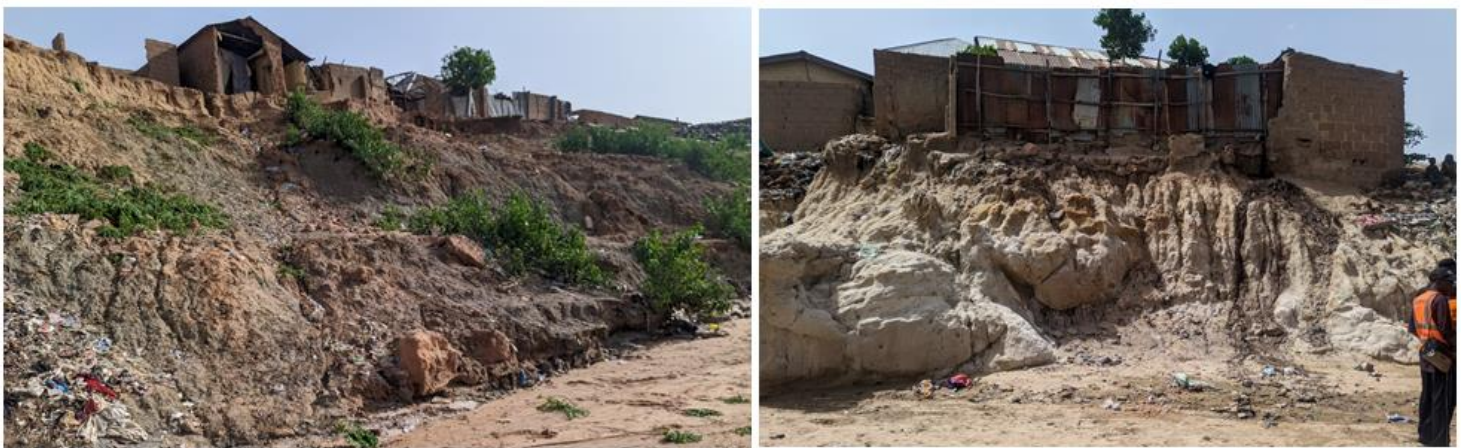
Fig. 10 Gully-induced slope failures in the moderately stable zones along Pantami Stream

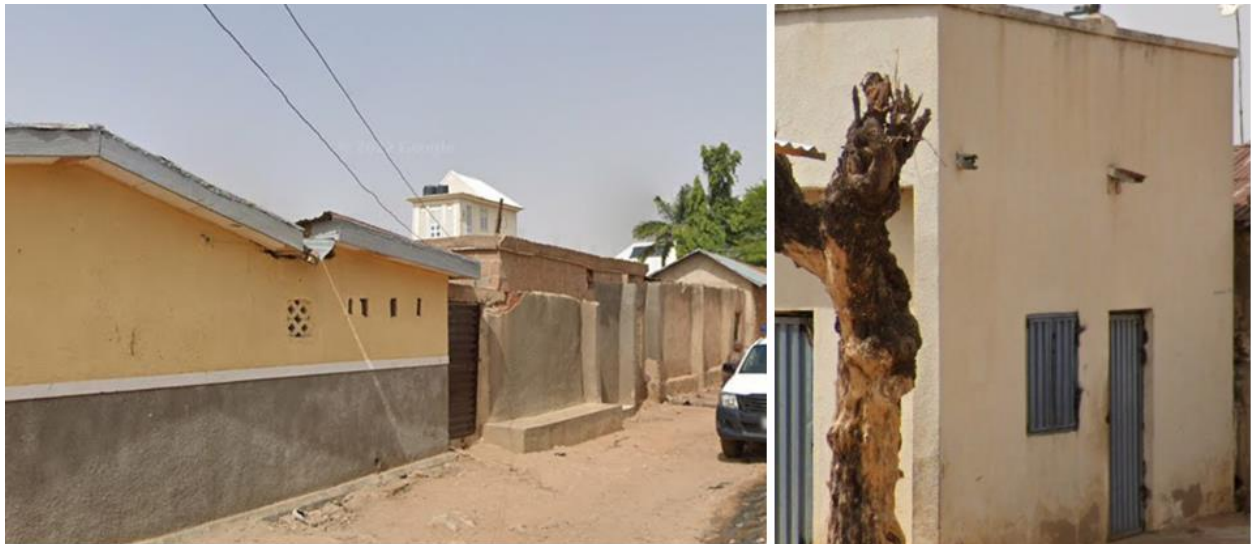
Fig. 11 Buildings devoid of structural cracks in the stable zones around FCE, Gombe
