**MECHANISM OF GULLY-HEAD RETREAT - A STUDY AT GANGANIR DANGA, PASCHIM  
MEDINIPUR, WEST BENGAL**

**\*SHIT, P.K. and MAITI, R.K**

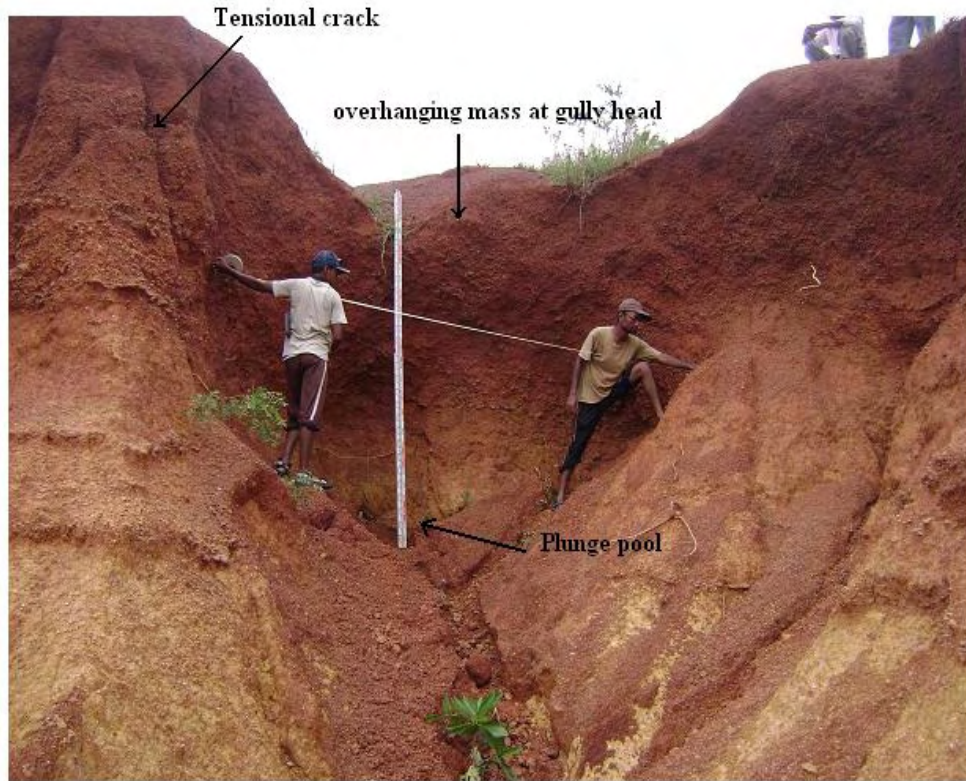
masses collapse later in the season when desiccation cracks develop from their base up to the ground surface. Bradford and Piest, (1985) investigated that basal headcut failure occurs due to collapse of the overhanging mass (Figure 4).

Figure 4 Overhanging mass at gully head, tensional crack and plunge pool

plunge pool erosion, destruction flutes followed by debris erosion, or undercutting of flutes by concentrated flow accelerate wall failure (Oostwoud Wijdenes *et al.*, 2000; Collison, 2001; Vandekerckhove *et al.*, 2001; Poesen *et al.*, 2002; Martinez-Casasnovas *et al.*, 2004). Tension cracks would develop between 30 and 50 cm upslope from the gully-head or gully-wall when desiccation and tension stresses play in combination and the condition would increase the through-flow velocity in the gully-head or gully wall, promoting collapse (Figure 4).

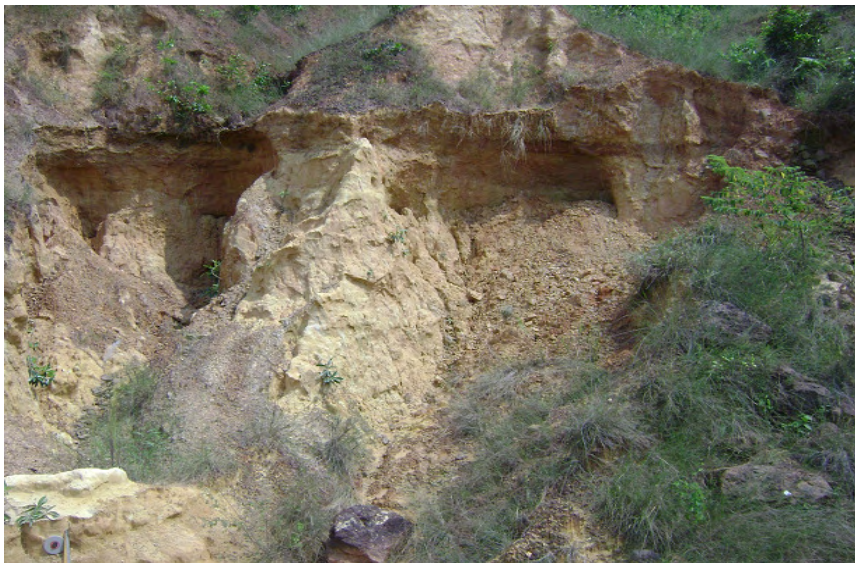
Figure 5 Alcove resulting from basal gully headcut failure in July, 2011. Note the displaced pedon resting at the base of the headcut, the seepage face on the headcut, and the overhanging slope on the top half of the headcut

The entire 23 sample gully heads registered remarkable retreat head ward (Table 2). Rate of retreat depends largely on the instability factors operating at each head. Instability results due to interplay of height, gradient, pressure of tension crack, depth of tension crack, angle of internal friction etc. Gully head B2, P1 and K33 registered maximum headward retreat due to more height and gradient. The gully heads like K7, K28, K23, S2, P33, P6 showed maximum height and slope, but could not attain maximum retreat. Instead of having maximum linear retreat, gully head B1, P1 and K33 did not register maximum area extension, as the circular dimension of alcove on gully face is restricted. Thus no linear relation could be established between these factors and gully head erosion (Table 1 and 2). A complex interplay among these factors occurs and a further detailed study is required to understand the relative importance of any of these factors (Figure 5).
