CASE REPORT**Spectrophotometric Evaluation of Crown Fragment a Year After Reattachment Using Fiber-Reinforced Post: A Case Report**KÜÇÜKEKENCİ FUNDAOĞLU Funda^{1*}, KÜÇÜKEKENCİ Ahmet Serkan²**OPEN ACCESS**

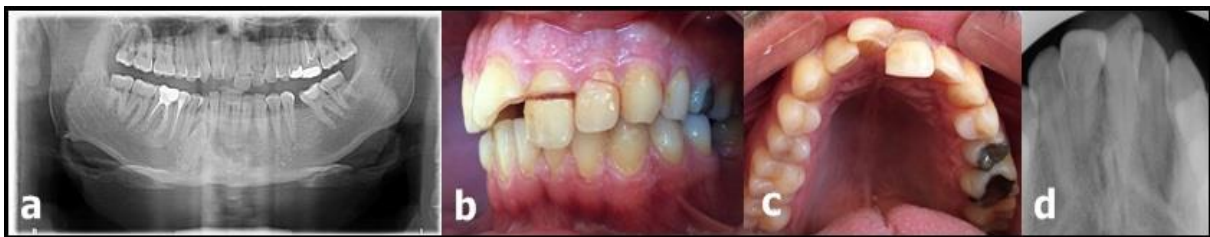
maxillofacial examination indicated that the maxilla and the mandible were intact (Figure 1a). Intraorally, examination revealed a complicated crown-root fracture of the left maxillary central (#21) and lateral incisor (#22). Moreover, the incisal one-third of the right maxillary central incisor (#11) was fractured, but the tooth presented slightly tender to cold and physiological mobility (Figure 1b). The diagnose was a noncomplicated crown fracture with hypersensitive dentin for 11. The maxillary left lateral incisor had a fracture horizontal on the buccal, 1 mm above the gingival margin and the central incisor had a fracture horizontal on the buccal, 3 mm above the gingival margin. A fracture extending from the buccal area to the subgingival space of the palatal area with pulpal exposing was observed in both the central and lateral teeth (Figure 1c). The incisal fragments had severe mobility, and during functional stress, the pain increased because of this mobility. A periapical radiograph indicated the crown of 21 and 22 with fracture track lengthening subgingivally, and the periapical side and the root structure were seen to be healthy (Figure 1d). This was diagnosed as a case of complicated crown-root fracture with irreversible pulpitis for 21 and 22.

Figure 1: (a) Preoperative panoramic radiograph showing intact maxillar and mandibular bone, (b) photograph of 21 and 22 have complicated crown fracture and 11 has noncomplicated crown fracture, (c) photograph of horizontal fracture track was lengthening the subgingival space on the palatal area, and (d) periapical radiograph showing healthy of periapical structure

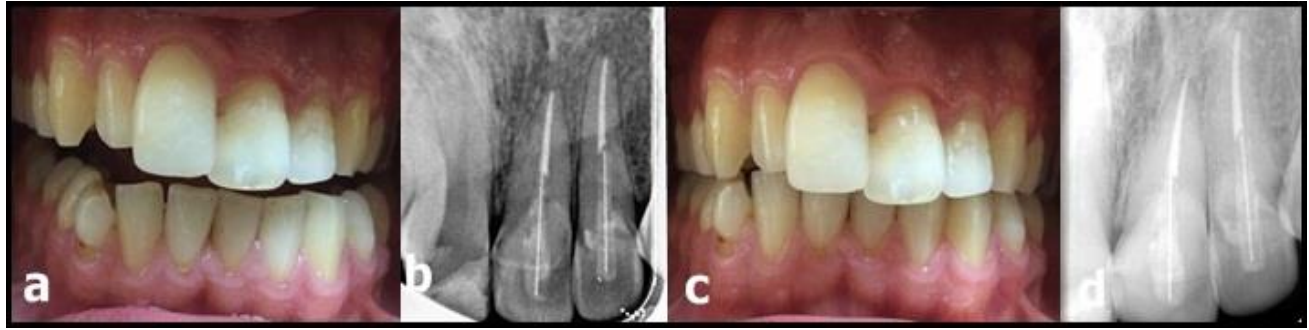
The patient was recalled after six months and one year. On clinical examination, 11, 21 and 22 were asymptomatic with satisfying aesthetics (Figure 3a, 3b). The maxillar right incisor was vital. On periodontal examination, gingival tissues had normal structure and normal contouring with 2 mm pocket. The intraoral periapical radiograph indicated healthy tooth structure with unspoiled lamina dura (Figure 3c, 3d).

Figure 3: (a) Photograph of six months follow up, (b) 6 months follow up with radiographically, (c) photograph of 1-year follow-up and, (d) 1 year follow up with radiographically

If ΔE is greater than 3.46, there is perceptible and nonacceptable color change; a value of ΔE 1.8 and 3.46 represent clinically perceptible but acceptable color change (7). In this case presentation, ΔE was obtained to be 2.76 for the left lateral incisor, and ΔE was obtained to be 2.41 for the left central incisor. The meaning is that there is clinically perceptible but acceptable discoloration.
