Assessment of Seismic Survey Line Cutting on Mangroves in the Kalabari Region of River State, Nigeria

Seismic survey line cutting is a common practice in the oil and gas industry. This research, in the Kalabari region of River State, Nigeria, assessed the impact of seismic survey line cutting on mangrove ecosystems from 1996 to 2012/2013. Employing field surveys, visual on-spot analysis, and mathematical calculations, the study showed a significant increase in mangrove tree densities in newer lines, indicating potential facilitated access for harvesting. T-test analysis demonstrated a statistically significant variance in mangrove tree densities cut between the old and new lines. The study reveals that cuts made in 1996 still had visible impacts in 2013, indicating long-term nature of the damage. The surveyed area was divided into grids for assessment, totalling 333.97 km², with 4.18 km² impacted by seismic line cuts. The findings suggest that 13 square metres of mangroves were destroyed per square kilometre due to these activities, highlighting significant harm to the ecosystems. Understanding these impacts is vital for effective conservation and sustainable management practices.

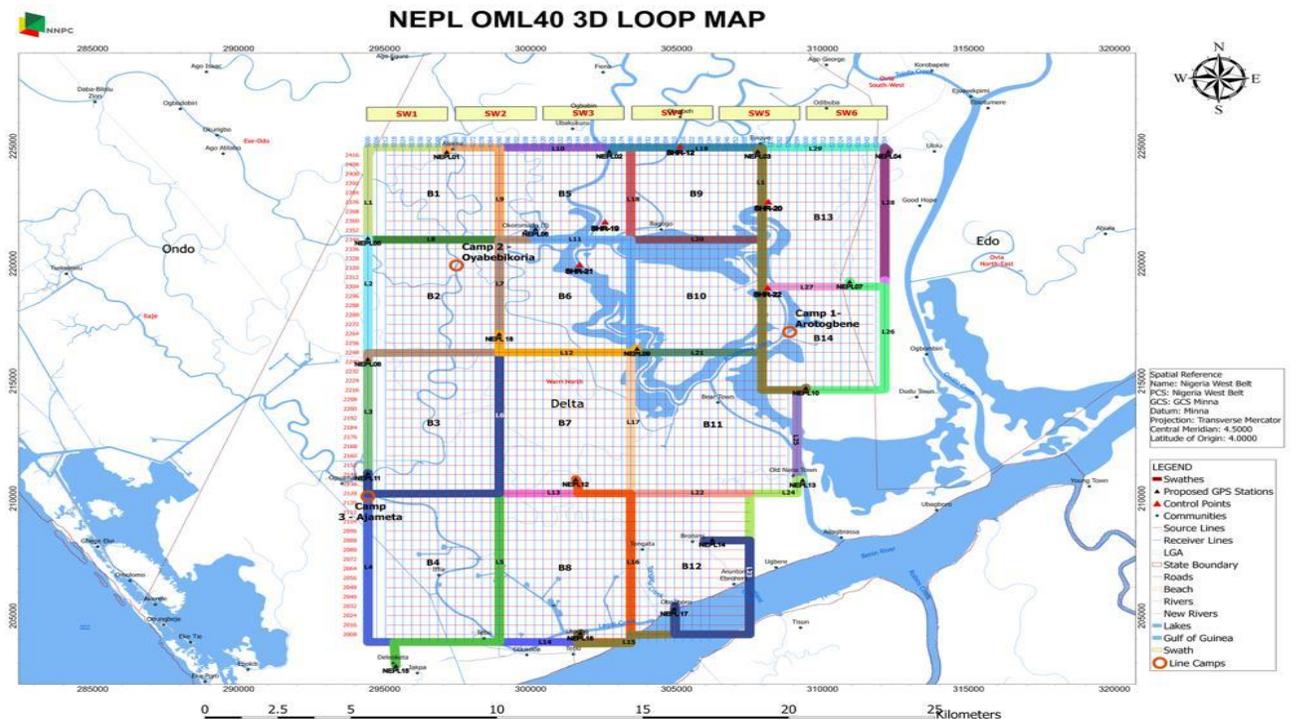
Figure 1: Area of prospect used for the study (BGP/CNPC, 2012)

The study area is located in Oil Mining License (OML) 40, covering parts of four local government areas (Akuku-Toru, Asari-Toru, Degema and Emohua) of River State, Nigeria. The prospected regions lie within longitude 475000E-490000E and latitude 65000N-95000N, with an estimated area of about 331.97km² (Figure 1).

For the prospect, the area was gridded into 41 vertical lines (receivers) and 77 horizontal lines (source). The distance between a receiver line to the next one was 350 metres while the distance between a source line to the next was 400 metres (Figure 1). Also, the distance apart from one geophone peg to another was 50 metres and deep hole drilling of 45 metres was used. Line width varies between 1 and 2 metres. The lines must be of sufficient width to safely transport man-portable drills, cables and equipment along their length. For 3D seismic operations shot points or holes are drilled with man-portable drills of depths ranging from 10 metres to 20 metres. Figure 2 shows a fresh 1.5m wide cut and cleansed seismic line.

The prospected area of study was gridded into 41 parallel receiver lines of 30.40 km each and 77 parallel source lines of 10.92 km each (Figure 1)

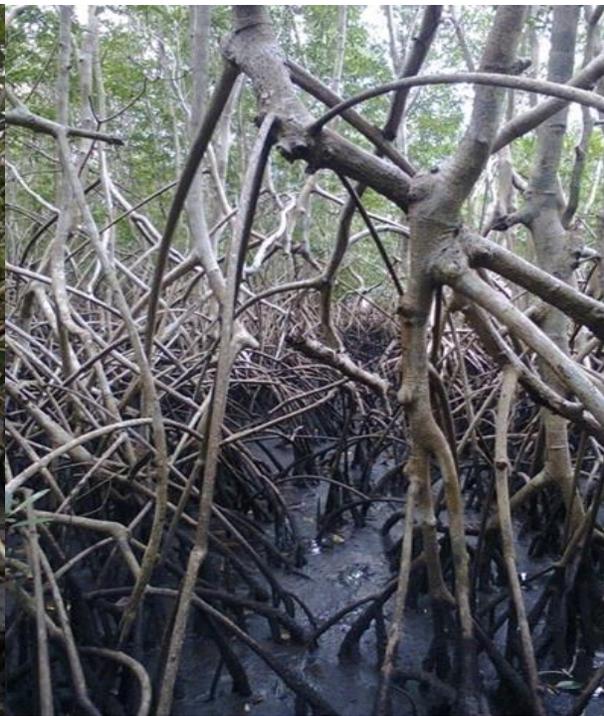
Figure 3: A seismic line of 1996

laid detonators, possibly travelling the lines more than once to resolve problems; and, after firing, removal crews (10) cleared the area of equipment. Figure 3 shows a seismic line where all seismic survey parties have worked.

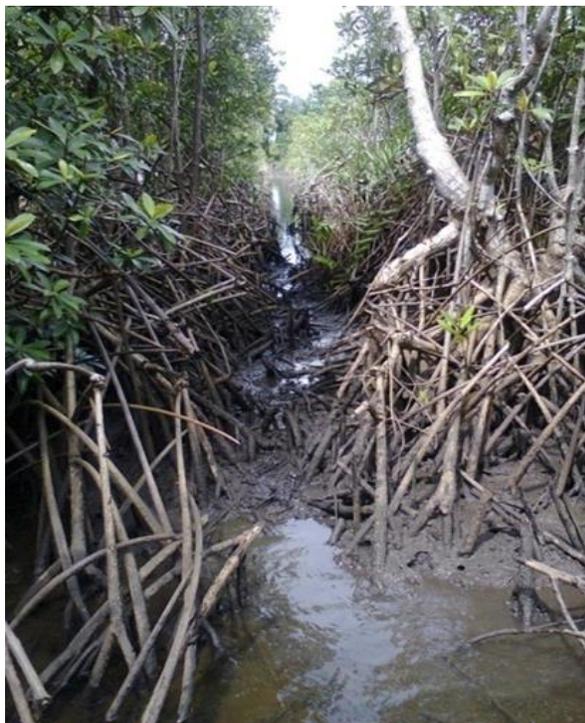
Figure 4: A worked upon seismic line in 2013

April 2013. Figures 2, 4 and 5 show the cleared lines of August 2012, January 2013 and April 2013 respectively. The seismic lines studied have length of 30.40 km for the receivers and 10.92 km for the sources. These lines cut across numerous creeks and speed boat was used to ferry the crew members across the creeks. Some parts of the lines chosen were closed to fishing camp communities while others were far from human settlements. The study area was reached in speed boats and work was carried out on foot using the seismic lines. Each seismic line was traversed by at least six separate work crews (minimum crew numbers are given in brackets): surveyors and line cutters (8) carrying a Total

of trees, can lead to increased tidal flushing, which slows down mangrove recruitment; seedlings are washed away before they become established if the soil lacks stability (Kaly *et al.*, 1997). The seismic line exposes the soil (Fig 4) to flushing which can also result in reduced levels of nutrients (Kaly *et al.*, 1997; Alongi & de Carvalho, 2008), and research on the effects of nutrients on *Rhizophora mangle* seedlings shows that phosphorous is a limiting factor in seedling development and, even when present, water-logged (Figure 3) and anoxic soils render it ineffective (Koch and Snedaker, 1997). This suggests that it may be necessary to artificially maintain soil profiles and increase nitrogen and phosphorus levels in damaged systems to aid their recovery (Kaly *et al.*, 1997; Alongi and de Carvalho, 2008).
