# CORROSION OF X60 STEEL INFLUENCED BY IRON OXIDIZING BACTERIA (*LEPTOTHRIX DISCOPHORA*)

A. RIM-RUKEH and Y. T. PUYATE

## ABSTRACT

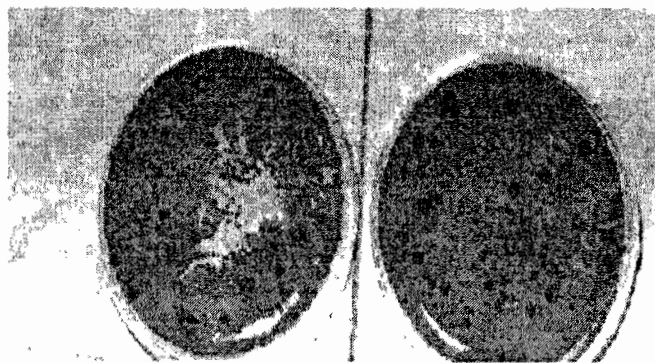
Fig 1 Colonized *Leptothrix discophora*

The culture medium used in the experiments contained (per litre of distilled water) 0.5g  $\text{NH}_4\text{NO}_3$  (ammonium nitrate), 0.5g  $\text{NaNO}_3$  (sodium nitrate), 0.5g  $\text{K}_2\text{HPO}_4$  (potassium hydrophosphate), 0.5g  $\text{MgSO}_4 \cdot 7\text{H}_2\text{O}$  (hydrated magnesium sulphate), 0.2g  $\text{CaCl}_2 \cdot 6\text{H}_2\text{O}$  (hydrated calcium chloride), 10g ferric ammonium citrate, and 10g Agar powder. The pH was adjusted to 7.0 – 7.2 by the addition of 50ml of 1M NaOH solution. The culture medium was autoclaved at 121°C and a pressure of  $1.2 \times 10^5$  Pa. After sterilization, the medium was allowed to cool to room temperature before dispensing into 2 (two) petri dishes (see Fig. 1).

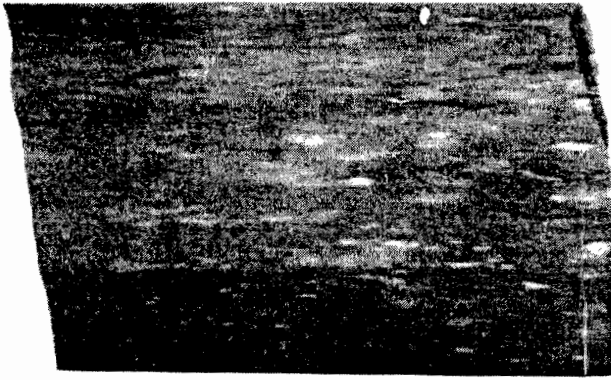
Fig. 7: Photograph showing pits on the surface of coupon retrieved from batch reactor 1 after 84 days.

Laboratory analyses on corrosion of X60 steel coupons immersed in formation water inoculated with iron-oxidizing bacteria (*Leptothrix discophora*), and without the bacteria, have been presented. It is shown that *Leptothrix discophora* increases the rate of corrosion of the metal by about 123 percent, and the corrosion of X60 steel in the presence of the bacteria follows a first-order kinetics. MIC (in the presence of *Leptothrix discophora*) results in the formation of patchy biofilm on the metal surface which may be attributed to differential aeration of the surface.

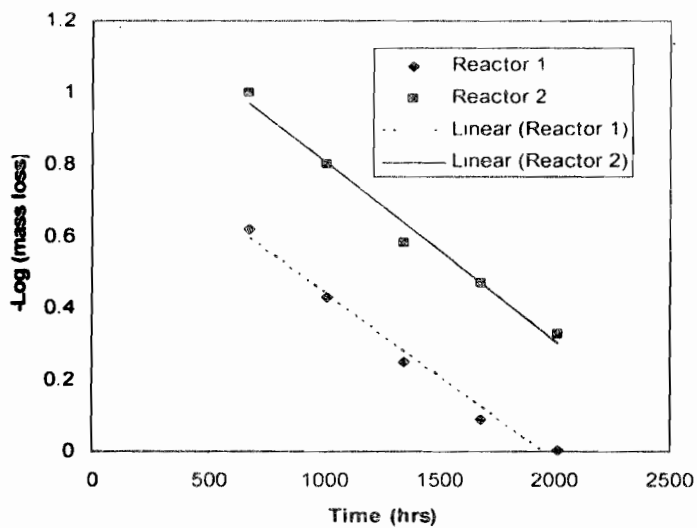
Fig. 9: Plot of Log (mass loss) of coupon against time.

where  $k$  is a proportionality constant that depends on the conditions in a specific environment. Figure 8 shows increase in mass loss of the coupons in both reactors with time, which is more pronounced in reactor 1 than reactor 2. The corrosive aggressiveness in reactor 1 is due to the presence of *Leptothrix discophora*. It may be seen from the trend lines in Fig. 8 that  $k = 0.0006$  (with an error of about 18%) in reactor 1, and  $k = 0.0003$  (with an error of about 10%) in reactor 2. When the log of mass-loss is plotted against time for both reactors, an approximate linear relationship is obtained (see Fig. 9), confirming a first-order chemical reaction between the microorganism and the metal. This method of using a linear relationship between log of mass-loss and time in determining the order of a reaction is reported in the literature (Jones, 1988; Omo-Odudu and Oforka, 1999; Rim-Rukeh, 2005). It is interesting to observe from Fig. 9 that, the condition in reactor 2 also conforms approximately to first-order kinetics, indicating chemical reaction between components of the formation water and the metal.
