MASS WASTING IN SONG AREA OF THE HAWAL BASEMENT, NE NIGERIA

N. E. BASSEY

ABSTRACT

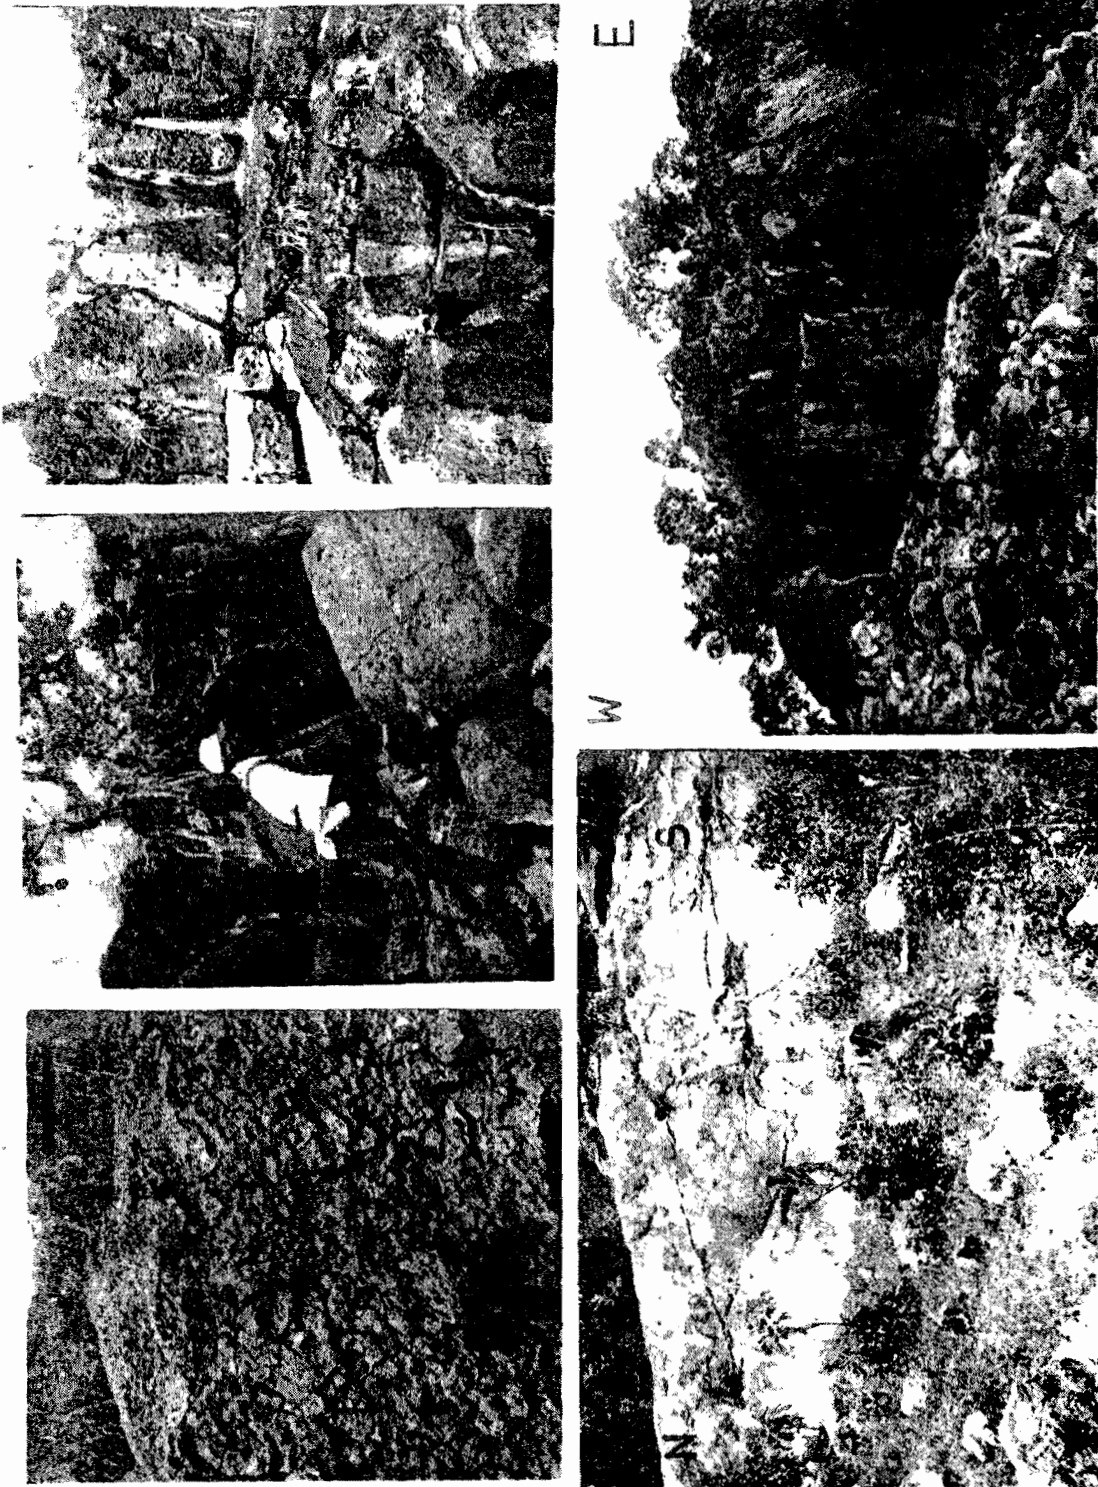
Plate 2B: Top left; part of an aplite intrusion at old Wuro Yakubu quarry. Middle and top right photographs show exposures of basalt along River Murchumchi channel. Bottom photographs show N-S and E-W trending fault planes in Song area.

Granites occur as intrusives in the gneisses. They occur as bodies of considerable sizes with lithological variations including aplite and amphibolites. Plate 2B (top left) is a field photograph of part of an aplite intrusion in the area. Exposures of aplite and amphibolite are found in the abandoned quarries at Wuro Yakubu and Vande Sawim hill. The granites are generally coarse grained and compact, outcrops are found at

study area Plate 2B (top middle and right) are field photographs of basalt exposures along Murchumchi river channel. The basalts are generally vesicular in texture and the amygdaloidal variety is common

Fourteen faults were observed during field mapping exercise. Only the major ones are shown for the purpose of clarity on the geological map of the area (Fig. 1). Two outcrops of fault planes in granites are shown in Plate 2B (bottom). The recognition of the faults was done following some criteria described by Billings (1972), and Hobbs et al. (1976). They
