# INFLUENCE OF GEOLOGY ON PAVEMENT PERFORMANCE: A CASE STUDY OF SHAGAMU-BENIN CITY ROAD, SOUTHWESTERN NIGERIA

T. K. S. ABAM, C. C. OSADEBE and G. N. OMANGE

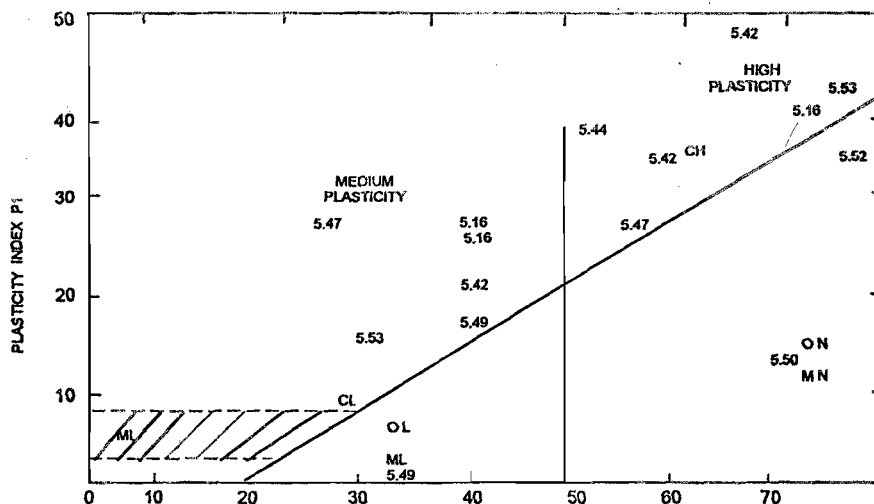
Fig. 7 Distribution of Plasticity characteristics of the soils

The soils classify mostly as sandy silt, clayey silty sand and clayey soils (MH, SC and CH) respectively based on the Unified Soil Classification System (USCS) and A-2 to A-7 in the AASHTO classification system (Table 3). A representation of the plasticity characteristics of the soils in the Casagrande plasticity chart (Fig. 7) show that they mostly fall above the A-line, indicating that they consist predominantly of inorganic materials. The degree of scatter on the plasticity chart reflects the degree of variability of the soils, particularly in clay types and percentage content of fines. The proportion of clay sized particle ranges from 15% to 77%. The percentage clay tends to be higher in the sub-grade materials that experienced widespread and severe pavement failure especially in the Ondo State section of the road.
