RECURRENT LANDSLIDES OF LAGAM ESCARPMENT, KABEN LOCATION, MARAKWET EAST, KENYA

KIPKIROR JEPKEMBOI LOICE, KIPSANG BERNARD ROP AND WYCLIFFE HABEL NAMWIBA

ABSTRACT

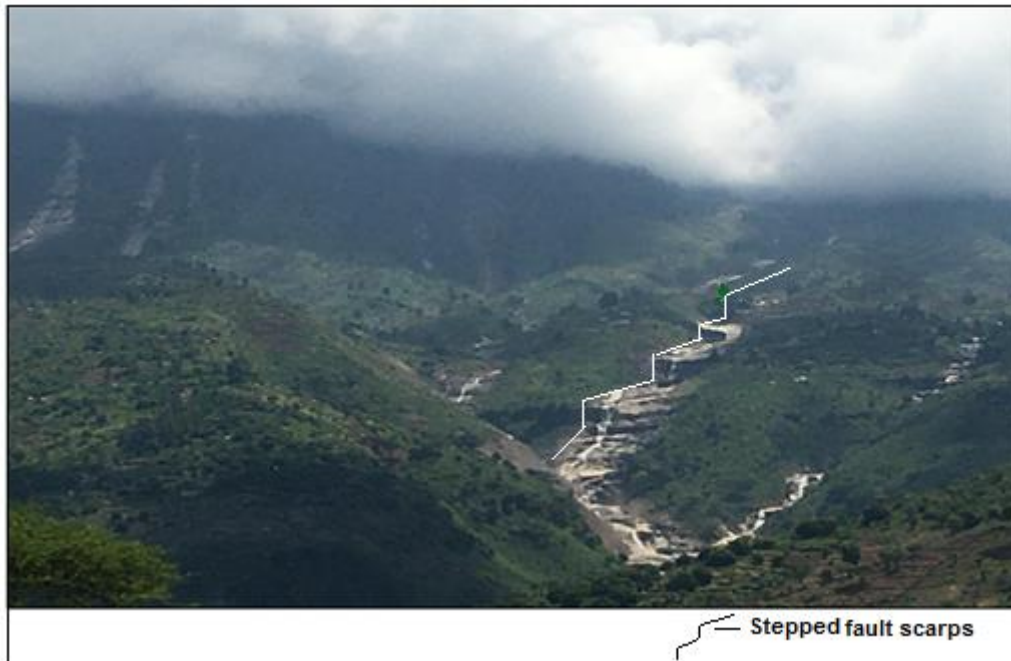
Plate 1: Emboreberwo and its post-landslide flow (April 2020).

Marakwet sections of the Kerio escarpment, to the west. Downstream, they become River Chesegeon. The mudslides left massive scars on the escarpment and rock trails, on the river valleys and farmlands from which local residents draw their livelihood. There were some mudslides at Kipchumwa location as well. Cracks have been reported on parts of Katilit and Kipchumwa, indicating that the landslide problem in the Lagam escarpment may not be over and could be spreading to other areas, outside Kaben location. Furthermore, step faulting may have enhanced the landslides in the area. Plate 1 show the step faults that appear to consist of normal faults and the rock that makes up the escarpment can be clearly seen from Plate 1.

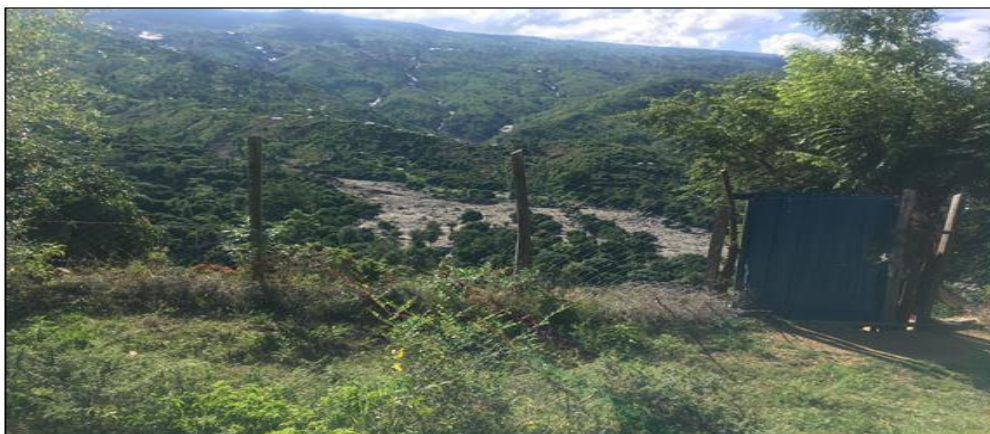
Plate 2: Farmlands washed away by the Lagam escarpment mudslides and Embosumer River on its lower section (April 2020).

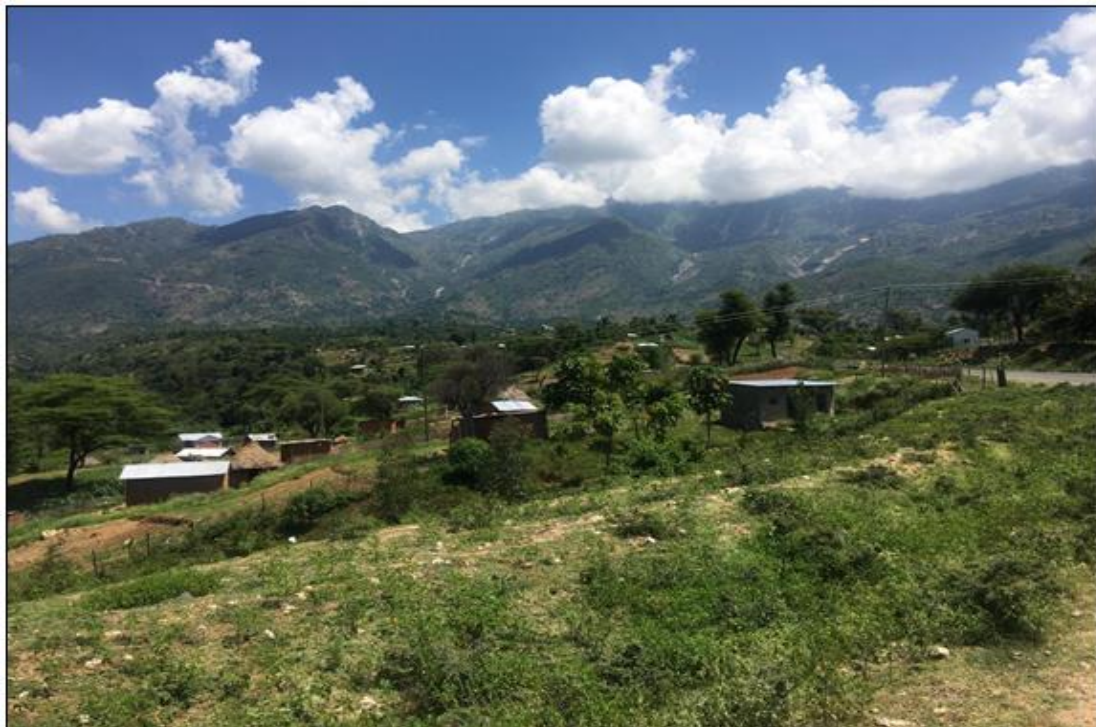
Plate 5: The landslide areas, Wewo Hill and Katilit -viewed from Sambalat (April 2020).

besides instigating landslides. The image and pictures represented by plates 4 to 6 depict geomorphological characteristics of the Lagam escarpment, together with

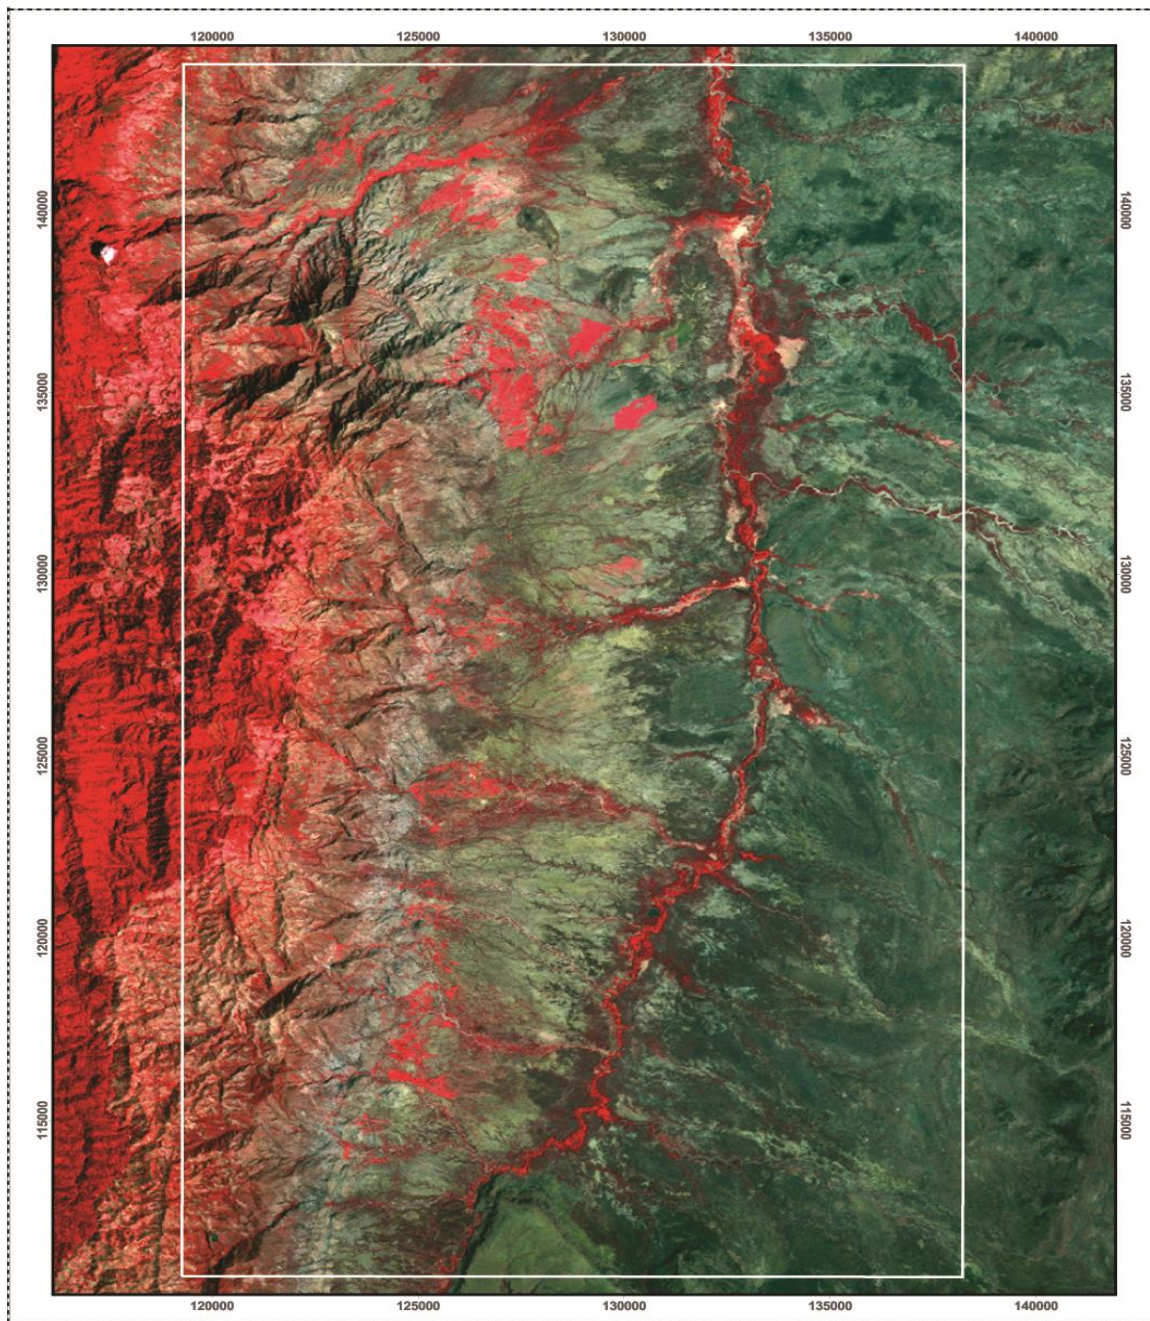
Plate 8: Kerio River regime in 1986 (Kipkiror, 2008)

Landsat Enhanced Thematic Mapper Plus (ETM+) False Color Composite (FCC) of Bands 2,3 & 4 of Image ID PATH 169 ROW 059 dated January 1986 depicting stream and river regime.
Resolution - 28.5 meters

In the 1986 satellite image (Plate 8), the Embobut forest and the Lagam escarpment have rich plant canopies (deep red) and most of the escarpment rivers were shrouded in vegetation. The rivers reaching Kerio River, from the escarpment, were also more. The image shows about 8 countable rivers that had vegetation on their courses, as they wound their way into the Kerio River. Also, from the image, the large rivers appear to have had many tributaries that, themselves, had vegetation on them. The study area's rivers display a dendritic drainage pattern, separated by raised and semi bare divides and interfluvies. The rocky areas (grey areas) of

the escarpment, in the 1986 image, also appear to be less widespread compared to the rocky areas shown by the 2000 image. In the 2000 image (Plate 9), the vegetation cover appears to have thinned immensely, both on the Lagam escarpment and in the Embobut forest- as shown by the lightness of the red colour in the two areas. The rivers reaching Kerio River, from the escarpment, also appear to have reduced to 5, with some becoming seasonal. The rivers to the south of the area, covered by the image, have sand and rock trains on their beds-appearing whitish on the image. The rivers joining Kerio River, from the East, appear to have had some headwaters in 1986 (evidenced by vegetation) but

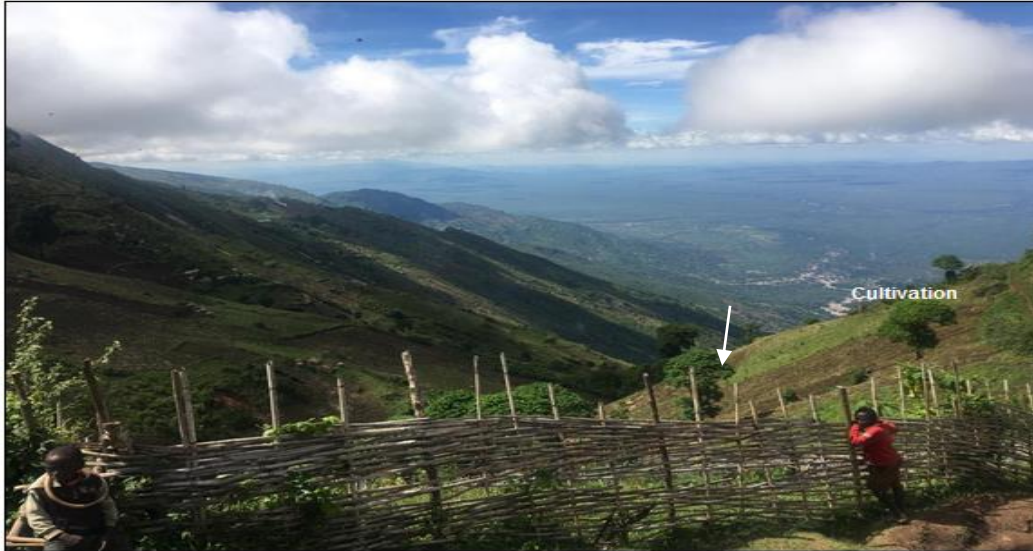
upland plateau, shows a section of the Embobut forest that has been mowed down, to pave way for agricultural land.

Plate 10: A section of the Embobut forest, adjacent to the Lagam escarpment (April 2020).

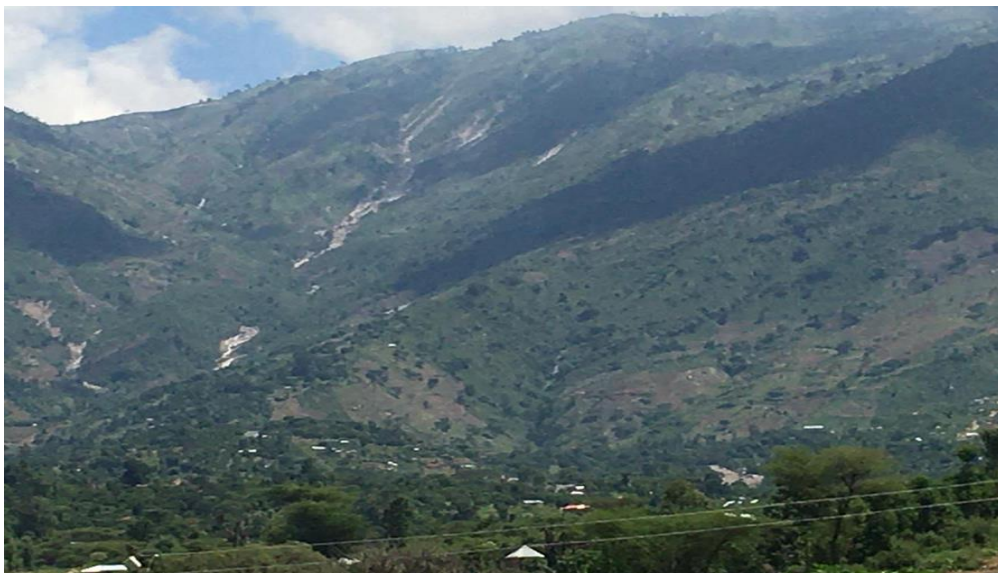
The clouds hanging on the area shown by the Plate 11, evidence the cool climate of the upland plateau. The bamboo twigs that make up the screen fence (Plate 16) do not only provide proof of deforestation of the Embobut forest but testify of the nearness of a bamboo forest. The picture also shows an elongation of the Lagam escarpment into the lower reaches of the upland plateau, besides showing landslide scars, poor farming practices (slash and burn agriculture) and a washed out Chesegon area.

Plate 11: Settlement and cultivation on the Lagam escarpment (April 2020).

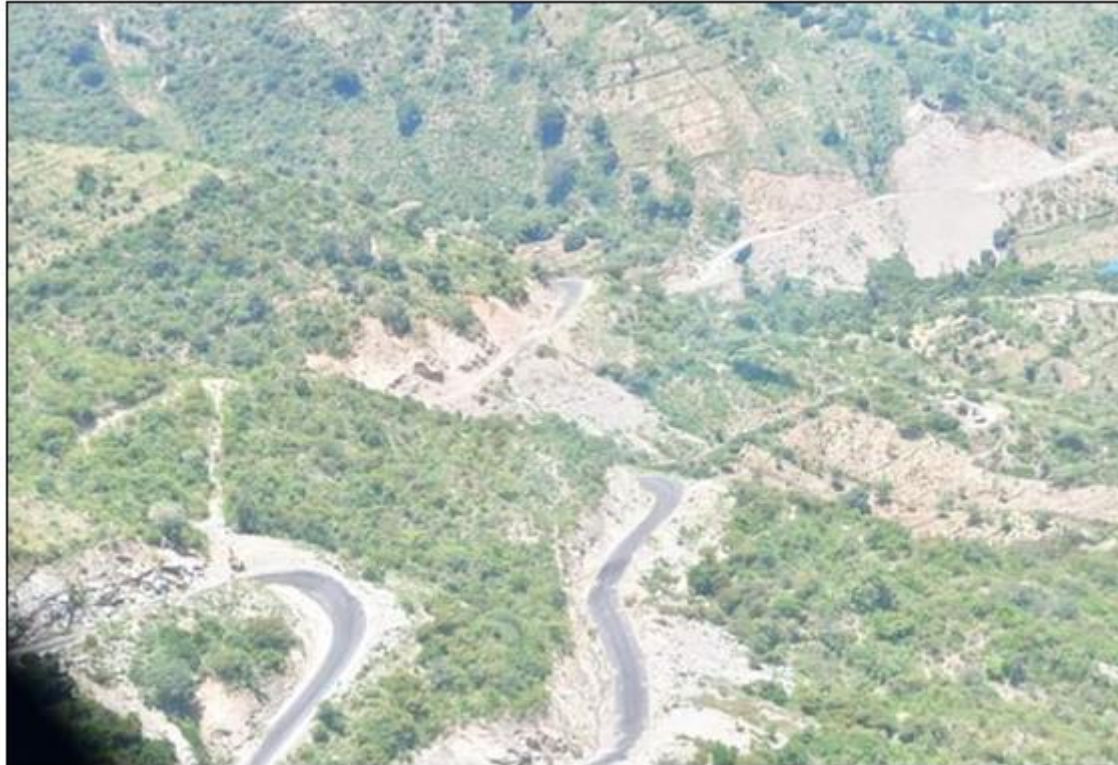
localities. Plate 12 shows a road section on the Lagam escarpment. The road shoulders are not only steep, but loose. Deforestation and dangerous farming, on the escarpment, is also evident on the upper parts of the area shown by the photograph. The photograph also shows road instigated landslides. In 2019, a family of four were killed by a landslide that originated from a road above their house, when heavy rains hit Tuturung area of Marakwet East.

Plate 12: A section of a road on the Lagam escarpment.

Landslides on the Lagam escarpment are also experienced in areas where roads cut deep into the slopes. Road network, in the area, is still on high demand but the hanging road shoulders should be effectively steadied and stability measures applied on them, so as to guard against landslides. The escarpment road shoulders slide onto the road or down the escarpment, from the road surfaces at several
