# ASSESSMENT OF PEDESTRIAN MOBILITY ON ROAD NETWORKS IN THE CITY OF KIGALI

DAVID NKURUNZIZA AND DR. RAHMAN TAFAHOMI

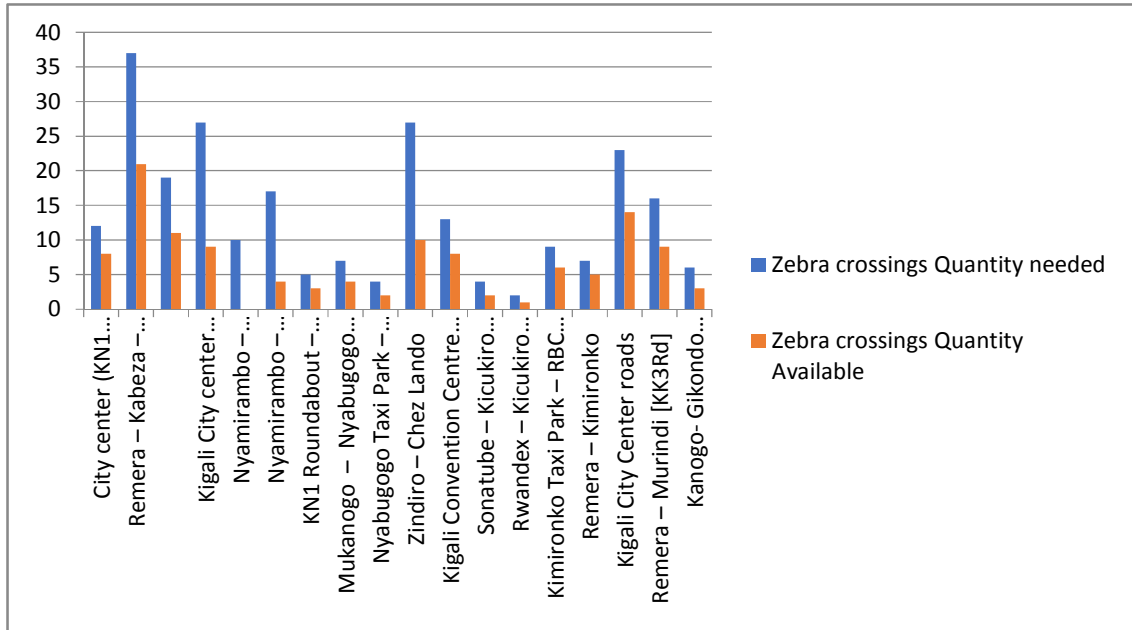
Figure 2: Comparison between Available and Needed Pedestrian Crossing facilities

From the field assessment on 18 visited road network, it was found that many of the needed crossing facilities for

pedestrians are missing and this is dangerous to the their safety. The figure 9 below shows that only 120 facilities are available instead of 245 required as per the field findings.

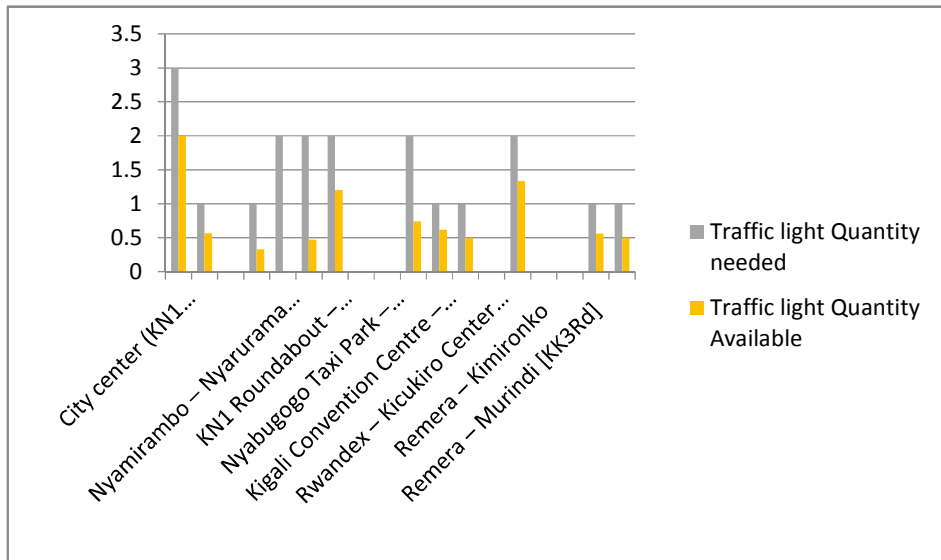
Figure 3: Comparison between Available and Needed Traffic Lighting Facilities

Also from the field assessment on 18 visited road network, it was found that the needed traffic lighting to facilitate pedestrians while crossing at junctions only 9 were available and installed out of 19 required to be installed as per the site and field visit data. Some of them 4 units were found not functioning at that time and needed repairs. Statistically computed results showed that only 47.4% of the traffic lighting facilities were implemented to help pedestrians to cross but still 44.4% of them are only reliable. So there is a need to increase these facilities and repair the ones out of service.

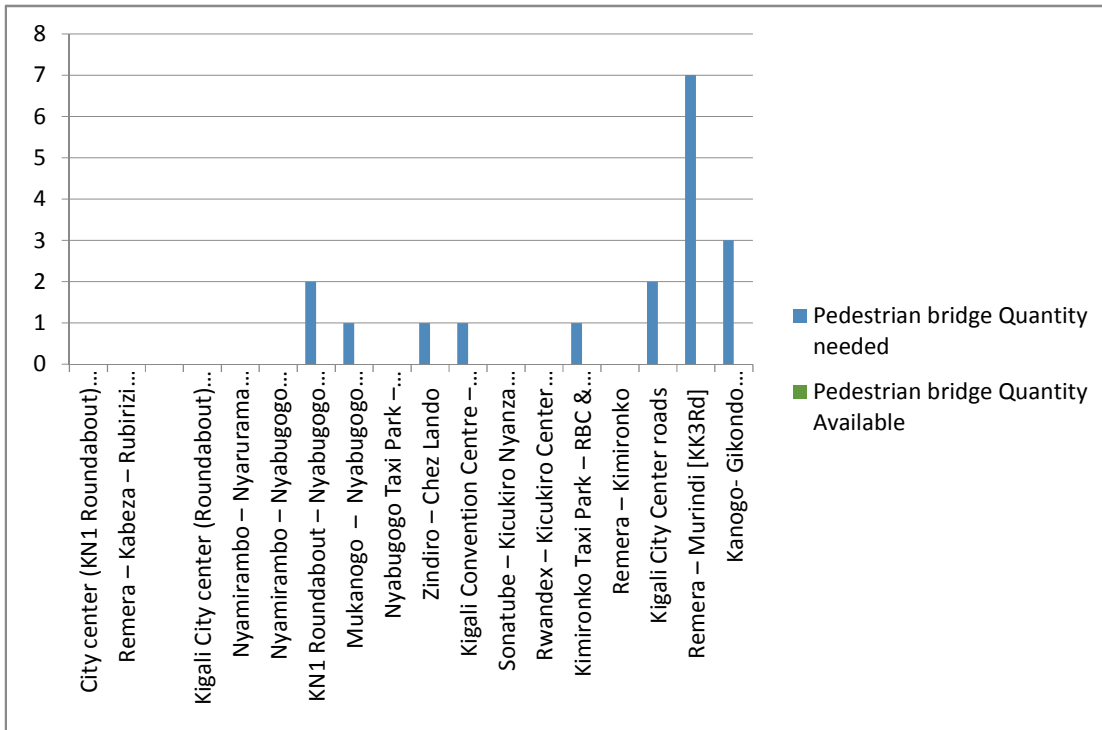
Figure 4: Comparison between Available and Needed Pedestrian Bridge Facilities

During the assessment of pedestrian needs facilities in this paper, it was found that they are needed for some places like at KN1 Round About to Nyabugogo (KN8Ave & KN1Rd) Network as an alternative of Zebra crossings, at KK2Ave & KN68St on the leveled side as an alternative to the zebra crossing for they are located in danger zone.

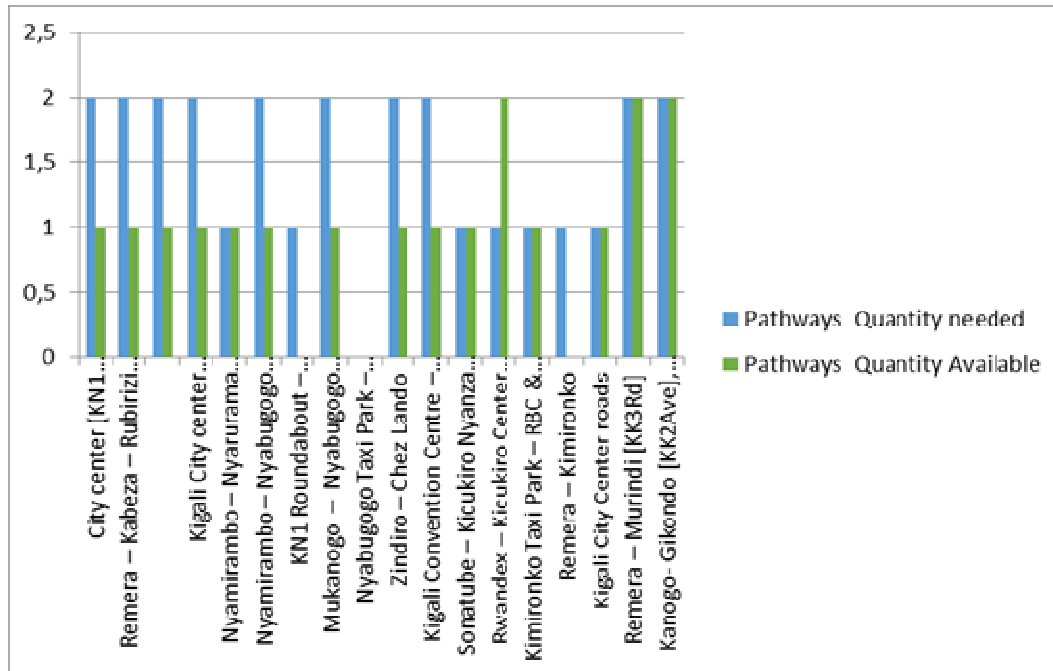
Figure 7: Comparison between Available and Needed Pedestrian Pathways Facilities

The paper found that around 67% of the required pedestrian pathways are built but still some of the road

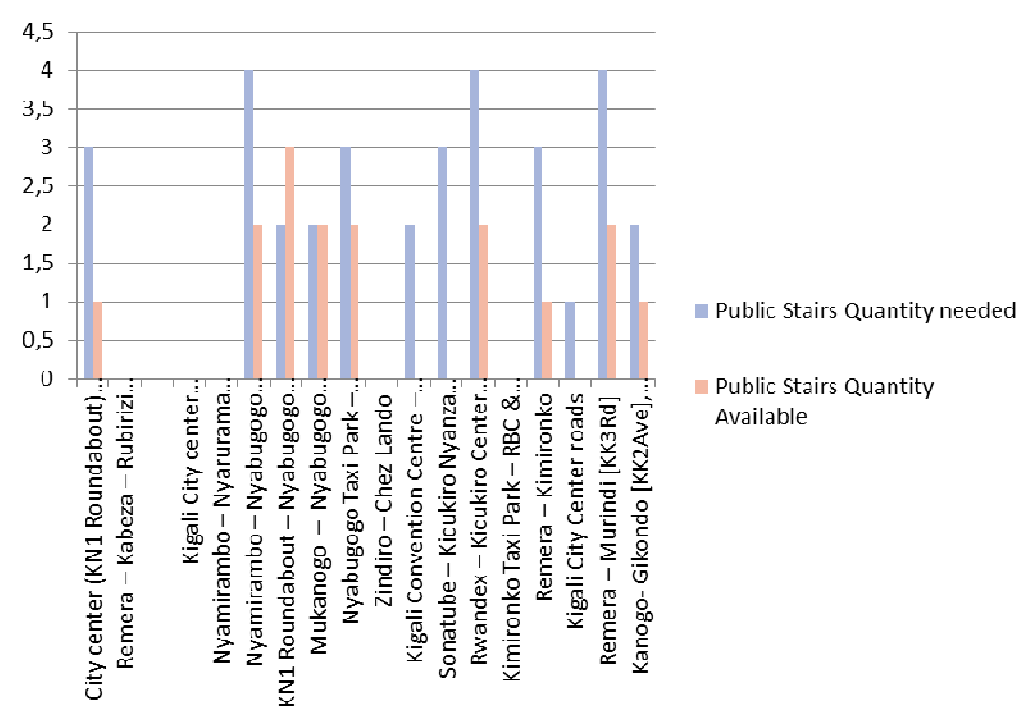
Figure 8: Comparison between Available and Needed Pedestrian Public Stairs Facilities

From the results, it was found that 48.5% of the required stair case facilities are provided and some are missing. Stairs which give pedestrians access to the roads need to have slip but rough staircase with a limited angle of

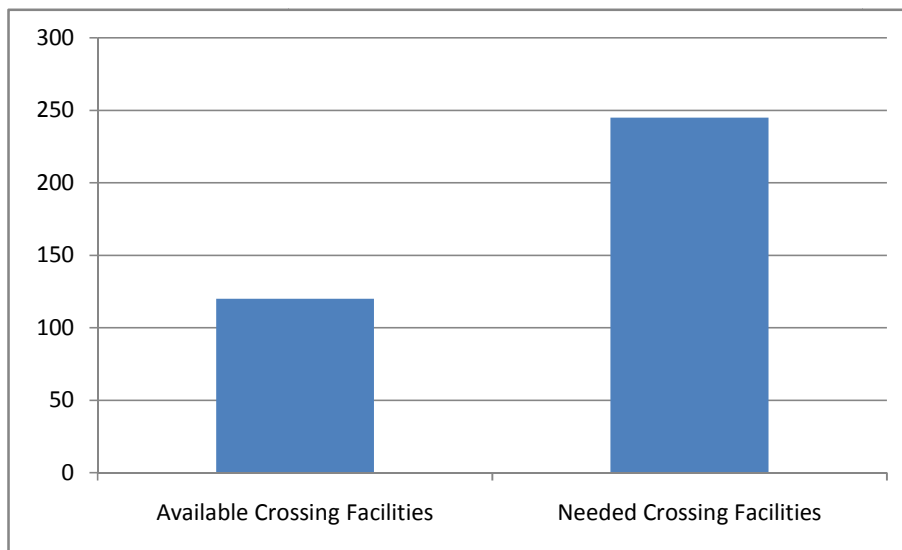
Figure 9: the available crossing vs the needed crossing facilities

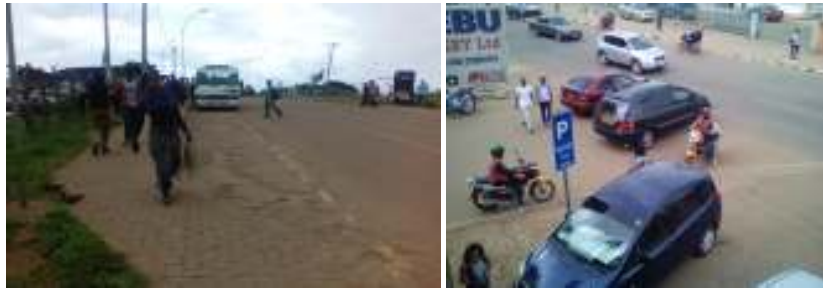
**Figure 10:** Some of the existing crossing without zebra painting and threat to pedestrians

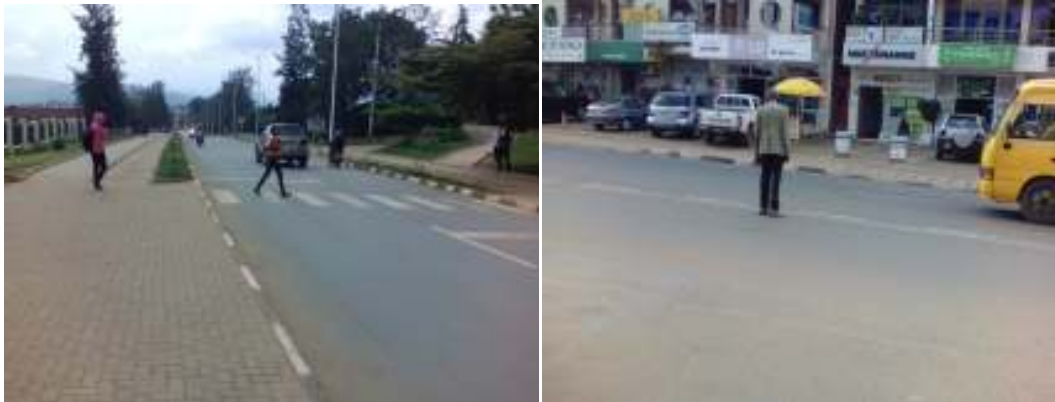
Warning signs are still very low on the road networks visited and it was found that almost 47% of the required are yet installed and this needs to be a priority so as to help pedestrians to escape from any road danger about their safety.

**Figure 11:** Zebra crossing without a warning sign (Left hand photo) on KG17Ave road and difficult/unsafe crossing at KN11Ave, Kimironko to Chez Lando (Right hand photo).

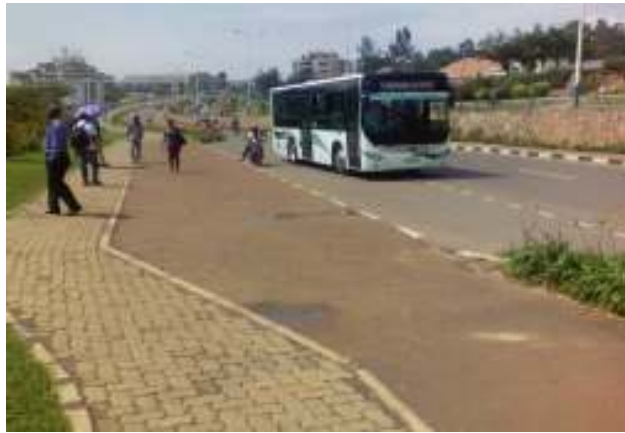
he or she is using road for daily base activities or trip. It was found that generally out of the required around 35% are constructed and operational. Still a large number is to be added as soon as possible. The figure below illustrates some of the road networks lacking shelters for pedestrians.

**Figure 12:** Bus stop without pedestrian shelter on KN501St

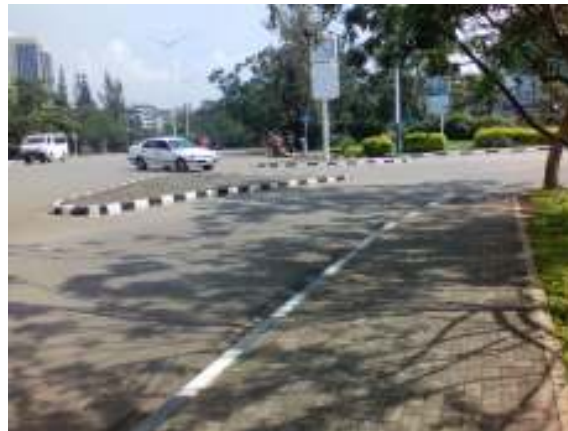
does not provide them and this is an encouraging indicator that in the near future the coverage is possible. Apart from the pedestrians pathways the escaping island are also useful for lanes separation and also for pedestrians to refresh while waiting for motor drivers to give a free way for him or her. They may be implemented in T-networks or junctions, on a wider crossover networks.

**Figure 12 :** escape island on a network of KG7Ave & KG544St

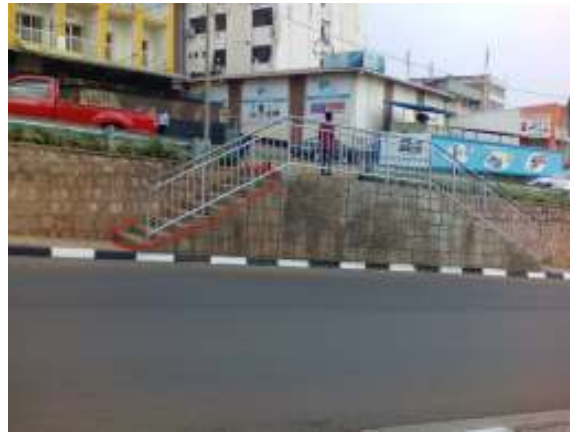
elevation which is not adequate to physically challenged people were only found on the field. At least one side access should be designed to facilitate physically challenged people.

**Figure 13:** a stair case on KN1Rd built recently in 2019

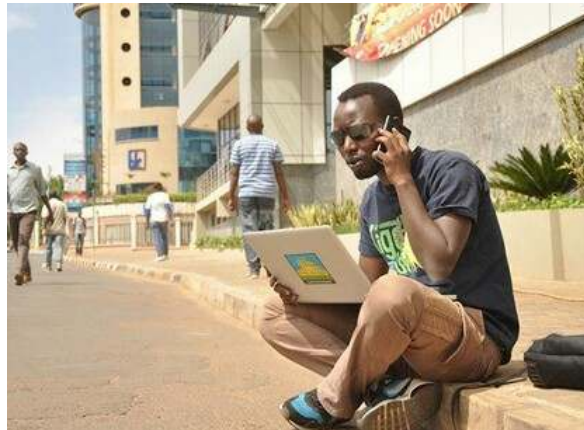
In the City of Kigali specifically the car free zone of Nyarugenge District, pedestrians are free to move and leisure; the zone like this is also needed in other Districts of Gasabo and Kicukiro of the city.

**Figure 15:** Car Free Zone of Nyarugenge District
