# STUDY OF THE NATURE OF URBAN FLOOD IN BENIN CITY, EDO STATE; NIGERIA

D. N. OGBONNA, G. T. AMANGABARA AND P. A. ITULUA

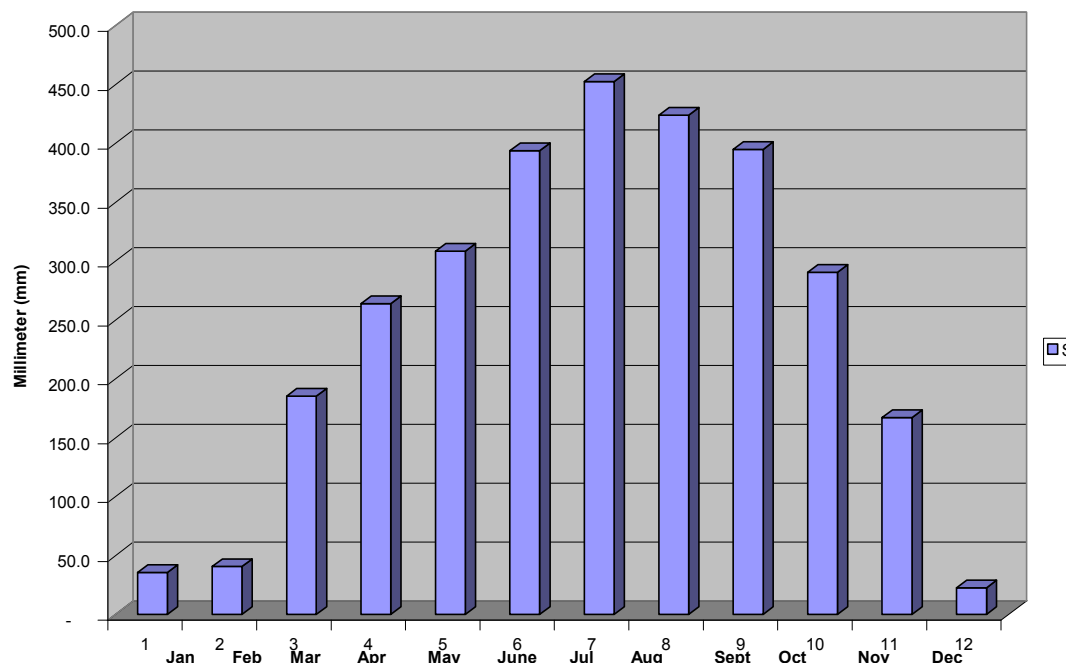
Fig. 3 Mean Monthly Rainfall 1997 - 2007

The city experiences rainfall throughout the year with peaks in July. Between 1997 and 2007 July and August were the wettest months. Lower amounts of rainfall were recorded from December to February (Table 1, Fig.3). The mean annual rainfall is, above 2980 mm. The wet season spread from April to October while the dry season is from November to March. The pattern of relative humidity correlated with that of the rainfall described above. High values (over 95%) occurred in the node in the rainy season. In the dry season, the high daily relative humidity values ranged from 86.5 to 94.0% and occur around 0600hrs. As a result of the heavy rainfall and other flood inducing factor e.g. building on floodplains, defective gutters, destruction of natural flood retention attenuations and low infiltration rate etc. the City experiences severe flash flood since the early 1980s (Odemerho, 1993; Omiunu, 1988).

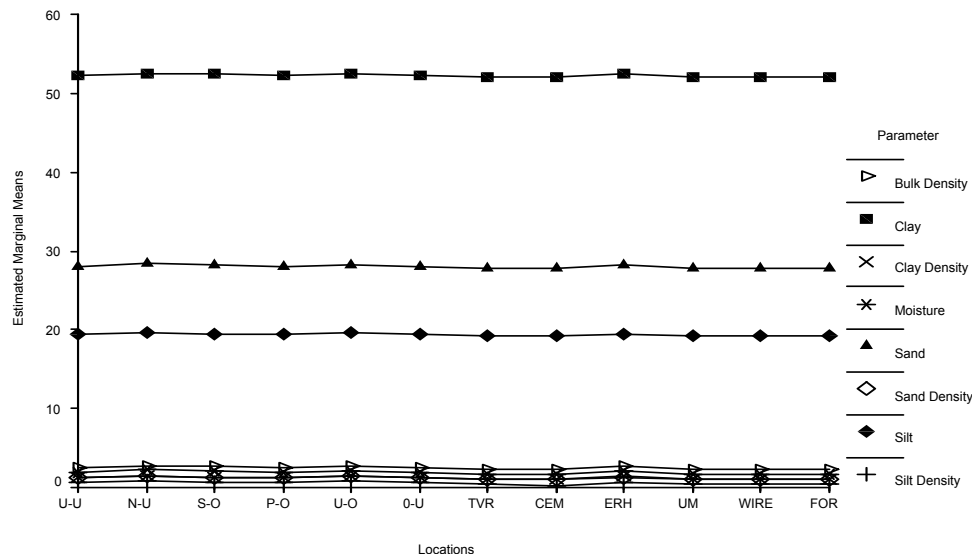
**Fig 2 Variability between locations & parameters of flooded areas**

Variability between locations and parameters of flooded areas in Benin

From the analyses to determine the degree of variability between and within locations of the factors of flooding in Benin City; There is no significant variation between the locations of the flooded area in Benin City at  $P > 0.05$  level of significance. However, there was significant difference in the variation among the parameters with Clay varying significantly at  $P > 0.05$  level of significance from all others, while silt and sand are not different from each other as similarities exist between the other parameters

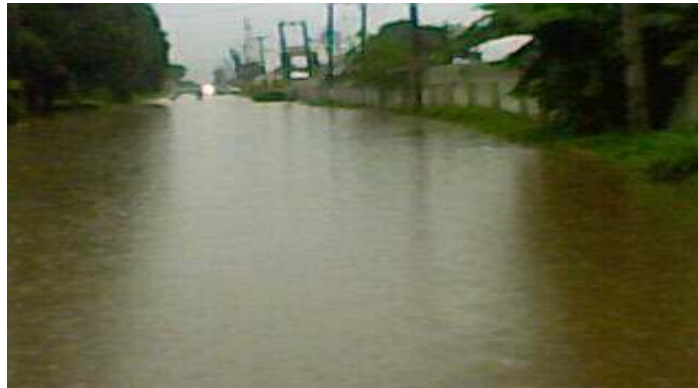
Flash Flood

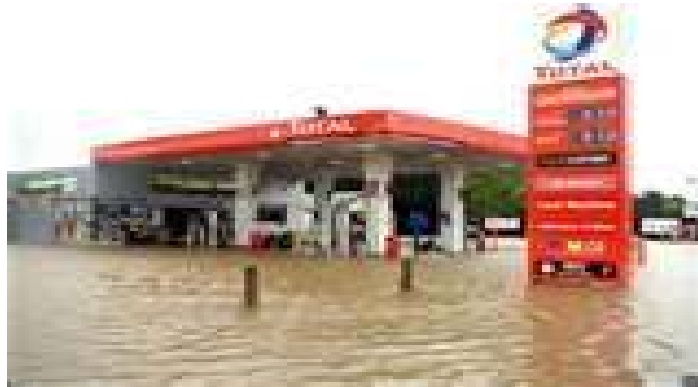
Urban Flash Flood

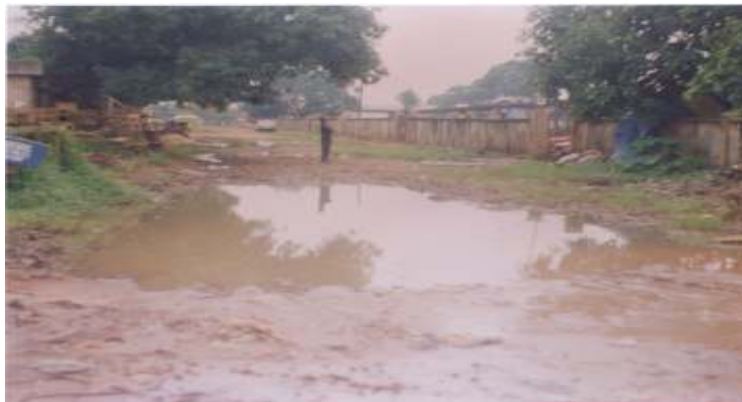
Flood Pondage
