# Blasting Standards for the Ghanaian Mining Industry\*

N. Amegbey, S. Yormekpe-Agbeno, and C. F. A. Akayuli

Amegbey, N., Yormekpe-Agbeno, S. and Akayuli, C. F. A. (2012), "Blasting Standards for the Ghanaian Mining Industry", *Ghana Mining Journal*, pp. 46 - 50.

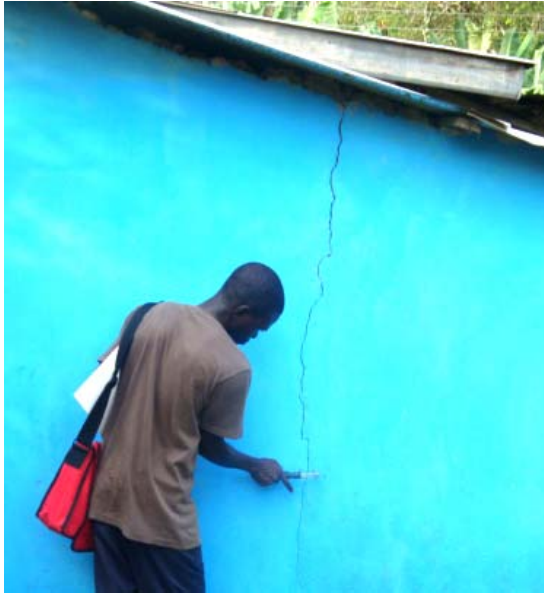
Crack Description: Near vertical crack extending from the peak of the gable to the ground level of the structure (Fig 1).

**Fig. 1 Crack on a Wattle and Daub Building**

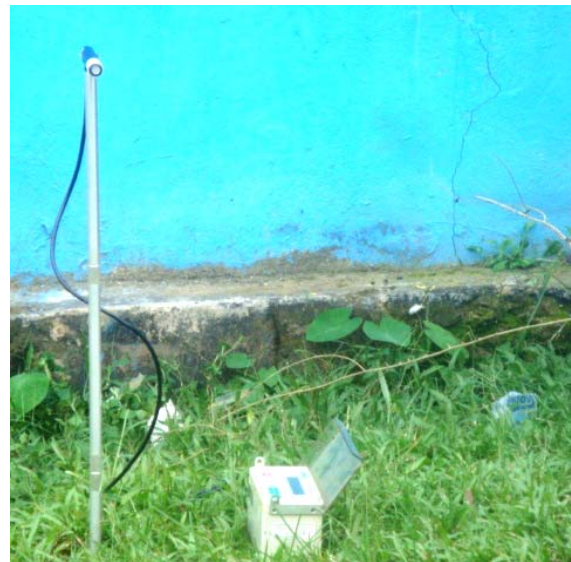
Crack Description: Through vertical cracks extending from the ground level to the gable. The set-up for the monitoring exercise is shown in Fig 2.

**Fig. 2 Set-up for Monitoring of Crack and PPV**

The instrument used for monitoring ground vibrations was the Vibratech Multiseis V mini seismographs, and for crack monitoring the Avongard Digital Calliper was used.

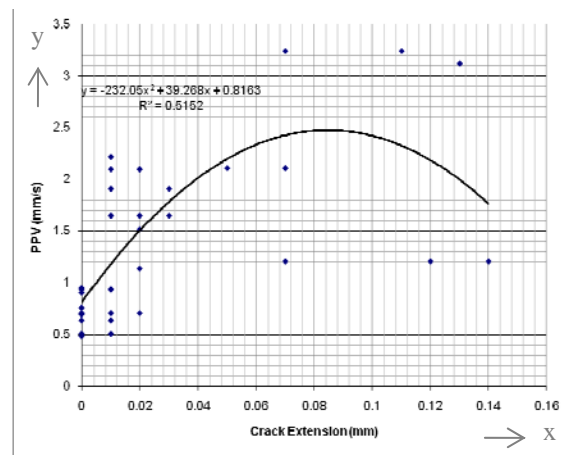
A total of 70 readings of crack monitoring data from various wattle and daub structures of ages between 4 and 10 years were obtained, and a graph of PPV against crack extension was drawn, and it is shown in Fig. 3. A critical look at the raw data obtained showed an elastic behaviour of the structures monitored. Crack extensions reduced sometime after the blast, though never to the extension measured immediately (up to 15 minutes) after the blast.

The graph of PPV against crack extension behaves like the stress-strain curve of a typical geo-material such as clay, silt or rock. Concrete also behaves similarly under load. The observed behaviour is expected since the wattle and daub structures that were monitored are made of clay reinforced with wooden

poles. The curve shows non-linear elastic behaviour with a maximum PPV. The following points can be defined on the curve:

**Zero Crack Extension:** This is the PPV that will not cause any extension in an existing crack. This means the blast vibration has no impact on the crack. On the graph the point at which the curve crosses the PPV axis is 0.8 mm/s.

**Fig. 3 Peak Particle Velocity and Crack Extension for Wattle and Daub Structures**

**Maximum PPV:** This is the PPV that a building crack can sustain under a given set of conditions such as temperature, wind etc. After this maximum PPV is exceeded, the crack undergoes loss of strength following little or no permanent deformation. This PPV is measured as 2.5 mm/s. Failure is said to occur at the maximum PPV or be initiated at the maximum PPV. Failure in this case is defined as the occurrence of permanent extensions in the crack due to weakening at the crack ends.

**Yield PPV:** This is defined as the PPV for which there is a departure from elastic behavior where some of the crack extension becomes irrecoverable. For the non-linear elastic behaviour, the yield PPV, like the yield stress, is usually very difficult to determine since the curve is not a straight line. Its determination is usually done by inspection of the curve combined with engineering intuition. By inspection, the yield PPV is determined as 1.6 mm/s.

currently in use, from results using the guidance level concept, and from crack extension monitoring results. From Table 5 an acceptable standard may be considered between the Maximum/Failure PPV of 2.5 mm/s and the Yield PPV of 1.6 mm/s. A PPV of 2 mm/s is therefore a suitable value for the Ghanaian industry. This value is just about the same value as the mean value (plus standard deviation) obtained from the mines (Table 3) over a 5-year period (2004 to 2008).
