Influence of rebar practice in the total cost of building construction projects: The case of Hawassa city, Ethiopia

Abstract

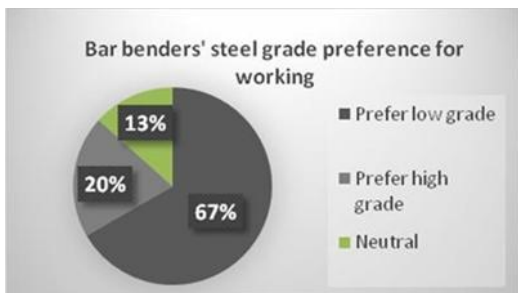
Figure 1: Bar benders’ grade preference

From the analysis of the questionnaire survey and interviews, it was found that the bar benders prefer to use a lower grade of steel which could be easily bent. Figures 1 and 2 show the bar benders’ grade preference and respondents’ perspective over the market availability of different grades of steel, respectively. About 67% of respondents have committed that working with S300 is easier while 13% have felt to work with the design specification which is mentioned as neutral. 73% of respondents have answered that S300 is quite commonly available to purchase out of their experience, whereas the remaining percentage of respondents have committed that even S420 is also available in the local market. As rare cases, while higher-grade steel has to be used as per the design, design alterations have come into play to fulfill the easiness of the bar benders to use lower grade of steel. Moreover, in the market commonly available grade is S300. The strength values of rebars are not known to the dealers who sell due to the certificates of quality assurance not being supplied to the dealers. But these reasons have shown insignificant impact on the cost increase of steel.

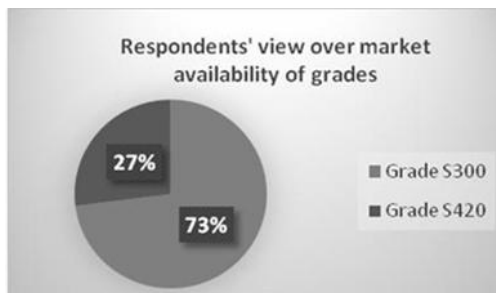
Figure 2: Market availability of grades

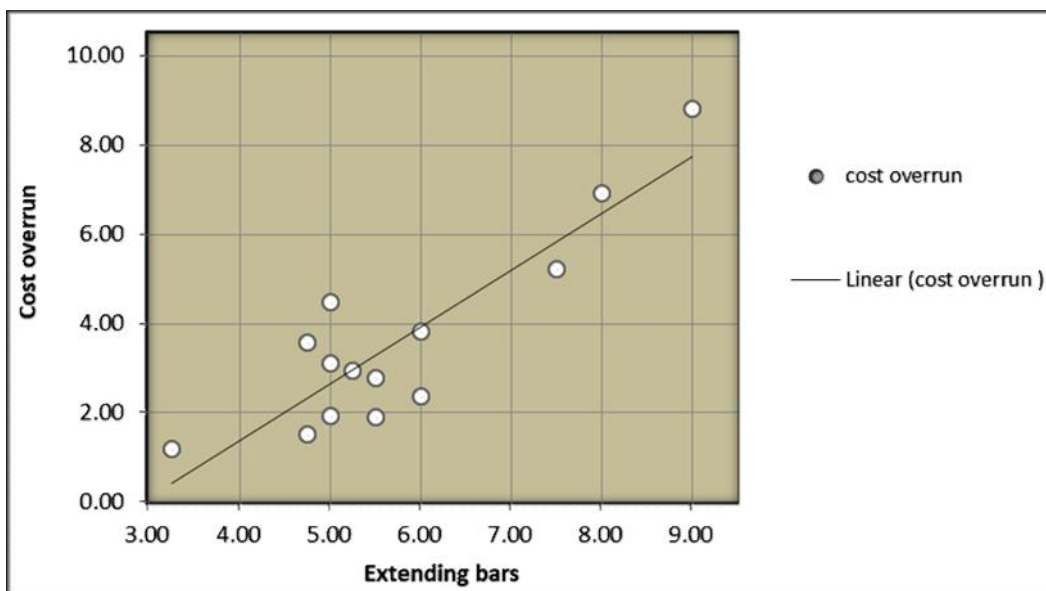
Figure 3: Regression line between cost overrun and extending bars beyond requirement

Regression analysis was conducted between the dependent variable (i.e. the cost overrun) and the independent variables (i.e. the factors responsible for cost overrun). The estimated value of cost overrun (X[^]) was found to be very close to the actual values of cost overrun (X) thereby the analysis expressed that the factors have close relation with causes for the cost overrun. For example, Table 7 shows the regression analysis between cost overrun percentage and the causing factor, extending bars wherein X[^] values were found to be close to corresponding X values. The standard error and significance were observed as shown in Table 8. The standard error in the regression line plot for the different causing factors was between 0.77 and 1.53 which are very low and acceptable values when compared to the mean value. Significance values for all the factors were too small like 0.0, which shows that the regression line can be linear without 0-degree inclination. Figure 3 shows the regression line drawn for one of the causing factors, i.e. extending bars and this proves that the significance and X[^] values can be reliable values. Thus, the relation between the dependent and independent variables is considered to be strong.

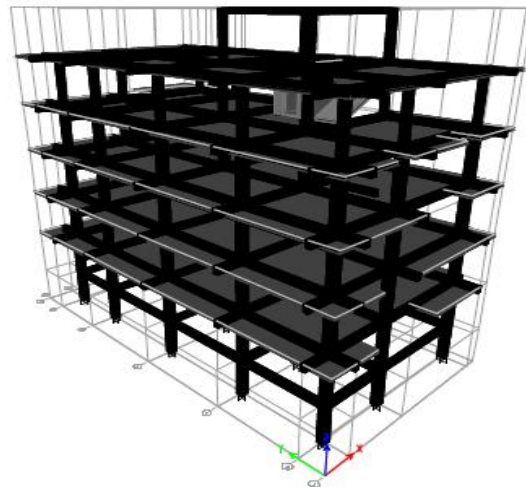
Figure 5: Bending moments in a critical frame

Figure 4 shows the 3D model of the building under a case study that was redesigned using ETABS whereas, Figure 5 shows the ETABS output of bending moment diagram for one of the critical frame having greater values of bending moments after the analysis. The structural design of all the components was done using Excel templates, and the BBS was produced by RebarWin7.97 software. Figure 6 shows a part of the output of BBS from RebarWin.

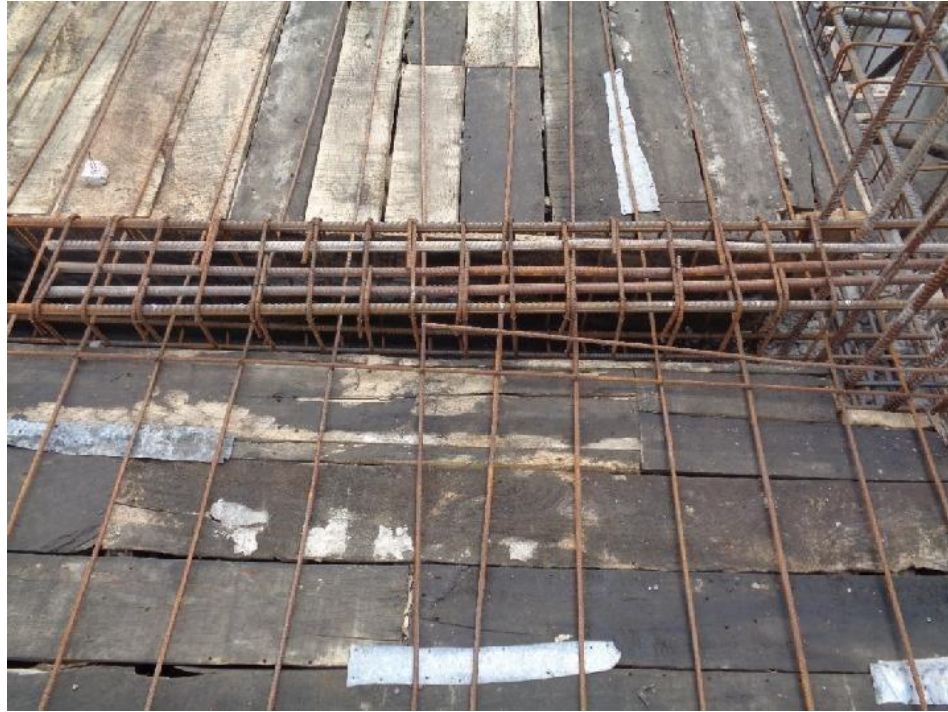
Figure 7: 90-degree bends in stirrups with greater hook length

1. While the drawings show 135 degree bending of hooks for stirrups, the bar benders bend only for 90 degrees, with a greater hook length as indicated in Figure 7. The hook lengths were almost half of the side length of a stirrup.
2. In slabs and beams, excess lengths were left uncared and uncut, which increases substantially the quantity of steel used as indicated in Figure 8 that shows the uncut bottom reinforcements that pass through a joint. Thus the reinforcement cluster could hinder the concrete placement too.
3. Quite manifestly, laps with excess lengths were found and were measured to quantify the wastage of steel.
4. Bending gain was not considered in detailing and on the site.

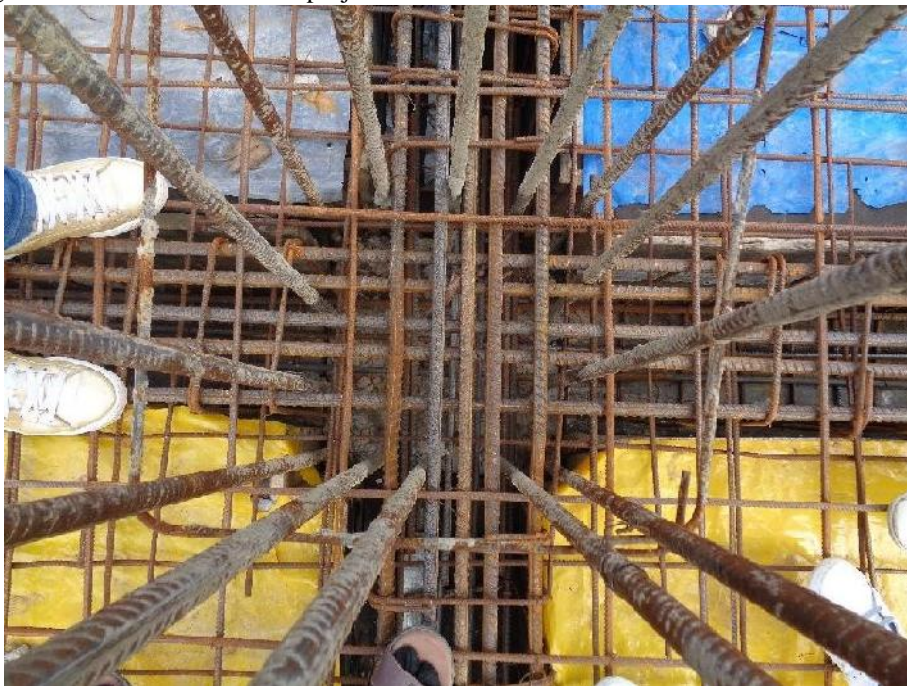
Figure 8: Rebar cluster in a joint, where bottom reinforcements were uncut
