Mineralogical and Geotechnical Properties of Subgrade Soils along Failed Portions of Abavo-Urhonigbe Road, Western Niger Delta, Nigeria

ABSTRACT: This paper presents the investigation of the possible causes of the incessant road failure associated with subgrade soils of the Niger delta using mineralogical and geotechnical properties assessment. Geotechnical investigation revealed clayey sand form the bulk of the subgrade soils composed generally of fine to medium grains with low to intermediate plasticity. Based on AASHTO the soil classifies as A-2 and A-6 with the granular soils being dominant. The average values obtained for California Bearing Ratio (CBR), maximum dry density (MDD), optimum-moisture-content (OMC) and shear strength are 19%, 1726 kg/m³, 15.70% and 286 KPA respectively. The angle of friction ranged from 18° to 25° indicates high presence of sand. X-ray diffraction analyses reveal the absence of expandable clay mineral. Collapse potential ranged from 1.3 to 10.8% indicating slight to severe collapse. High amount of settlement and field observation of intense failure revealed the soils as collapsible, particularly when inundated under poor drainage conditions. Thus,

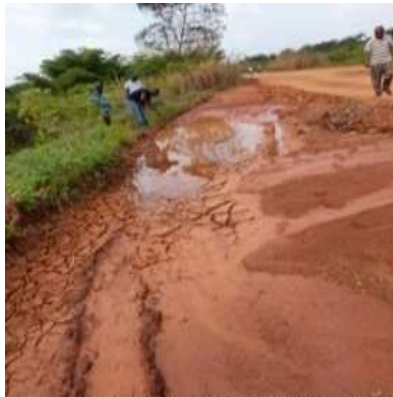
area covers a distance of approximately 16km and characterized by alternation of stable and unstable section (Fig 2a. and Fig 2b)

Fig 2a. Alligator Cracking and Edge subsidence

depressions are due to high precipitation prevalent in the Niger Delta, therefore adequate drainage at the shoulders of the road will be salient to avoid loss of subgrade strength due to ingress of water into the pavement.

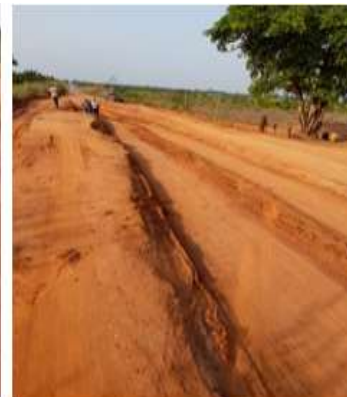
Fig 2b. Longitudinal Cracks

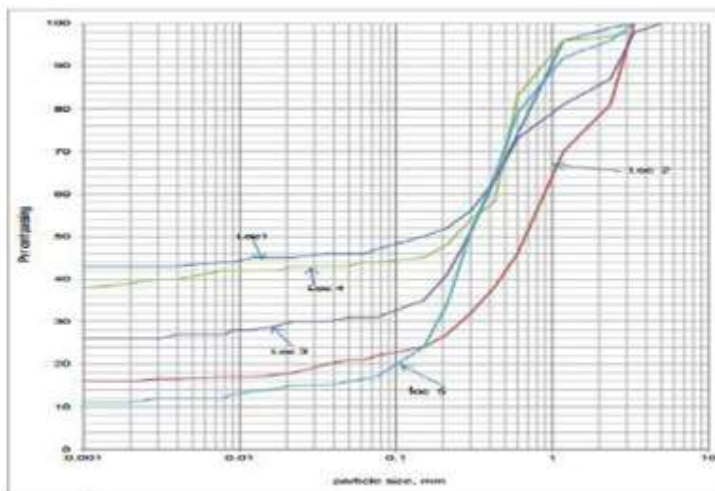
The Particle Size Distribution (PSD); The soils from the sampled locations consist of variable proportions of gravels, sand and fine fractions as represented in (table 2), gravel fractions: (0.1% – 19 %), sand fractions ;(55 % - 79 %), silt particles; (1.6 % – 6 %) and clay fractions (16 % - 40%). The PSD curve from Fig. 4, reveal fine to medium grained soils consisting mainly of A-2-7, A-2-4, A-2-6 and A-6 type of the America Association of State Highway and

Transportation Officials (AASHTO) classification system with the granular soil being dominant. The control points (CC1 and CC2), locations 2, 3, & 5 classifies as granular materials while location 1 & 4 classifies as clayey material which is consistent with the study of Ugbe (2011). The particle size distribution reveals the dominance of sand over fines which indicate a non-uniform distribution of grain sizes revealing the soil is poorly graded soil.

Fig 4. Typical Particle Size Distribution Curve

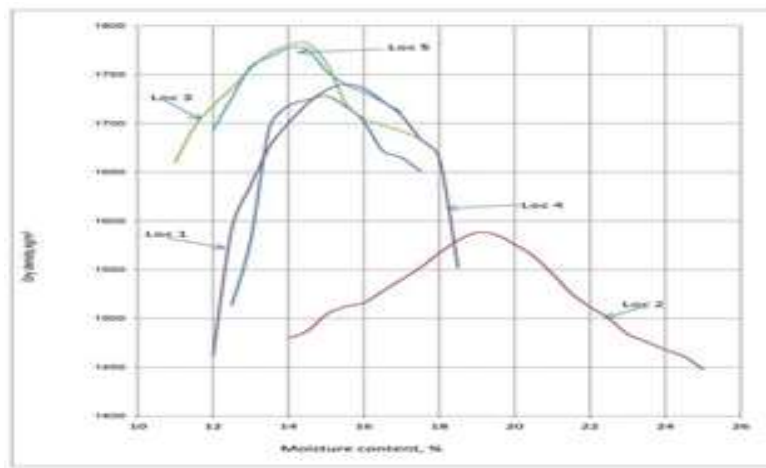
swelling potentials Ola (1982). The plasticity index of soils beneath the control stable segments ranges from 13-17 % while that of the failed segment ranged from 10-24 %. The soils are of low to intermediate plasticity, no value of plasticity index is greater than 50 %. *Compaction:* The maximum dry density (MDD) and optimum moisture content (OMC) has revealed values ranging from 1590kg/m³ to 1782kg/m³ and 14.2 to 19.1% respectively (Table 3). Location 2 had values short of the specification of FMWH (1997), having the lowest MDD at OMC and as a result of the weak engineering properties such location should be (cut to spoil) removed and replaced with a suitable subgrade material having desirable engineering properties during construction, The other locations 1, 3, 4 and 5 met the MDD of 1700 kg/m³ at OMC 5-15 % as graphically shown in (Fig. 6), but have relatively moderate values and would require ground improvement to increase the density of the subgrade soil.

Fig 6. Typical compaction graph of the samples from Abavo-Urhonigbe road
