Deformation Monitoring Using A Terrestrial Laser Scanner: A Case Study Of Alausa Shopping Mall, Ikeja, Lagos, Nigeria

BIM. Some applications aimed at assessing the stability and safety of the bridge were also illustrated and discussed. Hence, the objective of this paper is to monitor the deformation of Alausa Shopping Mall, Ikeja, Lagos, Nigeria

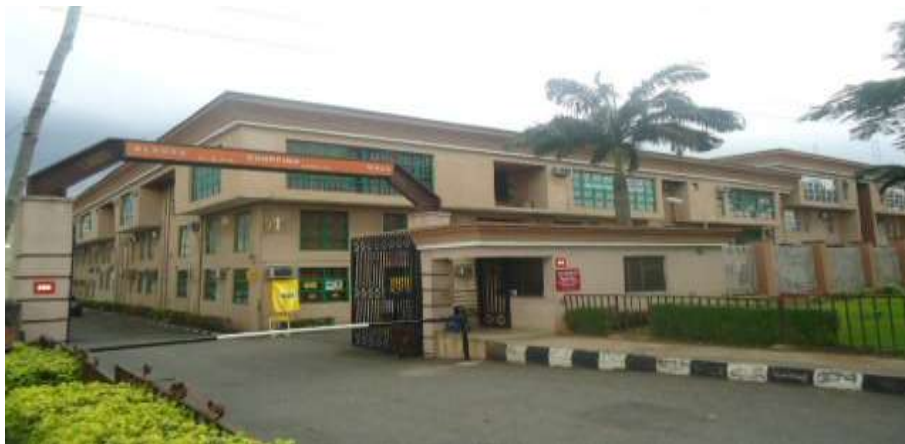
Fig 2: picture showing the Project Area (Alausa Shopping Mall)

Study Area: The study area is 131 Obafemi Awolowo Way, Opposite Radio Bus-Stop, Alausa, Ikeja, Lagos State. Commissioned on the 14th of December 2020, Alausa Shopping Mall is situated at the heart of Ikeja, the flourishing and bustling capital of Lagos state, which is Lagos's commercial and administrative centre. It is a hub for commercial activity and multinational enterprise. This cosmopolitan corner of Ikeja has one of the biggest business districts in Nigeria, playing host to offices and headquarters for companies and organisations. Alausa shopping mall is geographically located at latitude 6° 36'37''N and 6° 36'42''N and longitude 3° 21' 08''E and 3° 21' 12''E.

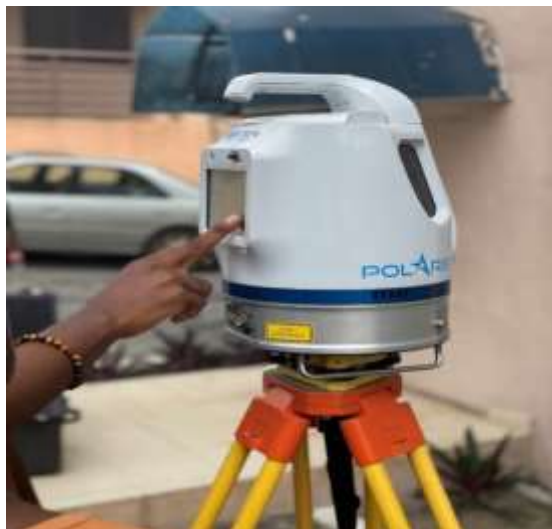
Fig 4: The setup of a LASER scanner during a scanning operation

Setting up the LASER Scanner: A tripod was set up at a suitable location with a tribrach affixed on the tripod, and with the aid of a LASER plummet, it was centred over the benchmark. The instrument was then mounted on the tripod which was centered over the benchmark figure 4.

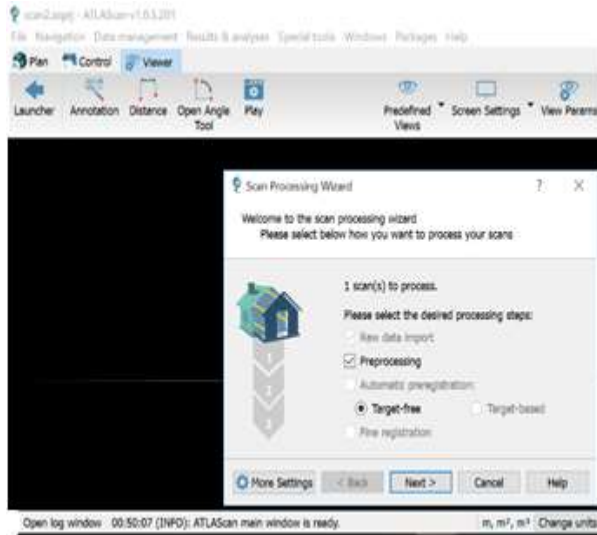
Fig 5: Data registration dialogue box for registering the scanned point

Registration: 3D LASER scanners are line-of-sight instruments; thus, scanning from different locations was required to cover areas of interest as much as possible. However, due to the multiple (5) scans, there were common points in different scans. Having known the scan positions, we automatically geo-reference the scan positions. The alignment and geo-referencing procedure is automated simply by running the Align wizard.

To align the scans, all scans are selected to align automatically, the coordinate system is set as “UTM (Easting, Northing, Attitude” and the project UTM zone is set as “31 North”) and since all scan positions of the scan points are known, it is easily geo-referenced to ensure fine registration against every constraining positions. After this is done, a fine registration is done automatically. After the fine registration process, a pdf report is generated to analyse the quality of the scan process in the form of a bundle adjustment report.

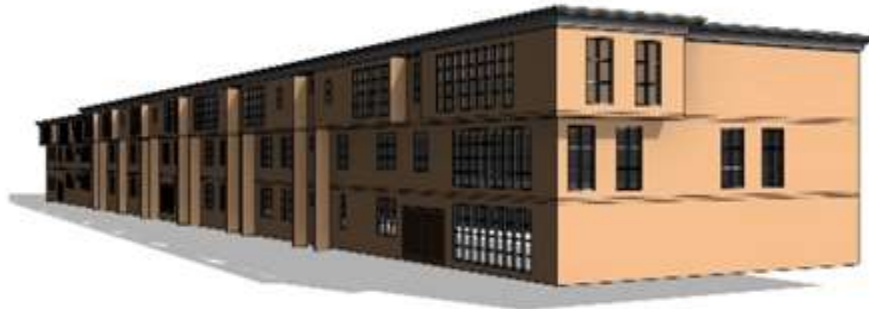
Fig 8: Developed 3D CAD Model

Presentation of Results and Analysis: 3D CAD As-built Model Creation: Having acquired a Lagos state vector plan which contained the detail of the building, the dimension of different segments of the building was determined, and with respect to the height of the building, an appropriate and suitable 3D CAD model figure 8 which represents a former condition of the building was developed through Revit and AutoCAD software.

Data Analysis: After building the 3D building on Revit, The LASER Scan model of the building was also imported into Revit, and the Horizontal and Vertical Differences between the dimensions of both models were determined Table 1 to 7.
