## Measurement of remaining storage, rate of siltation, and rate of erosion of the Ahmadu Bello University Farm Lake drainage Basin in Zaria

ADAMA BABA, MIKE AKAEGBOBI; KRZYSZTOF SCHOENEICH

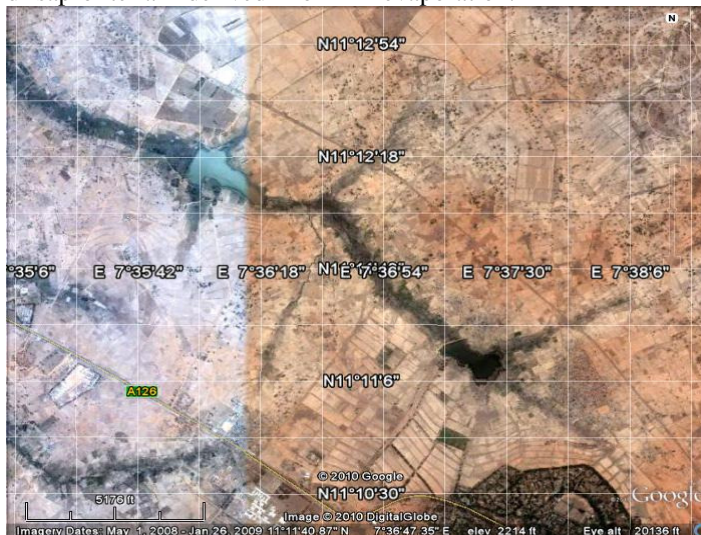
Plate 1: Satellite image of the study area: University Farm Lake and Bomo Lake

University Farm Lake, together with Bomo Lake which is located in its headwaters, drains an area 18,062,500 m<sup>2</sup>. In these University Farm Lake drainage sub-basin is 11,931,875 m<sup>2</sup>, while Bomo Lake drainage sub-basin is 6,130,625 m<sup>2</sup> (Plate 1 and Fig.1).

satellite image in the same green tones as the farmland which is surrounding the lake. With all these, edge of water was located with the utmost possible accuracy using combination of measurements shown in Table 2 and of satellite image in Plate 1.

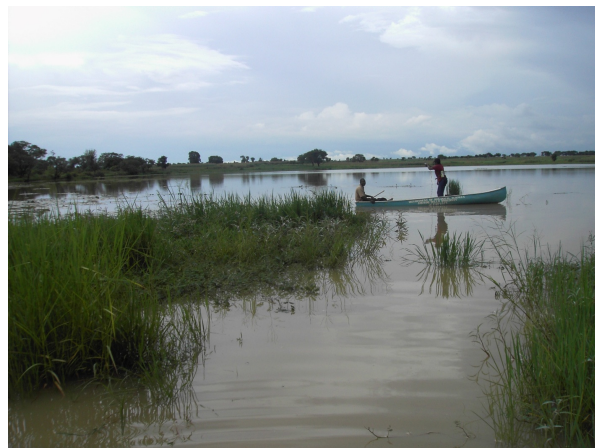
Plate 3: After forty three years of existence the original storage has been reduced by siltation.

The difference in level between the Dam top and the spillway crest is 4.0 ft (1.22 m) without allowing for evaporation and seepage losses (ground seepage flow) according to El-Turabi, 1972. According to the same source "the maximum lake capacity on the day of visit, 11<sup>th</sup> May 1972, was estimated at 330,400 m<sup>3</sup> (11.8 x 10<sup>6</sup> ft<sup>3</sup>). Since in light of the measurements done by the present authors on 18<sup>th</sup> August 2009, total storage measured was 349,911 m<sup>3</sup>, El-Turabi's estimation of the storage in 1972 seems to be grossly on the lower side. Report from the Farm Management (Couper, 1978) showed that the dam wall (embankment, earth dyke, earth fill dam – written in 2009) had been severely eroded by water lap over past seven years and this erosion will increase unless measures are taken to control it. Plate 2 and 3 shows abrasion of the dam body in August 2009.

Also, Gill (1977) after an assessment of the dam reported that there were severe rain cuts on the dam slope at several places. He also reported evidence of rat holes within the dam and recommended that the top 1-2 m portion of the dam be scraped and new earth fill be built. Also he recommended stone pitching at the sides to reduce intensity of rain cuts. He however termed his assessment of the structure a visual impression. It does not seem that Gill's recommendations were ever implemented, the present authors, in August 2009, observe.
