Soil and Groundwater Characteristics of a Legacy Spill Site

ABSTRACT: The soil and groundwater of a legacy spill site in Eleme Local Government Authority Area of Rivers State were investigated. The general land use of the area within 1500m radius of the spill site is devoted to farming, fishing and hunting. The main crops grown include yams, cassava, maize, sugarcane, plantain, banana, oil palm, coconut, raffia palm. Families own the land and this ownership is by inheritance. In recent times, people can purchase land for use and others can also hire. The stratigraphy of the subsurface at the study site is closely related to the local geology of the site. Basically, the local geology is that of the coastal plains sands. Generally, the water table at the study area ranges from a low of 0.0m (at ground surface) to a high of about 5.10m. Where it occurs within the subsurface, the groundwater was observed to occur either within the lower part of the sandy clay or within the sands and gravels layer. The general direction of the groundwater flow within the area was observed to be from the North West to the South East. Underground pollution plumes were also in this general direction with

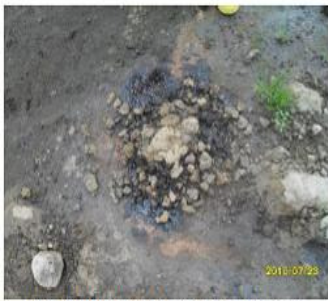
Fig 2: Visible oil seepage on the soil surface

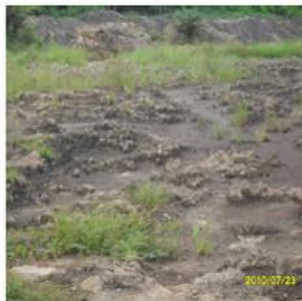
During the spillage, the crude oil ignited and burned for several days before the fire was brought under control. As a result of the fire, a layer of burned, carbonised residue has formed a crust on the surface of the site between the pipeline and surface-water pond approximately in the centre of the site. Photograph of the site are displayed below showing pile of surface material that had been scrapped by others from the North-West area of the site.

Fig 3: Caked soil at the site

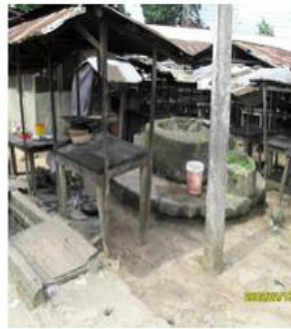
Figure 6: Existing Community Well

this direction. Monitoring wells and hand dug well were noted at two points within the location. 3 wells were also sighted at strategic points around the site. Dates of drilling and objectives of the existing wells could not be ascertained at the time of the visit to the site.

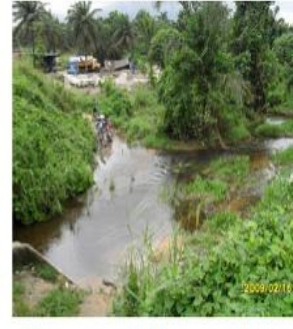
Figure 7: Section of the Ochani Stream

At the central area is a pond which flows into the Ejama-Ejor stream. The Ejamah-Ejor stream connects with the Kuleke stream which subsequently flows into the Ochani stream. The Ochani stream stretches through the East West Road follows a course of rivers into the sea. Beyond the central pond is a swampy area with degraded crude oil visible in the wet land.

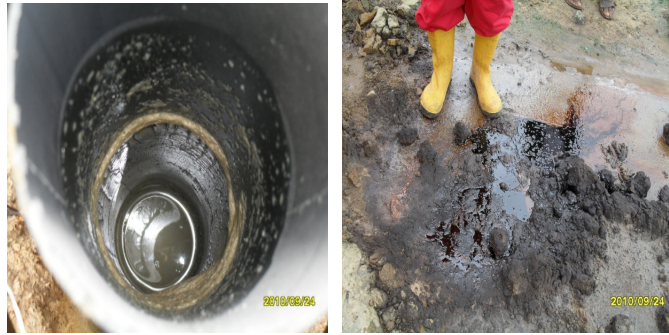
Fig. 8: Top view of exploratory borehole Fig. 9: Oil seepage hotspot near exploratory well

General Information on Exploratory Well	
B/Hole depth(M)	18
Casting depth (M)	0-14
Gravel Pack (M) screen depth	14-17.5
Sand Tilling	0-13
Depth from casting to ground surface (M)	0.08
Depth from ground surface to water table	5
Gravel pack depth (M)	13-17.5
Soil Description with Depth:	
1.2m of soil is brown to dark due to oil impact.	
4m of sandy grey clay with silt intercolations	
2.5m grey brown clay	
3.5m fine/medium coarse white grey (Screen zone)	
2m white clay thick and compacted	
Observations: Oil film on top of water is 2.5cm

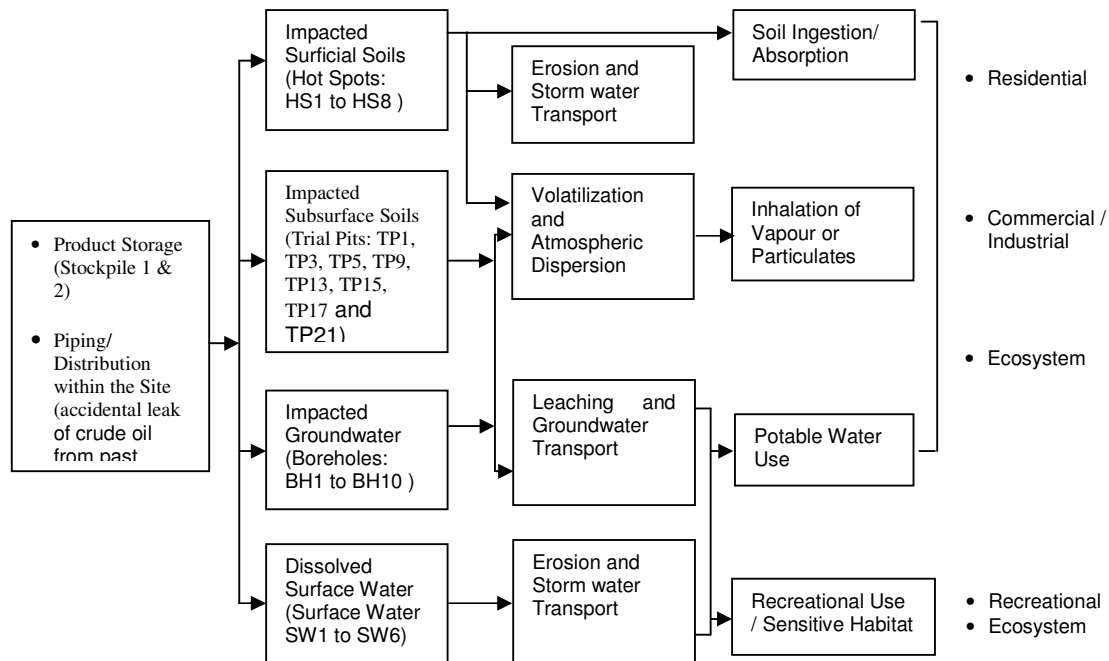
Fig 11: CSM- Exposure Scenario Evaluation Flowchart

the source of contamination. The exposure pathways to COPCs are through soil ingestion and absorption, inhalation of vapour or particulates, use of potable water for domestic and commercial purposes, recreational use of the environment and interaction with the sensitive habitat (see Figs 10 & 11).
