## Forensic investigation of the Gouache landslide disaster, Western Region, Cameroon

This study made use of a disaster forensic approach to investigate the root causes of the landslide disaster which occurred in Gouache, West Region, Cameroon on 29th of October, 2019 that registered 49 to 60 deaths. The aims of the study were to; 1) identify the natural and man-made causes of the landslide; 2) determine household vulnerability factors; and 3) identify the administrative weaknesses that led to the disaster. To achieve this, geological data was collected from field observations; rainfall data for a period of 30 years (1988 to 2018) with additional monthly data (January to December) for 2019 was obtained from the National observatory on Climate change (ONACC), Yaounde; satellite imagery from Landsat ETM+ and 8 (2001 and 2020) and SRTM DEM were used to assess land use/landcover changes and slope respectively; questionnaire administration, household and key informant interviews were used as primary data collection tools. Findings revealed that the root causes were: heavy rainfall that occurred prior to and during this event; the presence of weathered granitic rocks on steep slopes, an

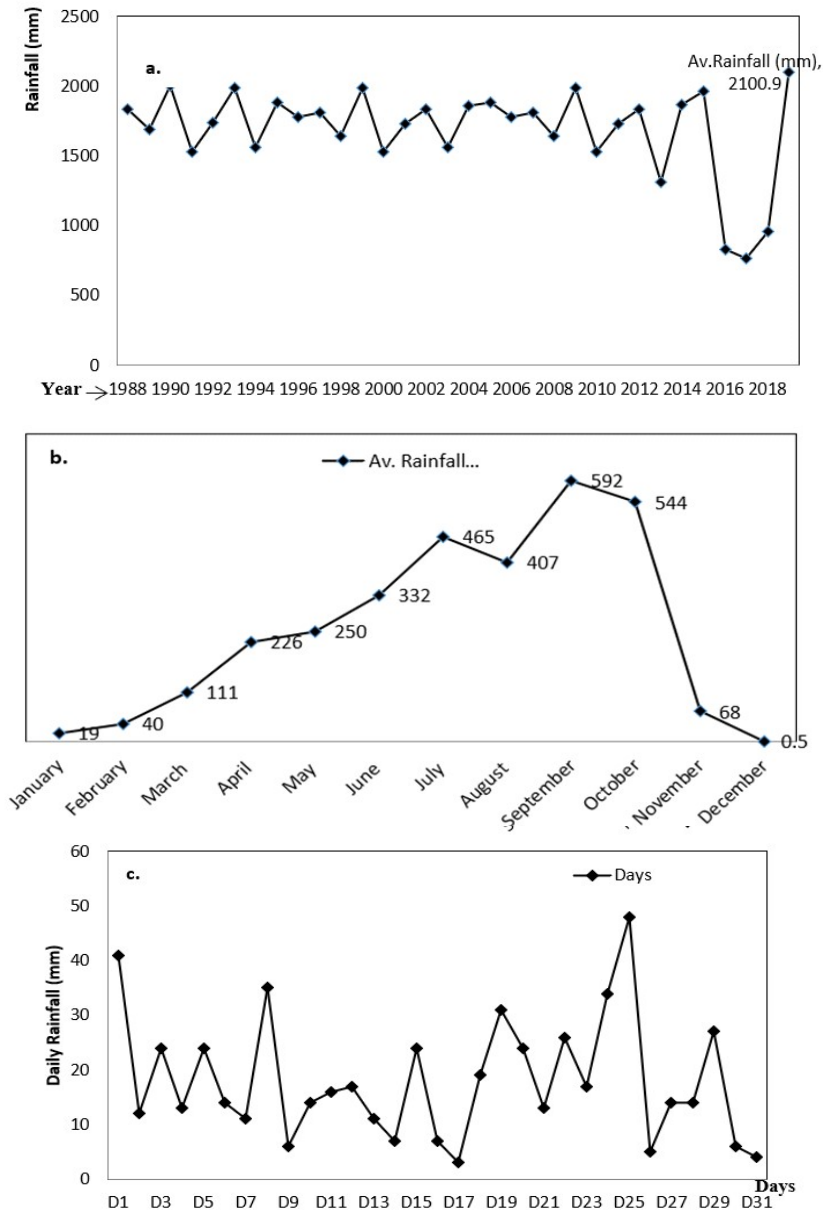
**Figure 3.** Rainfall plots showing a. yearly rainfall statistics for the last 30 years; b. monthly rainfall statistics in 2019 and c. daily rainfall statistics in the month of October when the landslide occurred

The rainfall plot for the last 30 years 1988-2019 showed that the highest precipitation of 2044.4 mm was recorded in 1985 meanwhile the lowest rainfall of 1313.7 mm was recorded in 2013 (Figure 3a). It started rising from 1864.4 mm in 2014 to 2100.7 mm in 2019. The graph shows a significant rise in average rainfall in the year 2019 in the past 31 years (Figure 3a). A rise in rainfall was recorded from January to September in Gouache with peak values in September (592

mm) and October (544 mm) that corresponded to the month of the landslide (Figure 3b). The lowest rainfall was recorded in the month of December (0.5 mm). Further analysis of the rainfall data for the month of October when the disaster occurred revealed that the highest rainfall was recorded on the 25 of October 2019 (Figure 3c). This was followed by a drastic drop on the 26<sup>th</sup> and a significant increase on the 29<sup>th</sup> of October when the landslide occurred (Figure 3c).

Heavy rainfall was cited by the respondents as the major natural factor that led to the Gouache landslide disaster (Figure 2). This information was corroborated with rainfall statistics plotted in Figure 3 which showed that the disaster occurred after peak periods of rainfall between September and October 2019. This information ties perfectly well with that of other studies that have examined the relationship between rainfall and landslide (Wiezorek, 1996; Gerrard and Gardner, 2000; Dai et al., 2002, Gabet et al., 2004; Alcântara et al., 2023; Marengo et al., 2023). Heavy rainfall leads to high water infiltration and increase in pore water pressures that reduces shear resistance on a slope and promote the downhill movement of material (Dynes, 1994). Average annual precipitation for Cameroon is approximately 1568 mm, while the mean number of wet days is around 138. This then shows that Gouache community has experienced a significant rise in rainfall over the past 30 years compared to rainfall recorded in 2019 (2100.7). In addition, the loss of vegetation in the past 19 years in the area as portrayed in Table 1, is believed to reduce the rate of evapotranspiration on slopes, leading to higher groundwater levels which reduces cohesion through the loss of root strength and increases overland flow, enhancing the rate of erosion (Crozier and Glade, 2005).

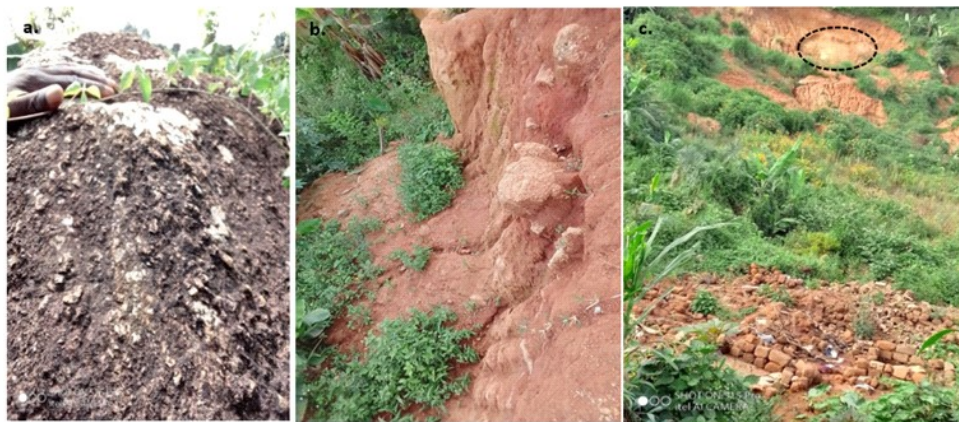
**Figure 4.** Geology of Gouache at the landslide site showing: **a)** Fresh granitic rock, **b)** clayey soil with intercalations of weathered granites and **c)** landslide scar

The nature of the geology of the area was also seen to be another natural contributory factor to the disaster. Geological data was obtained from field observations and investigations. The major rock types observed in the area were granitoids (Figure 4a) that had weathered to produce sandy and clayey soils (Figure 4b). Granitoids are light-coloured felsic rocks characterised by a coarse grain texture. The main minerals found in granites include plagioclase feldspars, quartz, and biotite. Feldspar (pink and white) decomposes chemically into clay minerals. Another important constituent of granite is quartz grain which is very resistant to chemical weathering and does not convert to any other mineral. It eventually goes into solutions but very slowly. Hence, disintegrated granite yields lots of quartz grains which are transported mostly by running water as sand grains. From these observations, it can be deduced that the original bedrock of the

Bafoussam III Municipality is the granite feldspar which is an intrusive (or plutonic) igneous rock.

Granitoids are known to react with naturally formed acids to form clay, which is a weathering product of rock mass and contributes to landslide occurrence because of its chemical and physical properties. However, clay has a high potential to shrink or swell depending on the water content. This characteristic of clay makes it prone to sliding off a slope once it is saturated with water. It is believed that the intense rainfall which is experienced in Bafoussam not only contributes to the weathering of the rock mass found there, but also increases the water content in the clays that in turn leads to reduction in the stability of natural slopes. Also, building on slopes or cutting off the toe of the slopes further decreases their stability. As a result, the area becomes more susceptible to land sliding, which could explain why such an event had occurred.

Looking at the geology, the rock types observed at the site of the landslide were weathered granitoids or granites that had broken down to form clayey to sandy soils (Figure 4) located along water channels (springs) found on moderate to steep slopes (Figure 5). Granitic soils are widely recognized to be very sensitive to weathering and vulnerable to landslides. The presence of springs/ streams at the foot of the slope where the landslide occurred, increased the susceptibility of the slope to sliding. Many landslide disasters have been recorded in Japan on granitic slopes following heavy rains (Chigira and Ito, 1999). Taha and Kabir (2005) further attested that in Malaysia, slope instability tends to occur more frequently in granite soil formation compared to metasediments.

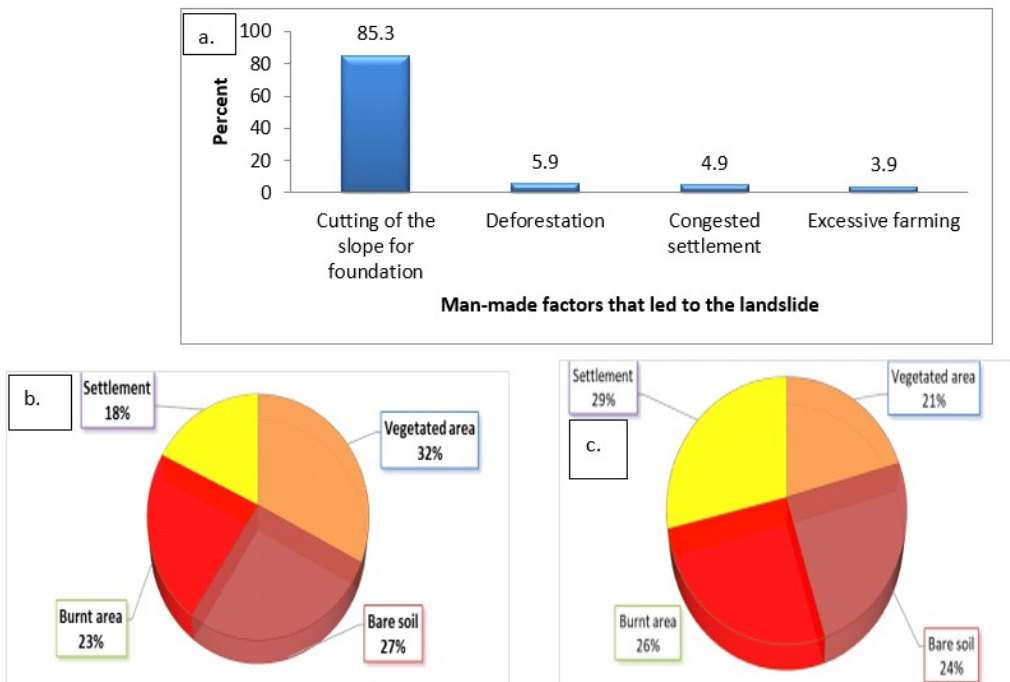
Figure 6: Anthropogenic factors that led to the landslide from: a. Respondents perception and b&c. landuse /land cover changes showing the total surface area (%) covered by different land covers in the Bafoussam III Municipality in: b. 2001 and c. 2020

the cutting of the slope for the construction of foundations of houses (85.3 %). This factor was followed by deforestation 5.9 %, congested settlements 4.9 % and excessive farming 3.9 % (Figure 6a). Other anthropogenic factors mentioned by key informants were: settlement on steep slopes; cutting of the toe of slopes for road construction and through erosion by a stream in a valley; the presence of cavities in the subsoil, and increased population in landslide risk zones.

Land use and land cover analyses using Landsat satellite imagery within a period of 19 years (2001 to 2020) in Gouache distinguished four major classes: vegetated area, bare soil, burnt area, and settlement (Figure 6b&c and Table 1). The statistics in Table 1 summarized in Figure 6b&c, show that between 2001 and 2020, there has been a significant decrease in vegetation from 32 to 21 % which shows an increase in human activities on the slope. Settlement increased from 18 to 29 %, the burnt area also increased from 23% to 26%, meanwhile, bare soil had a significant decrease from 27% to 24% (Figure 6b&c). All of this is as a result of a great increase in human activities on the slope which significantly contributed to the landslide

The major anthropogenic factors that caused the landslide were linked to poor land use/ land cover practices that led to deforestation and cutting of the slope for foundation/construction purposes (Figure 6). Other factors included congested settlement and excessive farming. Kjekstad and Highland (2009) and Margottini et al. (2013) mentioned that, human activities such as construction of highways, clearing land for crops, mining and quarrying, and other activities that alter drainage patterns; causes change in the vegetation regimes; alter the grade of the slopes; and usually result to change in the morphology of the landscape and could cause landslides. Dorren (2004), however, indicated that human activities leading to decreased stability of hill slopes are still minor when compared to geological factors, but are of great importance locally, such as undercutting of slopes during quarrying or excavation for infrastructure. Studies carried out by African Wildlife (2006) and Huppert et al. (2006) attest that, the cumulative impact of human activities without regard for nature has turned recent landslides from a natural phenomenon into a man-made disaster of epic

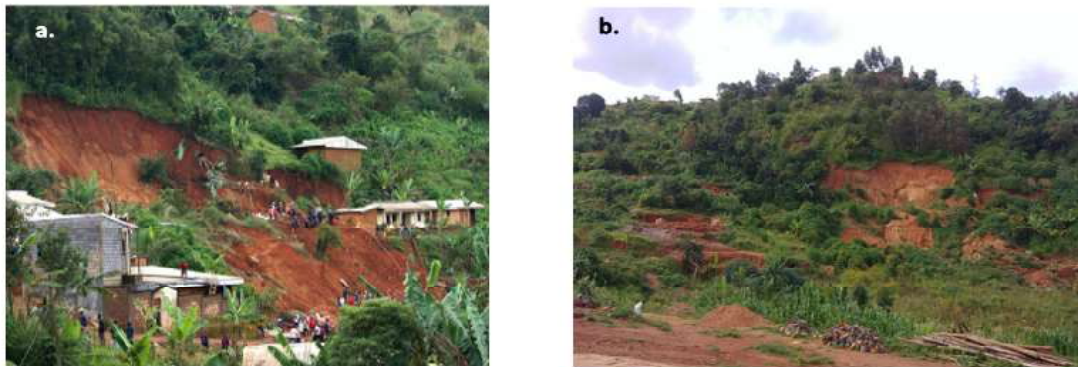
**Figure 8:** Landslide site at Gouache showing: **a)** the landslide scar in the centre and buildings that were unaffected at the side of the scar; and **b)** demolition of these buildings after the landslide event

Houses that were not affected by the landslide (Figure 8a) were all demolished by the council after the landslide event (Figure 8b), and hundreds of persons relocated to different areas where they were provided with a temporal residence.
