Physical vulnerability assessment and household preparedness of Buea Municipality to seismic hazards from Mount Cameroon Eruptions: A cause for concern

Nchini Livinus Wayih¹, Mabel Nechia Wantim^{1,2*}, Tuhmbom Engelbert Nkwain², Samuel Ndonwi Ayonghe²

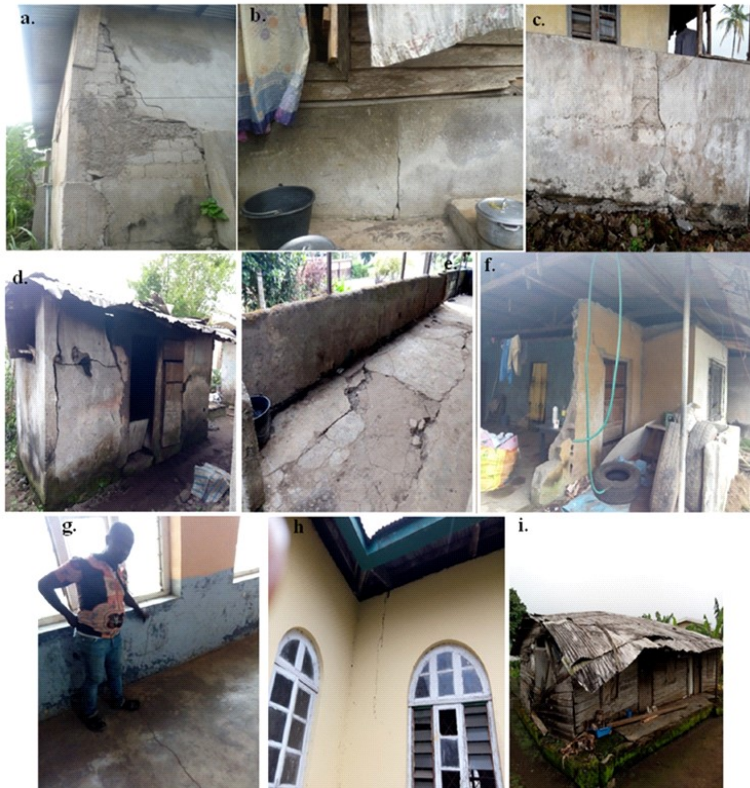
Fig. 4. Photographs taken in 2018 (19 and 18 years after the 1999/2000 eruptions) showing the destruction caused on houses by the 1999/2000 earthquakes from MC in the following localities within Buea Municipality: a-b. cracked wall and foundation in Great Soppo; c-e. old poorly maintained residential buildings in Buea Town with cracked walls and floor; f. partially destroyed inhabited house at Poto-poto quarters in Bokwango; g-h. cracks on walls in buildings at Sasse college; and i. dilapidated wooden house in Tole village

In 1999, the impact of seismic hazards escalated significantly, affecting Buea municipality more profoundly than previous eruptions (Fig. 3c; Fig. 4). Major and minor damages were observed across various neighbourhoods including Bokwaongo (specifically in Poto poto quarters; Fig. 4f), Buea Town, Small Soppo (even Sasse College was affected; Fig. 4gh), Bonduma,
