**SEISMIC PERFORMANCE ON STIFFNESS AND HYSTERESIS LOOP OF
INTERIOR WALL-SLAB JOINT FOR TUNNEL FORM BUILDING DESIGNS TO
BRITISH STANDARD**

M. A. Masrom^{1,*}, H. M. Yee¹, M. E. Mohamed² and N. H. A. Hamid²

¹Faculty of Civil Engineering, Universiti Teknologi MARA, 13500 PermatangPauh, Penang,
Malaysia

Published online: 17 October 2017

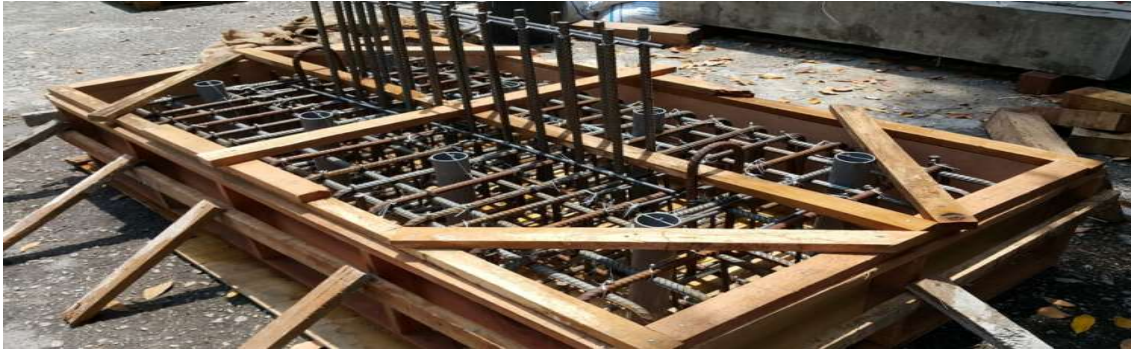
Fig.2.Preparation of foundation beam cage

The sub-assembly of RC wall-slab joint comprises of foundation shear wall and floor slab were constructed on strong floor of Faculty of Civil Engineering, Universiti Teknologi MARA, Malaysia. Initially, the foundation beam's cage was prepared in the lab prior to the construction of formwork as shown in Fig. 2. Fabric wires mesh (BRC-7) were cut according

to the size of the floor slab and wall panel. Reinforcement bars with 12mm diameter were used to tie wall and slab skeleton at cross-bracing joints with 200mm spacing between each other.

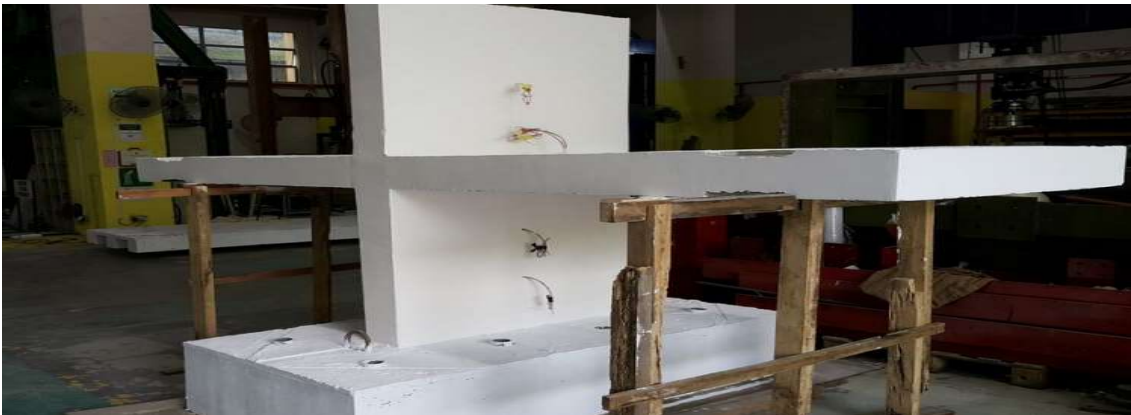
Fig.3. The wall-slab specimen is ready for testing

The wet concrete was poured up to the level of slab steel mold and let the wet concrete to cure and hardened for a few days. The sub-assembly of wall-slab joint was painted with color before any experimental work took place. This specimen a shown in Fig.3 is ready for instrumentation and experimental set-up before start testing.

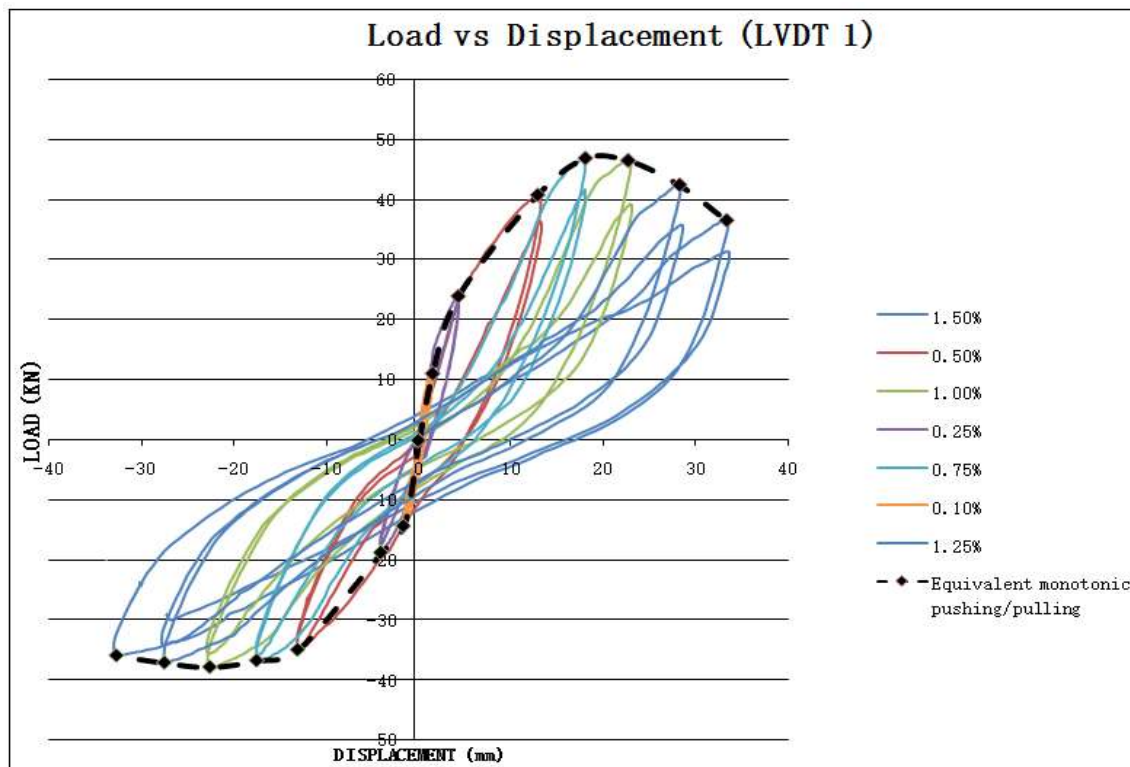
Fig.7. Hysteresis loops of wall based on LVDT 1

The hysteresis loops of wall-slab joint have plotted by using the data obtained from 0.1% drift until 1.5% drift as shown in Fig. 7. It shows the hysteresis loop of wall-slab joint which based on data obtained in LVDT 1. By observing the individual hysteresis loop at every drift percentage, it can be discovered that the individual loop shows the small enclosed pattern of loop. This indicate the small energy dissipation in the system which not effective to maintain longer under lateral cyclic loading. Consequently, the brittle failure happened in the wall-slab connection.

The biggest hysteresis loops were occurred at LVDT 1 which located the closest to the double actuator. The significant loss of stiffness (resulted from high-energy dissipation) has identified in the early of drift level (0.1% to 0.5% drift) and followed by gradual fashion until end of experiment. Therefore, this type of structure needs to increase the percentage of reinforcement

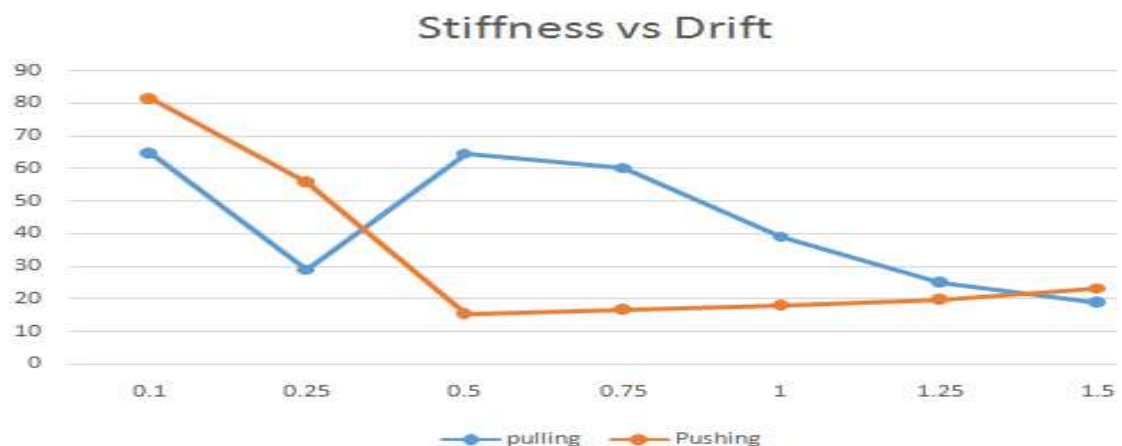
Fig.11. Stiffness profile of wall based on LVDT 4

It was discovered that LVDT 4 as shown in Fig. 11 was showed the similar pattern of stiffness as discussed in LVDT 3. Fig. 12 shows the cracks occurred at wall-slab joint. Spalling of concrete occurred at top part of the joint when the lateral load is applied on top of the wall. Applied lateral cyclic loading on the sample was induced the alternate tension and compression stress at the joints.

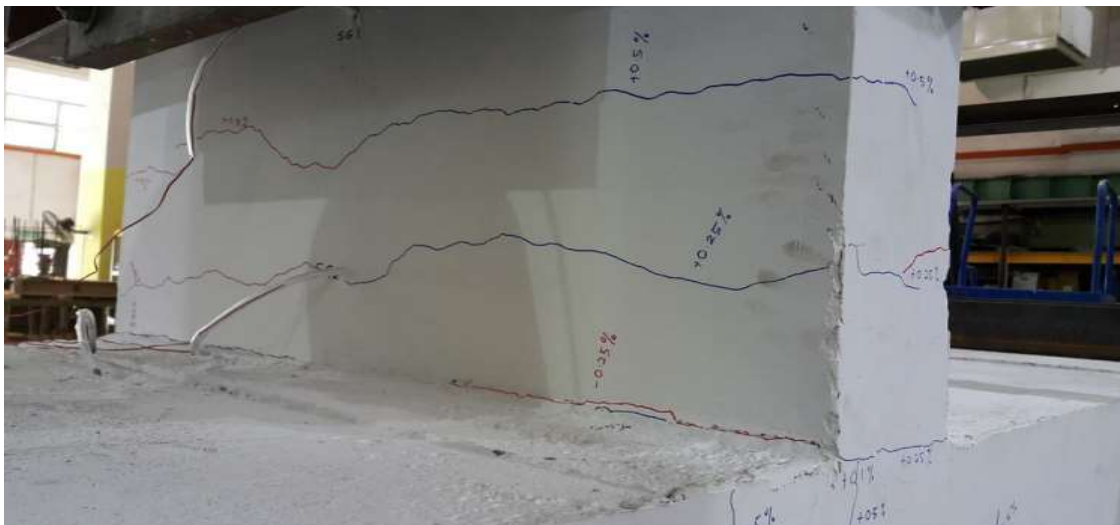
Fig.13. Cracks at wall-slab joint from rear view

Fig. 13 shows the crack on the wall from rear view. It can be observed that the higher stress was induced many cracks at wall which closed to the vicinity of wall-slab joint. Stress in the upper part of wall-slab joint is greater than the bottom part. Therefore, a lot of cracks occurred at upper part of the wall and the cracks started to propagate from slab to both sides of the wall.

bars in the concrete and proper detailing at joint is required for seismic loading. Many cracks were observed in the vicinity of the wall-slab joint. Most of the cracks developed at the rear wall, bottom of slab and wall-slab joint surface. It was discovered that the wall-slab joint was governed by brittle modes failure. The minimum amount of vertical and horizontal steel at the wall-slab joint was unable to carry the additional load. Therefore, spalling and cracking of concrete cover were observed, longitudinal reinforcements yielded and fractured suddenly without any warning.
