## CASE STUDY

# An evaluation of small-scale irrigation schemes infrastructure

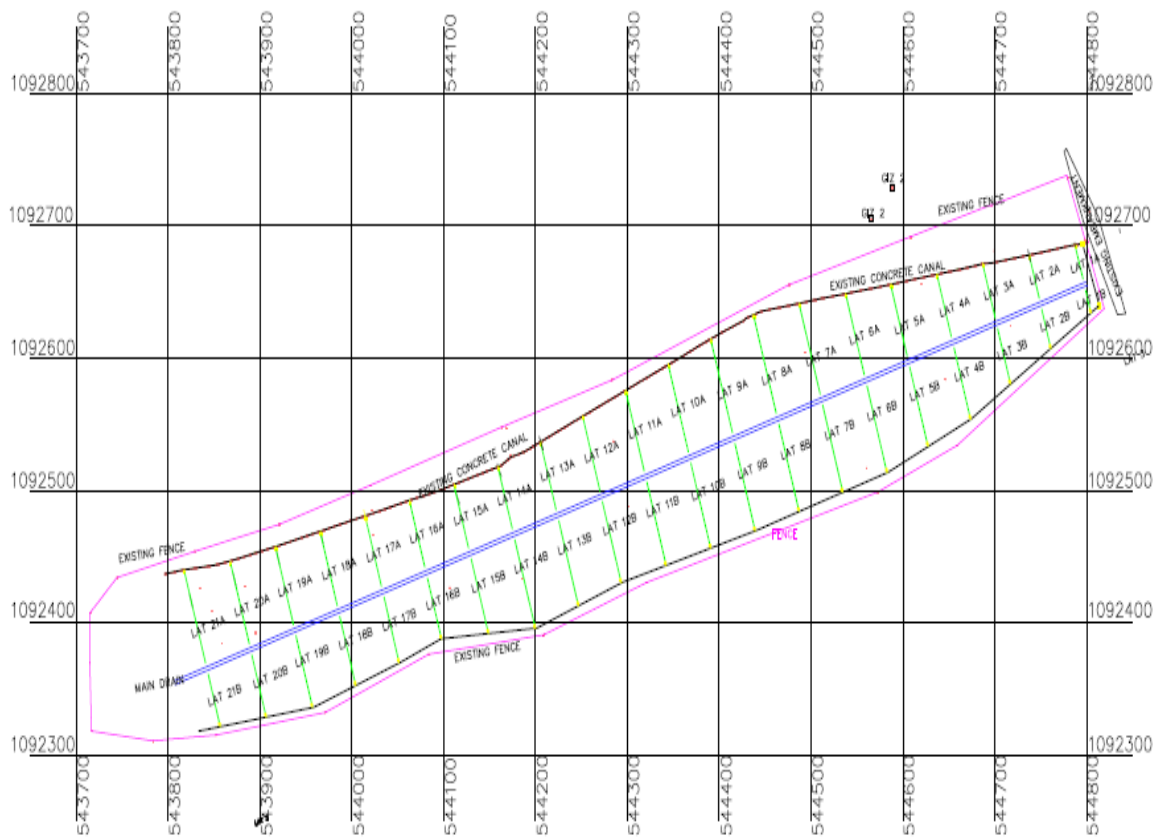
Figure 2 General layout of the Yeleyiri irrigation network

small-scale irrigation development project implemented by the GIDA between 2001 and 2003. The scheme is made of one main canal which is responsible for the distribution of water on the scheme. The scheme has no secondary and tertiary laterals. However, the scheme has a fenced irrigable area. According to GIDA, the reservoir's area of the dam is 157 000 m<sup>2</sup>, and allows for an irrigable area of 18.50 ha . The general layout for the Yeleyire irrigation network is indicated in Figure 2.

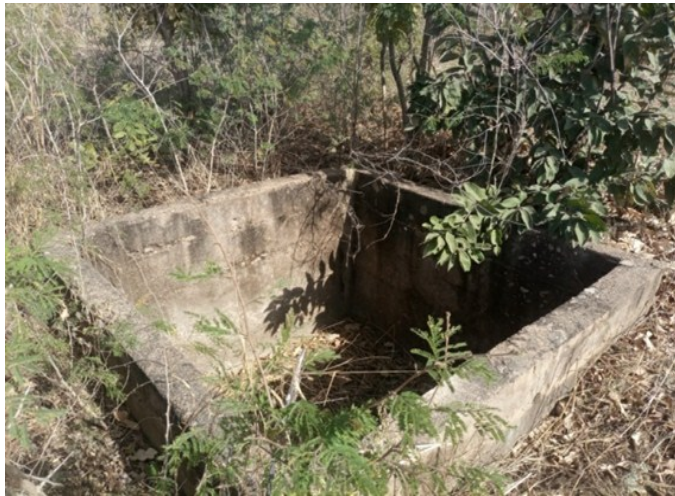
to water for irrigation. There were seventy-six (76) tanks to irrigate the fields. The tank had a dimension of  $2m \times 2m \times 2.5m$ , thus the volume of each tank is  $8 m^3$ . However, some of the tanks did not receive water as result of broken down pipe network. Figure 6 below shows a typical tank at the Pulima irrigation scheme that do not receive water.

**Figure 6** A concrete tank not receiving water due to broken pipe network at the Pulima irrigation scheme

| S/N | Component | Section | Proposed Intervention |
|---|---|---|---|
| | | Tanks system | Clear tanks of bushes and shrubs growing around the reservoir. Carry out maintenance works on the tanks. |

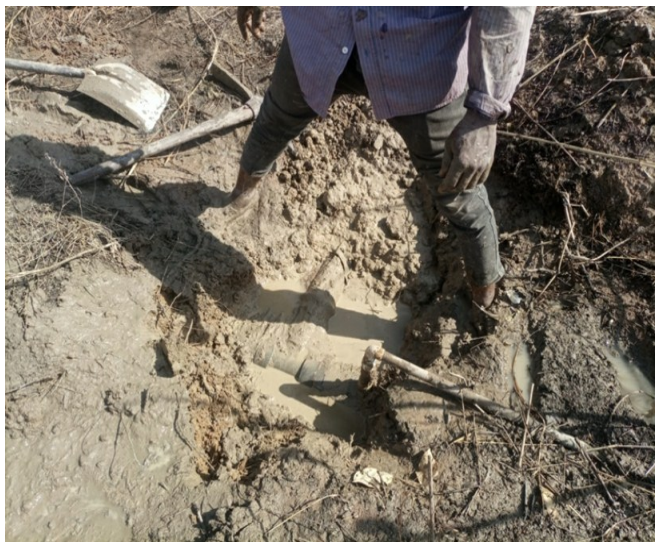
In addition, there were eight (8) standpipes across at various sections of the area, which were used to support irrigation. Some of the pipes connecting into the tanks were also completely broken making it difficult for some sections of the irrigable area to have access to water for irrigation (Figure 7 illustrates a pipe that was broken and leaking). Also, 15 number of the  $\frac{3}{4}$  valves were leaking at various sections with most of the pipes blocked and thereby preventing water from reaching the tanks.

**Figure 7** Assessment of broken down pipes to tanks at the Pulima irrigation scheme

| S/N | Component | Section | Proposed Intervention |
|---|---|---|---|
| 2 | Water distribution and the irrigable area | Pipe layout | Replace broken down 3/4 pipes connected to tanks. Remove and replace blocked and broken down 3 inch pipes in the main line |

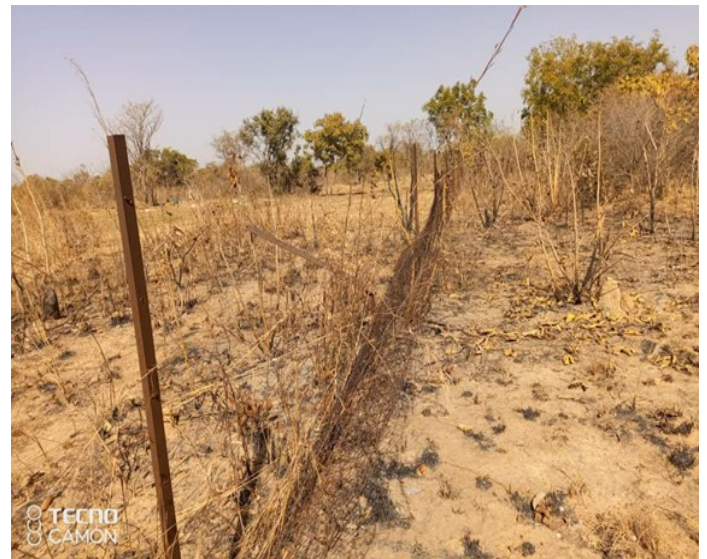
Furthermore, the researchers observed that the irrigable area was fenced but in a deplorable state. The main fence gate was broken together with some of the poles and the wire mesh. 25 number of the fence posts were broken, allowing animals access to the farm (Figure 8 shows portions of the broken wire mesh fencing). Consequently, Breetzke *et al.* (2022) observe that fence must be placed around the irrigable area to avoid livestock from entering and, also, to protect against theft.

**Figure 8** Portions of broken wire mesh fencing

| S/N | Component | Section | Proposed Intervention |
|---|---|---|---|
| | | Fence | Replace broken sections of the fence and repair the 2 broken gates. |

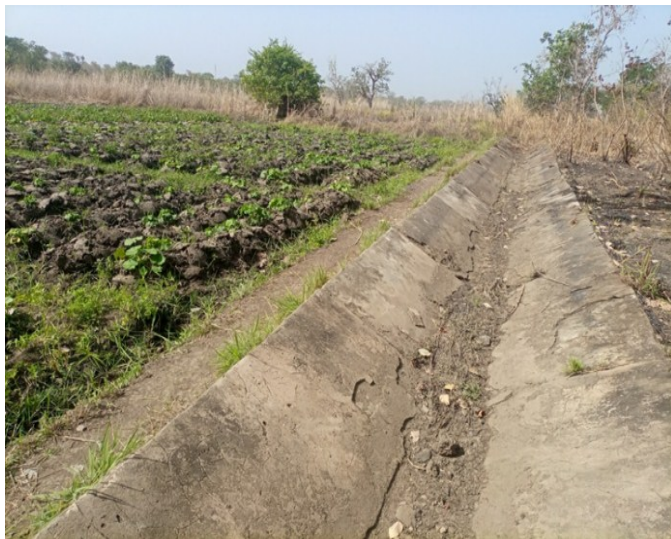
Water on the Yeleyiri Irrigation scheme was distributed by one main canal with a length of 1250 m. The researchers during the fieldwork observed that, portions of the main canal was cracked (as shown in Figure 11) and was therefore unable to convey water to all parts of the irrigable area due seepage from the canal bed. Also, there were no secondary or tertiary canals, thus, water from the dam was unable to reach the far ends of the irrigable area. The absence of the laterals made farmers to spend long hours waiting for water to reach their fields, which had led to majority of the farmers abandoning their plots at the far end of the irrigable area from the dam. Consequently, the

**Figure 11** The main conveyance with the canal lining removed at the Yeleyiri irrigation scheme

| S/N | Component | Section | Proposed Intervention |
|---|---|---|---|
| 2 | Water distribution and the irrigable area | Irrigable area | Provide a second main pipe or canal of 1250 m length and 15 number laterals of 60 m length laterals to effectively conduct water to parts of the irrigable area |

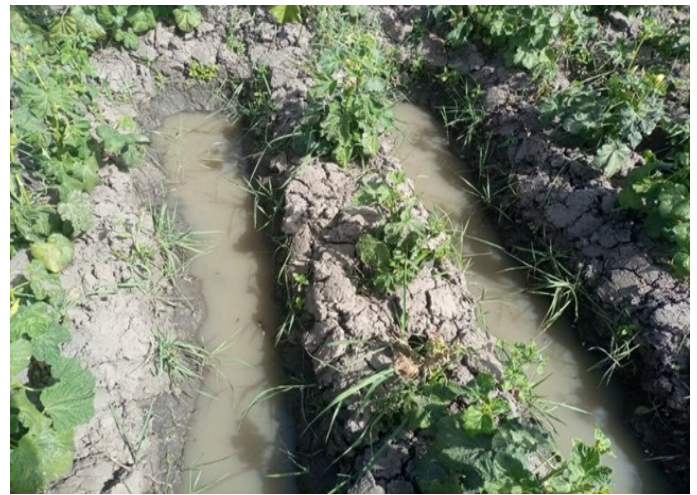
The assessment showed that there was no main drain on the Yeleyiri Irrigation scheme. The absence of the main drain had created a water-logged situation on the field, thereby affecting soil fertility and crops productivity. Drainage was one of the major challenges confronting the Yeleyiri Irrigation Scheme. Figure 12 shows a pond of water within ridges in the irrigable area of the Yeleyiri irrigation scheme due to poor drainage.

**Figure 12** Ponds within ridges in the irrigable area of the Yeleyiri irrigation scheme due to poor drainage

| S/N | Component | Section | Proposed Intervention |
|---|---|---|---|
| | | Drainage | Construct a main drain to drain excess water of the irrigable area. Drainage should include sub-drains and main-drains |
