**Architecture in Southern Algeria: A Study on the Factors and Causes of its Collapse and the ways of its Preservation:
Ksar Melouka “Melouka Palace” as a Model.**

Keywords: Architecture; Ksar Melouka; Touat; Rehabilitation; Preservation; Restoration.

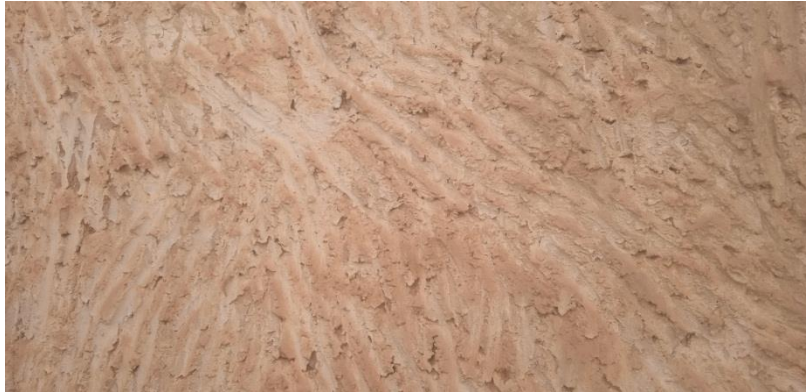
plaster the walls with mud mortar, builders use a flat wooden piece, and sometimes even their hands, leaving visible traces on the walls, as shown in the following image.

figure 01: The image illustrates the use of hands in plastering the walls.

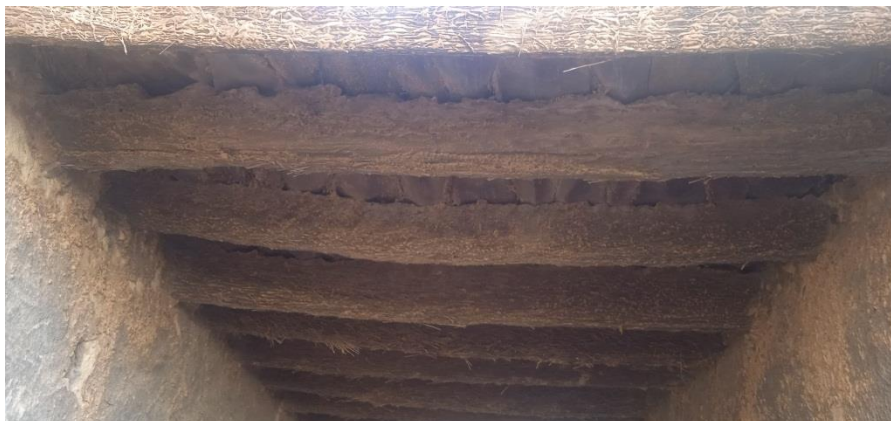
Palm trunks were used in the roofing technique of the palace due to their abundance. The roof takes the shape of the covered area, with a series of prepared wooden pieces placed vertically on the walls, spaced equally apart. Then, the leaf bases (*Kurnaf*) are placed on top of them, as shown in the following image.

figure 02: The image illustrates the technique of roofing with palm wood.

Afterward, it is covered with palms fibers or worn-out clothes, then the whole structure is covered with clay. Afterward, it is polished to create a smooth layer. In building this type of roof, it is important to ensure its slope

towards the roof gutters "*mizeb*" to prevent water accumulation. In this technique, the length of the room does not exceed three meters based on the length of the palm wood. The thermal insulation increases with the thickness of the clay material used above the palm wood, but it should not exceed 40 cm to maintain its compatibility with the load-bearing capacity of the wood for this thickness¹³.

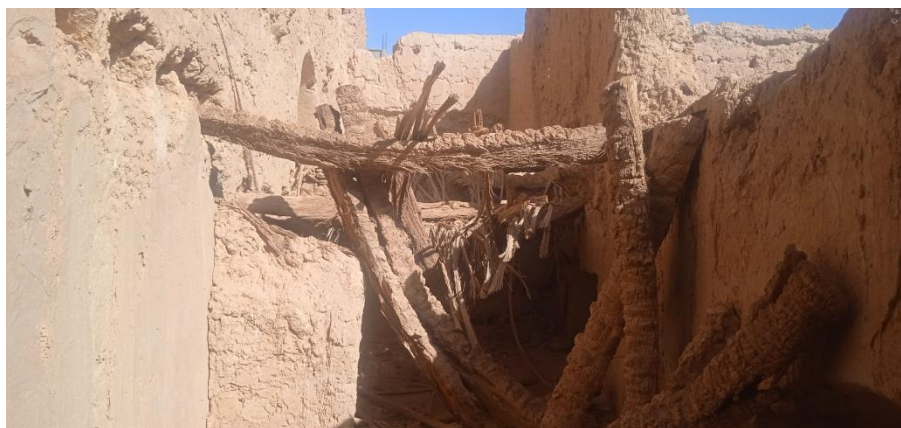
Due to the fact that palaces “*Ksour*” are located in a desert environment where rainfall is rare, it is seldom discussed; however, this does not prevent us from addressing this factor. The building materials used in these monuments are highly affected by rainwater, which works to disintegrate the building materials and can directly penetrate the roofs of the buildings and their various elements. This is especially true considering that rainfall in these areas can be sudden and sometimes heavy, lasting for periods of up to 48 hours. It often leads to the collapse of many buildings, and rainwater frequently manages to infiltrate buildings through the gaps between walls and windows, as well as through the porous nature of the building materials and the roof surface. The following image illustrates this:

figure 03: The image illustrates the effect of rainfall on *Kasr Melouka*.

Water is considered the main and principal factor in deteriorating the buildings built with soft bricks, because the increase of water provokes the total separation of clay’s minerals and moving them from their places. This case happens directly when the buildings are exposed to heavy rains, and happens indirectly when rain water is flowing on their walls¹⁸.

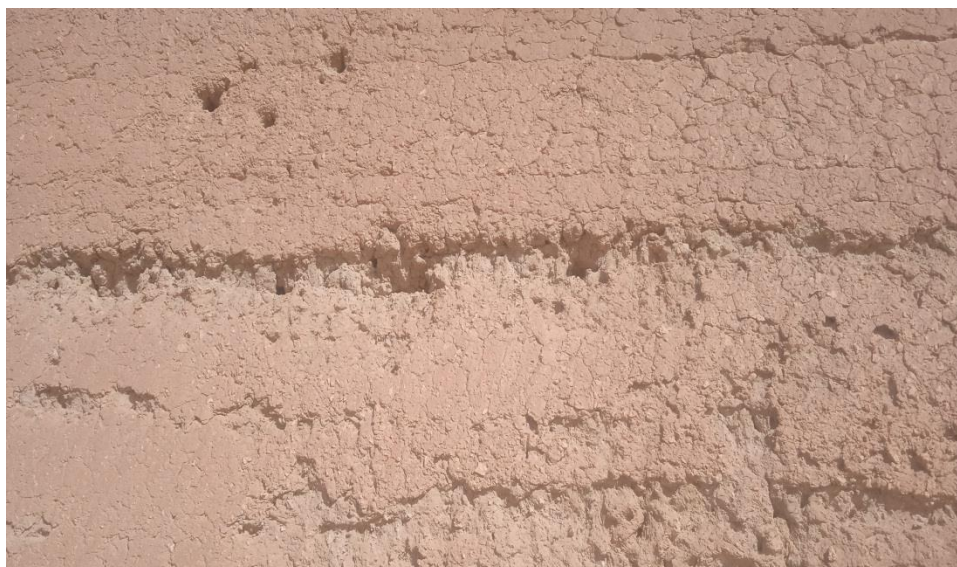
to the deterioration of buildings made of soft bricks, which is an important factor directly affecting them, primarily through the phenomenon known as sandblasting²³, as illustrated in the following image:

figure 04: The image illustrates the impact of wind on the northern wall of *Kasr Melouka* **Source:** The researcher.
