# Hollow Mill for Extraction of Stripped Titanium Screws: An Easy, Quick, and Safe Technique

Removal of jammed titanium screws can be difficult due to the problem of stripping of the hexagonal heads of the screws. We present a technique of extraction of stripped screws with the use of a standard 4.5 mm stainless steel hollow mill in a patient of peri-implant fracture of the radius fixed with a titanium locking plate 2 years back. The technique is quick, safe, and cost effective.

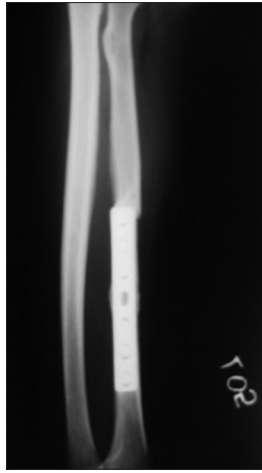
**Figure 1:** Peri-implant fracture at the proximal end of the plate

two years of radius plating with LC DCP (Synthes, India). The X-ray showed a transverse fracture of the left radius at the proximal end of the plate [Figure 1]. After routine examination and work up, the patient was taken up for surgery.

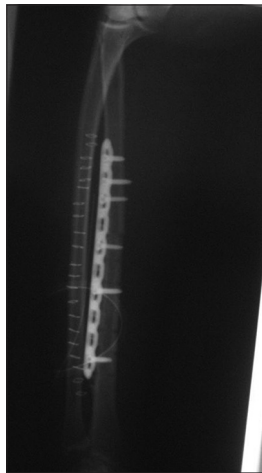
**Figure 3:** X-ray after removal of the original implant and application of the new implant

The tapering drill bit designed for removal of titanium screws by cutting the threads in the shaft of the screw in the reverse drilling direction was not available. We used a locally manufactured stainless steel hollow mill, actually designed to cut the bone around screw during jammed screw removal from the bone. Using it in a high-speed drill, we were able to grate out the titanium metal at the plate hole - screw head interface which facilitated the plate removal. The protruding screw heads from the bone were then easily held by a nose plier and removed by rotatory motion. To prevent contamination of local tissue by metal particles, wet gauge pieces were kept around each side of the plate. The fracture was reduced and fixed with a new 10-hole titanium locking plate, making new holes on each side of peri-implant fracture [Figure 3].

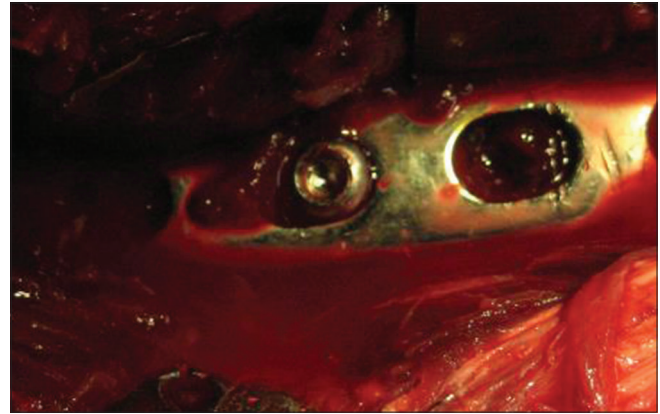
**Figure 2:** Stripped screw head

During the surgery, removal of the two screws from the plate on the opposing ends of the plate was difficult and resulted in stripping of the sockets of the screw heads [Figure 2].

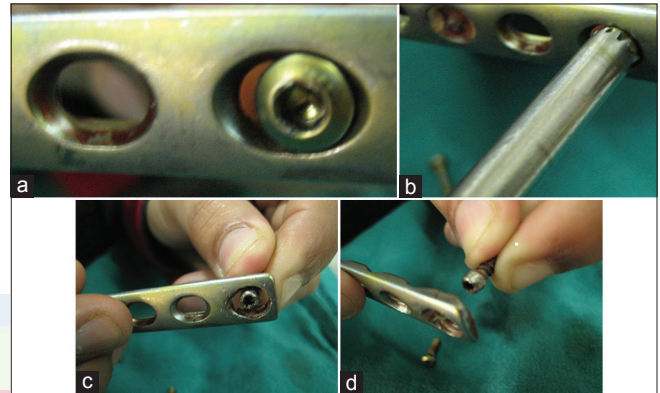
**Figure 4:** (a) Stripped head of a jammed screw (b) Use of high-speed stainless steel hollow mill around the head of the screw (c) Enlarged hole of the plate after grating of the metal from the periphery of the hole (d) Screw head passing through the enlarged hole

Figure 4a-d experimentally demonstrate the steps of removal of a screw from one of the undamaged holes of the extracted titanium plate by reproducing the steps used in the surgery.

alternative. Since the principle of the present technique is based on the enlarging of the size of hole in the plate rather than reducing the size of the screw head [Figure 4b], the technique can be applicable to the stripped screws in the case of cold welded locking screws as well.

The present procedure is simple and quick that can be performed universally without any specific inventory of tools. A stainless steel hollow mill, which is a part of the standard DCP sets, is mostly universally available. The stainless steel being harder than titanium, the high-speed rotation of the mill quickly grinds the holes of the titanium plate making it wide enough to allow the passage of the screw head [Figure 4a-d].
