Analysis of Spatial Bacteriological Quality Variation of Domestic Water Source Points in Mbarali District, Tanzania

¹Gislar E. Kifanyi*, ²Hildegard Kasambala, ³Rosemary Kavishe, ⁴Moses Moyo

^{1,2,3,4} Mbeya University of Science and Technology, P.O. Box 131, Mbeya, Tanzania

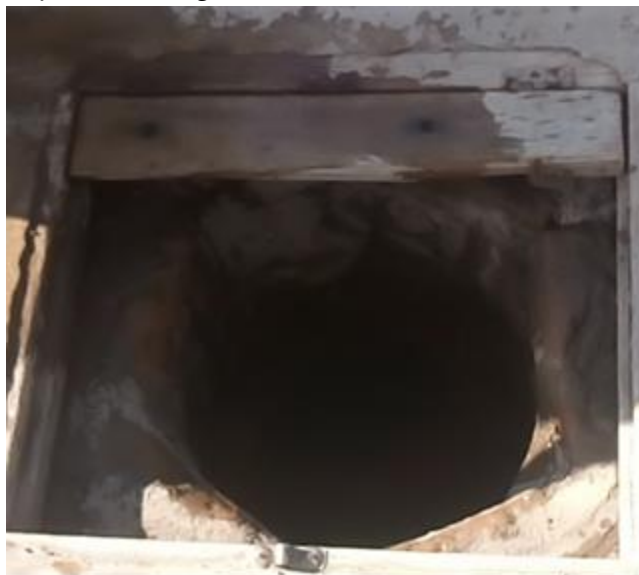
Photo 1(a)
Unprotected Dug Well

As depicted in Photos 1(a) and (b), we found water source points situated approximately 5 meters adjacent to the residential area. It was further observed that wastewater was flowing from the residential area into the water source points. For example, the direct deposition of feces into the water body increases the survival rate of pathogens due to the rapid sorption of contaminants onto bed sediments (Goss & Richards, 2008). According to a study by Liu *et al.* (2019), animal manure and feces are key sources of

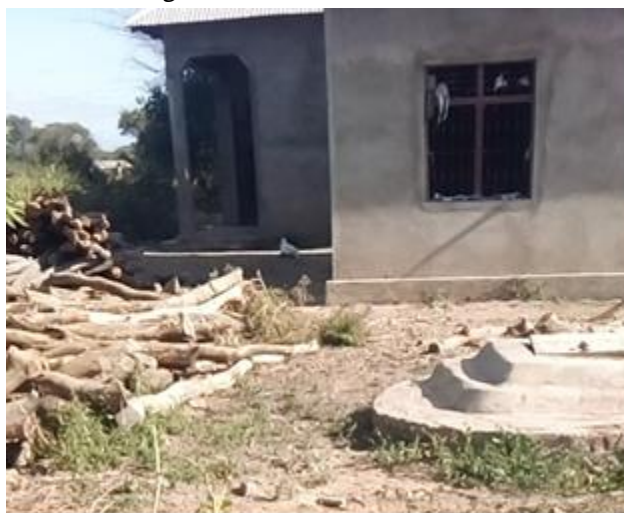
Photo 1(b)
Protected Dug Well

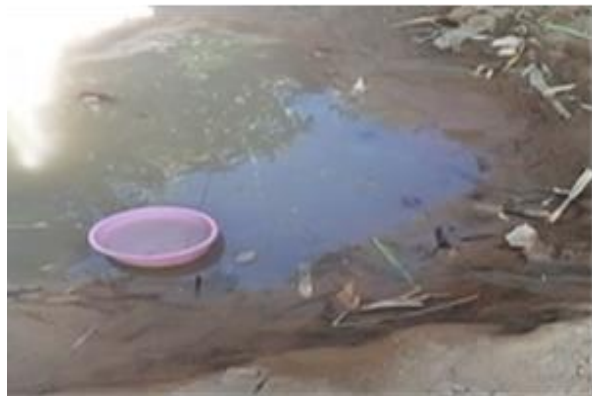
Photo 2(a)

Unimproved Unfenced Unprotected Dug Well

It should be noted that most of the dug wells found in the study area were unprotected and highly polluted, smelling odd. The dug wells were observed to contain high turbidity and sedimentation (see Photos 2(a) and 2(b)). Shrub thorns were used to protect the dug well from cattle and wild animals.

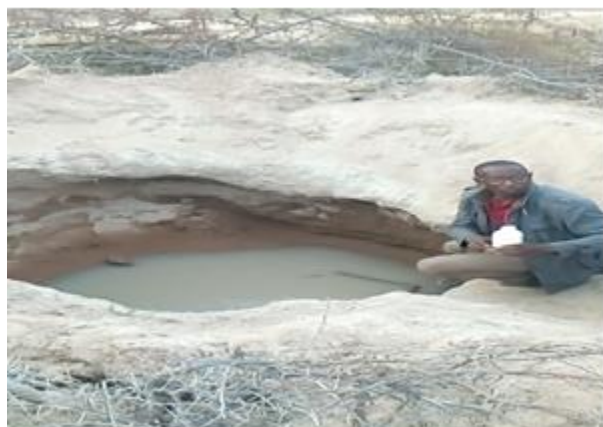
Photo 2(b)

Unimproved Unprotected Fenced with Shrub Thorns
