Drinking water quality and identification of fluoritic areas in Machinga, Malawi

S. M. Sajidu^{*1}, F.F.F Masumbu¹, E. Fabiano¹, C. Ngongondo²

ABSTRACT

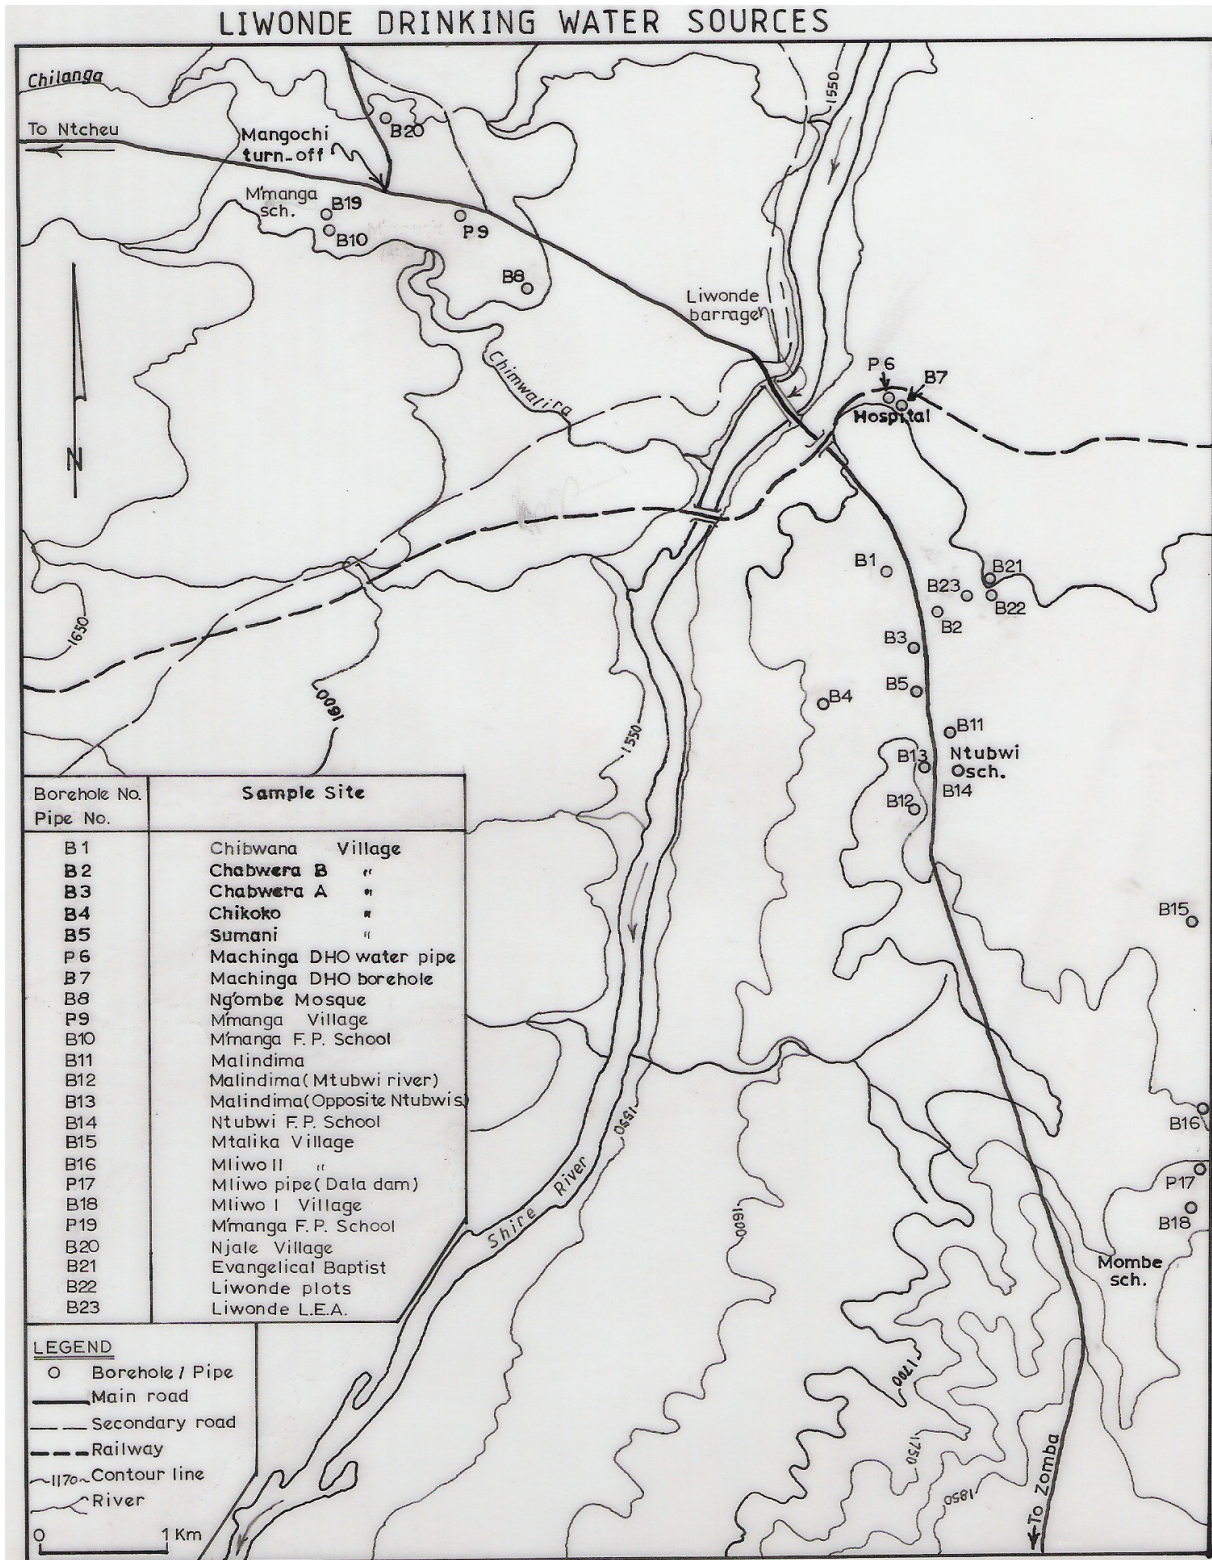
Figure 2a: Map of Liwonde showing boreholes and water pipes, which were sampled.

The study area is located between 15°02'S to 15°07'S of the Equator and 35°10'E to 35°15'E of Greenwich. Figure 2a shows locations of the sampling sites. Population size (for those aged 18 years and over) of Liwonde Township in 2004 was 8,262 (NSO, 2004). No population figures were available for the study areas outside the township but the estimated total population for the whole study area is over 14,000. Samples were collected from several drinking water sources, which were mainly boreholes.

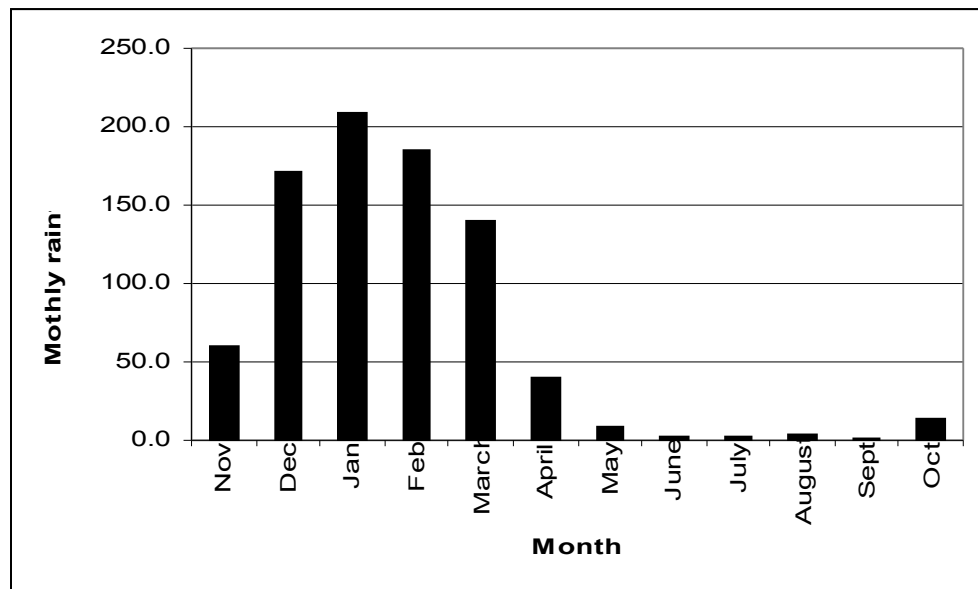
Figure 2b: Monthly average rainfall profile for Liwonde

The area is among the hottest areas in Malawi with mean maximum temperature at 39° Celsius and mean minimum temperature at 7.2° C. It is a relatively low rainfall area and the mean monthly rainfall distribution is shown in figure 2b.

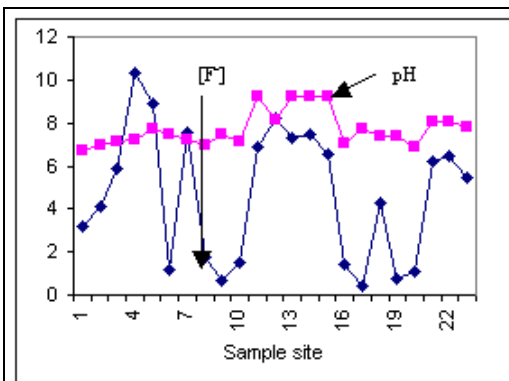
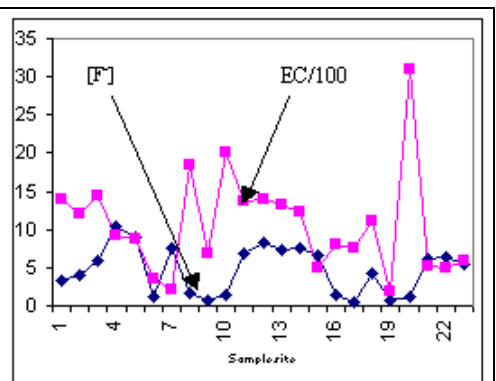
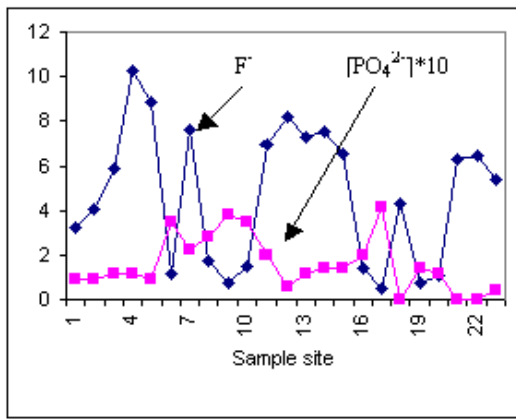
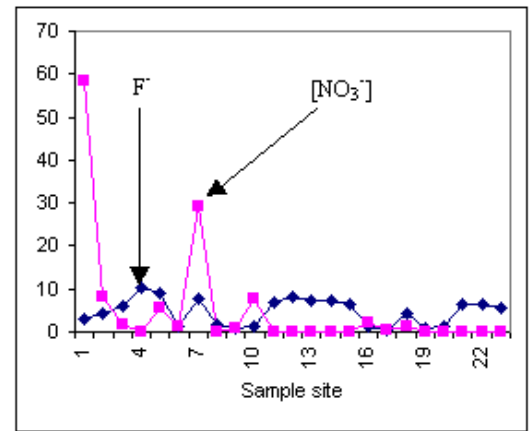
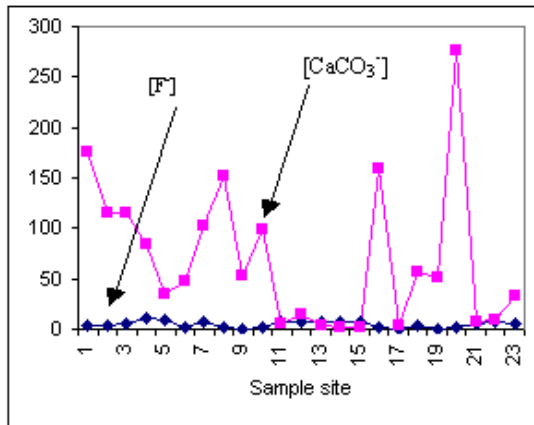
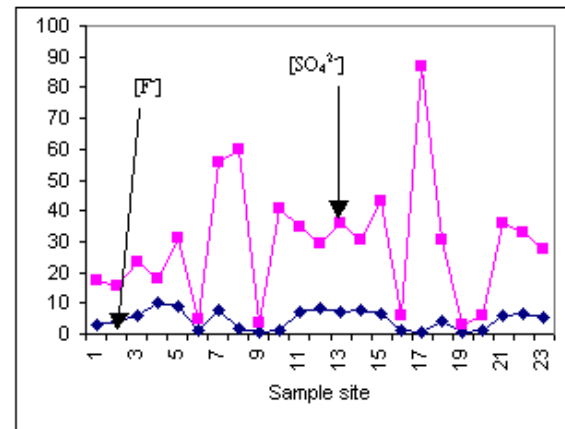
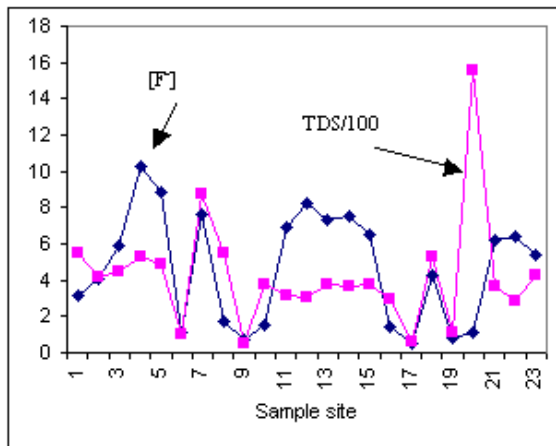
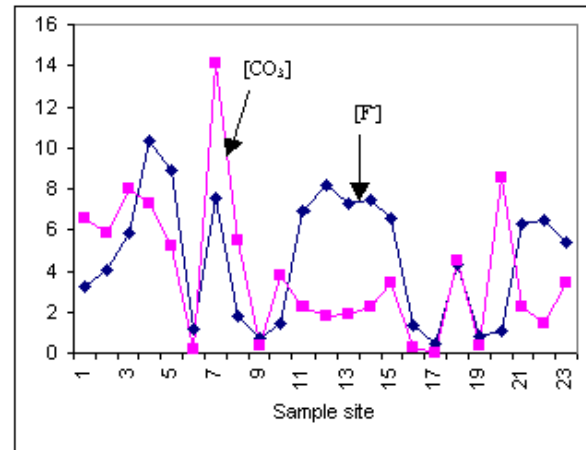
Figures 3A to 3H: Graphs of fluoride levels compared to levels of other (indicated) parameters for dry season analysis

Graphs showing the correlation of fluoride content with other water

parameters were determined and are presented in Figures 3A to 3H. In general, the graphs show positive correlation between the concentrations of fluoride with pH, total dissolved solids and carbonates. However, phosphates correlated negatively with the fluoride concentration and no obvious correlation was graphically depicted in the case of fluoride concentration and electroconductivity, nitrates, total

hardness and carbonates. Further work on multiple regression is needed in order to correlate the behaviour of fluoride on other water parameters.
