ORIGINAL PAPER

A Preliminary Inventory of Hazardous Medical Waste Disposal Systems and their influence on Groundwater Quality in Lusaka

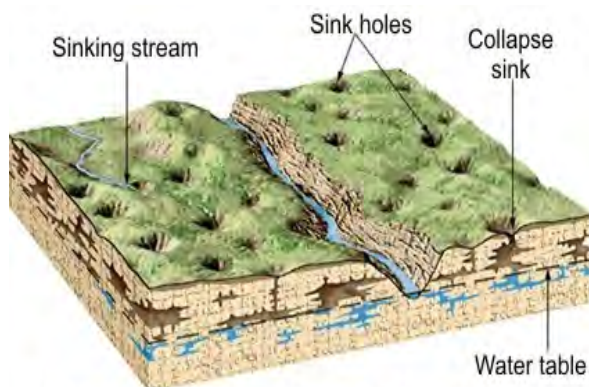
Regions with mank sink holes exhibit karst topography

Figure 1. Typical karst topography in a marble terrain

Karst is an area of irregular limestone in which erosion has produced fissures, sinkholes, underground streams, and caverns (as shown in Figure 1 in the text).

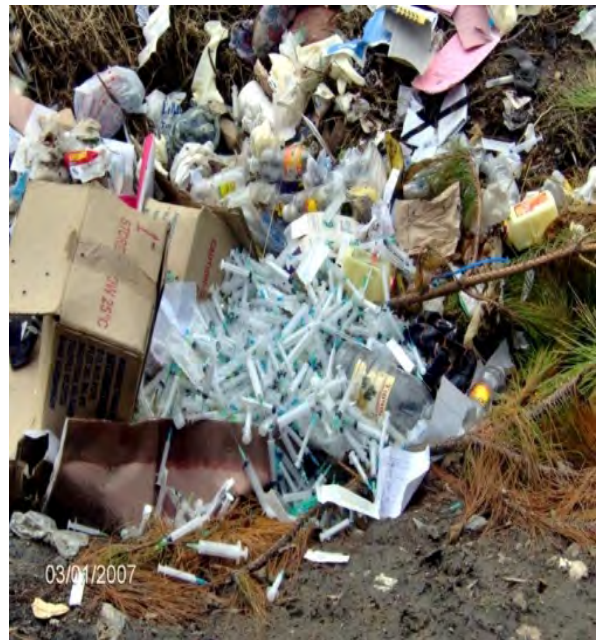
Figure 5. Disposal of sharps at an open dump

a) *Refuse pits* used to dispose of papers, plastics and empty plastic bottles, kitchen waste and food remains. However, there have been instances, when sharps and other incineratable wastes have sometimes ended up in refuse pits (Figure 5). Such a practice poses the obvious danger of re-use of such waste and the potential for the spread of infectious diseases.

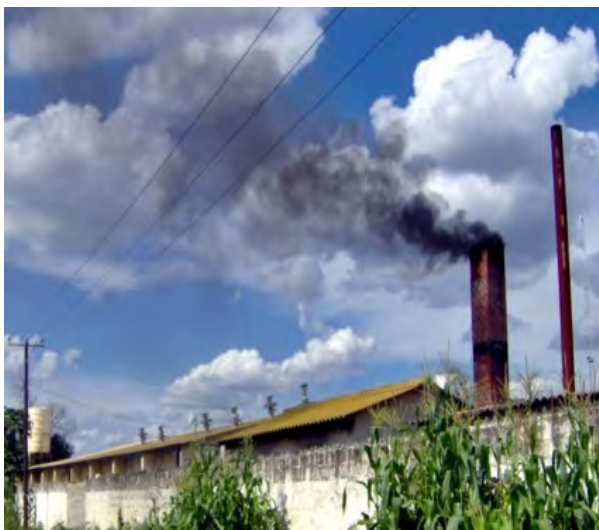
Figure 6. Incinerator chimney bellowing out smoke at a clinic in one residential townships

- c) *Incinerators* these still constitute the disposal method of choice for expired drugs, sharps, sputum bottles, and soiled cotton swabs. Incinerators cater for waste of heterogeneous chemical composition, whose combustion characteristics are determined largely by where it is generated. Therefore, such waste requires to be burned at very high temperatures. However, being in a country that is stressed by resources, use of incinerators that operate mainly on expensive fuel has not been very efficient. Further, although most of the medical wastes deserve incineration, most of the health centres' incinerators were dysfunctional at the time of this research. Consequently, medical wastes most of it *untreated* ended up in open dumps, while ash remains found application as manure for growing vegetables. Another challenge posed by the use of incinerators arises mainly from the smoke that bellows out of their chimneys (Figure 6). Because of the height of the chimneys, smoke ends up enveloping residential areas that are located on the downwind side of the chimneys, thereby posing different forms of nuisances to the residents.

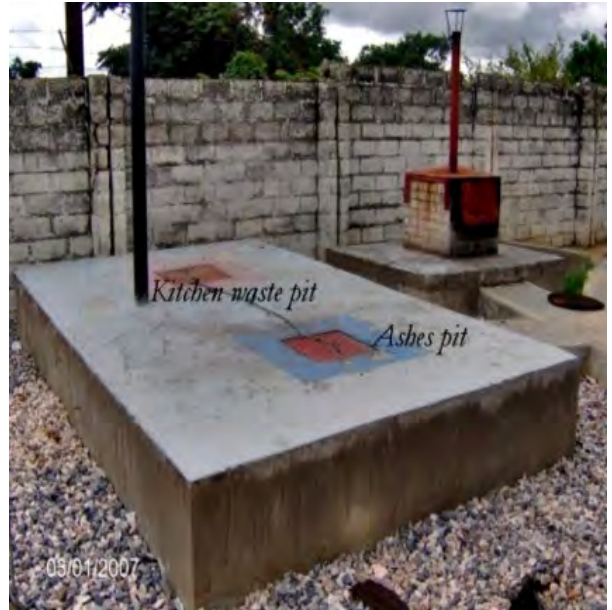
Figure 7. Container for incinerator remains at George clinic

Although inappropriate disposal of waste has gone unabated in most healthcare centres of Lusaka, George clinic has chosen to be an exception by containing incinerator remains in lined underground excavations (Figure 7).

Finally, this research wishes to recommend that best practices with regard to handling and disposing of incinerator ashes as observed at the George clinic must be replicated in other healthcare centres in Lusaka and elsewhere throughout the country. A summation of these activities is likely to constitute a good starting point to ensuring a city with a safe and protected natural environment, in which people may live a healthy and productive life.

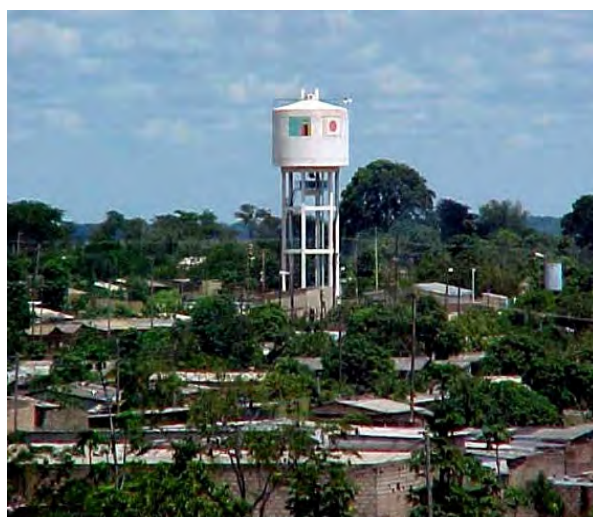
Figure 8. One of the tanks used to distribute water in George compound.

- a) The source of water to the George clinic is the JICA boreholes that are drilled on the outskirts of the settlement. The water is conveyed to the tanks that are erected within George compound, chlorinated, and conveyed to consumption points, including George clinic. One tank actually stands within the George clinic grounds. There is one such tank at George clinic (Figure 8).

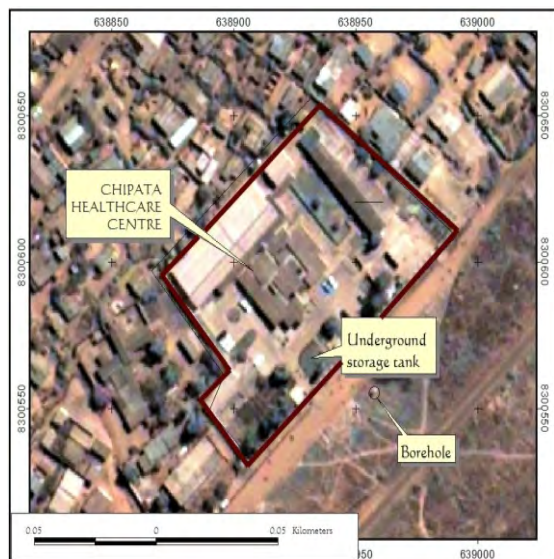
Figure 9. Location of Chipata healthcare centre and the water supply borehole and distribution underground tank.

- b) The Chipata clinic borehole is situated away from the main area of human activities (Figure 9).
