Rehabilitation of a Failed Implant-Supported Mandibular Complete Denture Using Cast Copings: A Case Report

Clinical Case: A Case of an 84-year-old female who presented to the Prosthetics clinic, University of Benin Teaching Hospital, Nigeria for rehabilitation of a failed implant-supported mandibular complete denture using bar cast coping. She had an all-on-four implant-retained mandibular overdenture with a resilient liner done outside the country. The prosthesis was replaced with a new acrylic mandibular overdenture retained with cast copings and a bar over the implant. She had one and four weeks of post-insertion review.

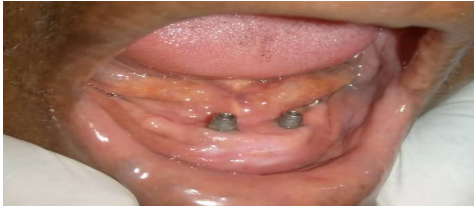
Figure 1: Clinical photograph of the lower jaw

A case of an 84-year-old female who presented to the Prosthetics Clinic, University of Benin Teaching Hospital, Nigeria on account of difficulty in mastication and speech due to loose fitting and non-retentive implant-supported mandibular overdenture. The patient has had multiple dental visits and is currently wearing an implant-supported overdenture on the upper and lower jaws which was done 3 years ago, outside the country. She complained of problems with the lower implant-supported overdenture which became loose; making it difficult to function with it. Also due to the bulkiness of the zirconia prosthesis, it wasn't easy to use her oral musculature to support and retain the prosthesis. Medical history revealed that she is a known hypertensive and diabetic patient, though well-controlled. On oral examination, it was observed that she had an upper implant-supported complete denture suspected to have been retained with screws. A similar view was held about the lower implant-supported denture. A careful examination of the mandibular overdenture revealed a smooth matrix outline into which the implant abutments fit without an indication that screws retain it, therefore it was concluded that it was retained by a resilient liner (fig 1).

The lower jaw had implant abutments around the canine and first molar regions. Implant abutments around the first molar regions were at the gingival margin and appear not to have contributed to the overdenture retention. The mandibular ridge was severely resorbed and the vestibular sulcus reduced. Periapical radiographs of the implants revealed adequate implant osteointegration (Fig 2). The

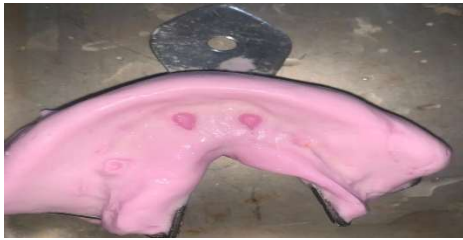
Fig. 3: Alginate impression of the lower jaw

Upper and lower alginate impression was made (fig 3 and 4), and all stages for fabrication of complete denture followed (special tray fabrication of the lower arch, secondary impression, bite registration, try-in of wax denture, denture delivery) (fig. 5 -7). Special consideration was made for the implant abutment to fit into the overdenture as relief for the implant abutment was made on the fitting surface of the denture (fig. 8a, 8b and 8c). Glass ionomer cement was then used to cement the denture on the implant abutment (fig.9a and 9b). Post-insertion fitting was satisfactory and post-insertion instructions were given with follow-up appointments for review.
