DETERMINATION OF GSM SIGNAL PENETRATION LOSS IN SOME SELECTED BUILDINGS IN RIVERS STATE, NIGERIA

ABSTRACT

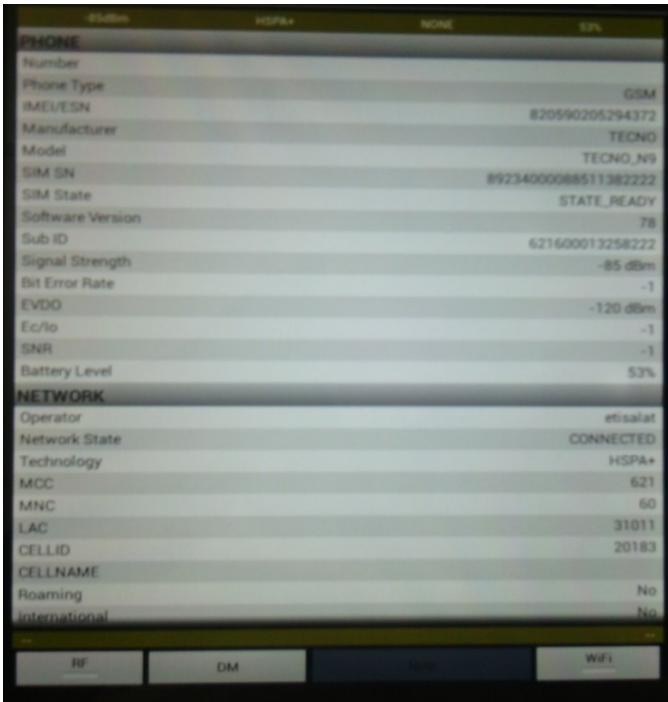
Figure 1: Tecno Tablet MS showing RFST Software data measurement

The measurement locations comprised different buildings as stated in section 2. In each location, sixty measurements were conducted in thirty different days (twice for each day, morning and evening) on each of the building pattern namely: mud building with rusted corrugated iron sheet roof, mud building with thatched roof, sandcrete building with rusted corrugated iron sheet roof, sandcrete building with unrusted corrugated iron sheet roof and building with Alucoboard wall cladding. Figure 1 is a display of one of

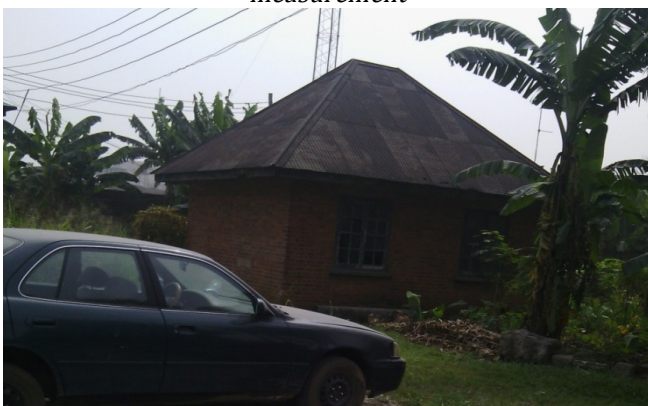
Figure 3: Mud House with Rusted Corrugated Iron Roof Sheet

the measurements conducted on etisalat network while figure 2 is the geographical location of the measurement site as displayed on the RFST software. In each of the buildings, measurements were first conducted outside the building before the inside measurements, this is to ascertain accurate measurement of the wall penetration loss. Figure 3 through 6 respectively is the buildings in which the measurements were conducted.

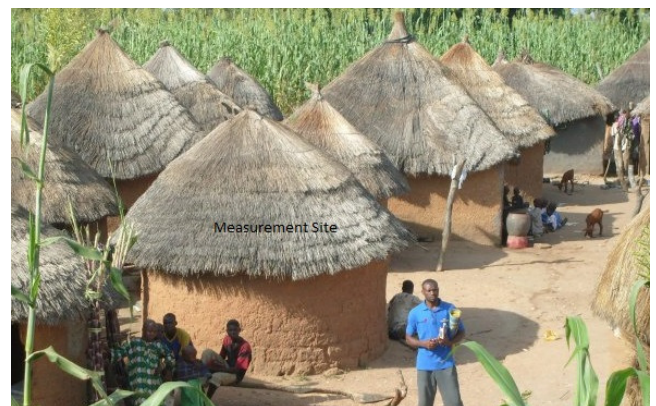
Figure 4: Mud House with Thatched Roof

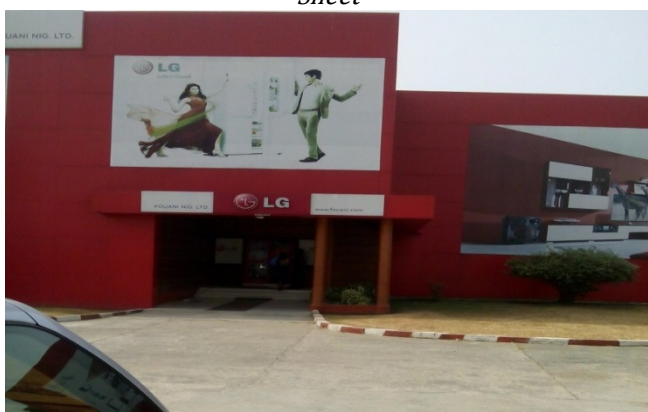
Figure 5: Building with Alucoboard Wall Cladding

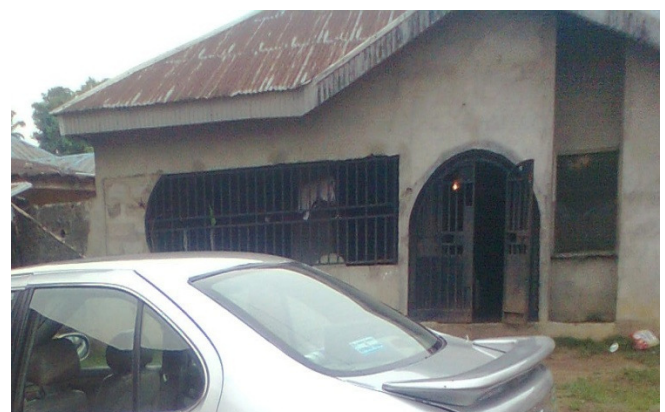
Figure 6: Sandcrete Building with Rusted Corrugated Iron Sheet Roof

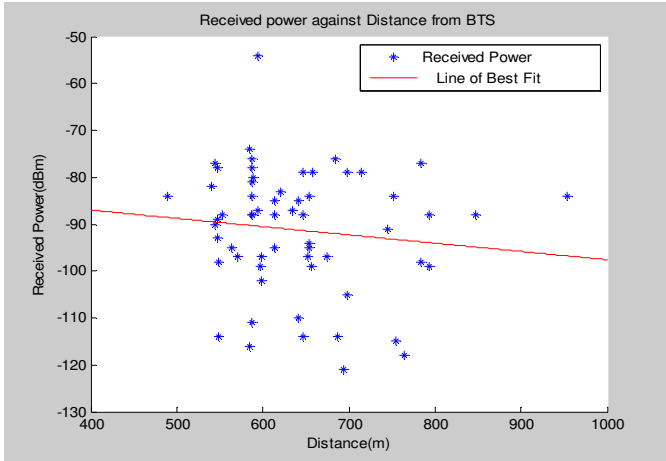
Figure 10: Scatter points best Fit for Elele Measurements

The sandcrete building with unrusted corrugated iron roof sheet has the least signal penetration loss. Figures 10-13 are the plots of the average received power against the distance from the serving base transceiver station (BTS). The line of best fit as well as the equations and their standard deviation are expressed. At Elele, the Etisalat network has the highest received power of -54.3dBm measured in a sandcrete building with unrusted corrugated iron sheet roof and the Airtel network has the least received power of -122.2dBm measured in a building with alucoboard wall cladding. Similarly, at Omoku and Port Harcourt, the MTN network has the highest received power of -53.4dBm

$$y = -0.017629x - 86.95 \tag{5}$$

This means that for every increase of measurement distance of 1m, the received signal strength decreases by 0.0017629dBm and at a minimum distance of 400

meters from the BTS, the received signal strength is -86.95dBm.

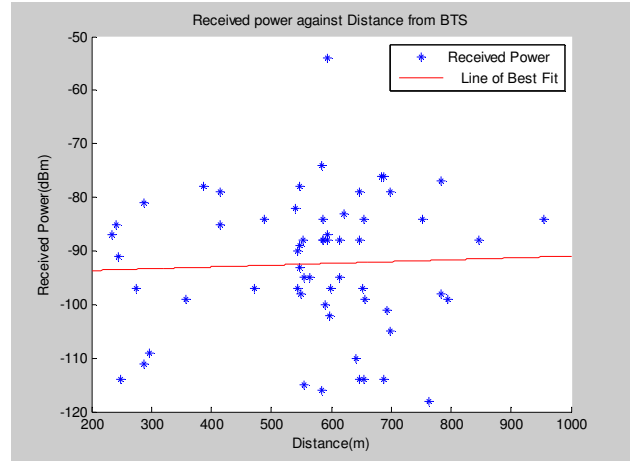
Figure 11: Scatter points best Fit for Port Harcourt Measurements

$$y = 0.0033585x - 94.323 \quad (6)$$

This means that for every increase of measurement distance of 1m, the received signal strength increases by 0.0033585dBm and at a minimum distance of 200 meters from the BTS, the received signal strength is -94.323dBm.

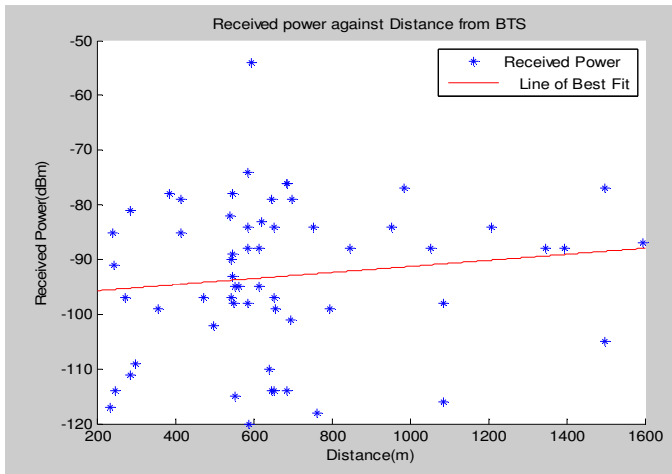
Figure 12: Scatter points best Fit for Omoku Measurements

$$y = 0.0055334x - 96.807 \quad (7)$$

This means that for every increase of measurement distance of 1m, the received signal strength increases by 0.0055334dBm and at a minimum distance of 200 meters from the BTS, the received signal strength is -96.807dBm.

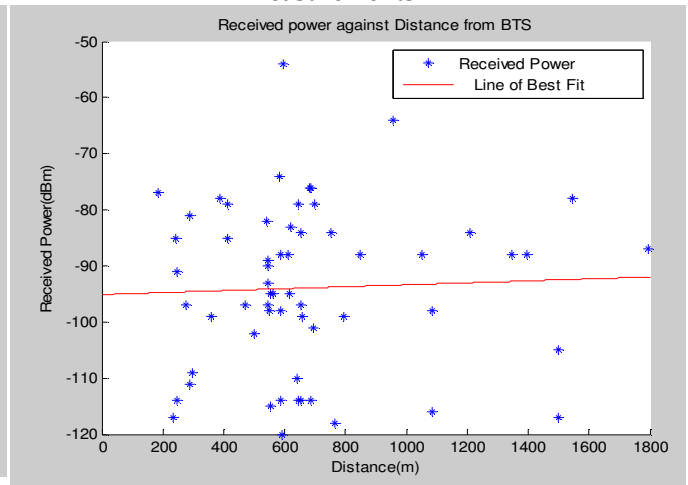
Figure 13: Scatter points best Fit for Emohua Measurements

$$y = 0.0017304x - 95.093 \quad (8)$$

This means that for every increase of measurement distance of 1m, the received signal strength increases by 0.0017304dBm and at the BTS, the received signal strength is -95.093dBm.
